SB, Trimmy S II – 343 R, 345 RX, Washer, 2004-06

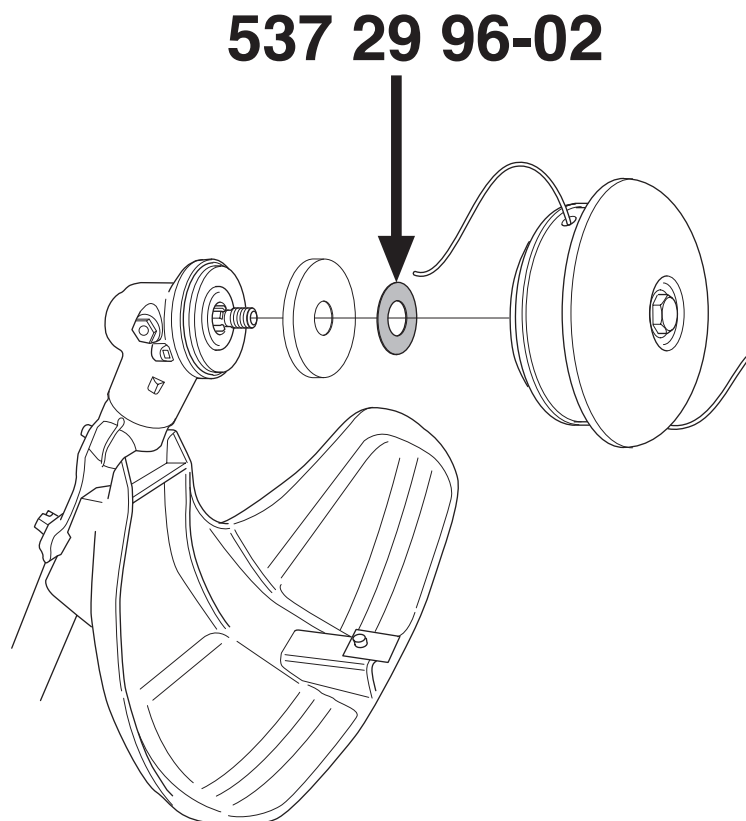
When the Trimmy SII is fitted to the 343R and 345Rx a gap occurs between the driver on the bevel gear and the top of the trimmer head. This means that the trimmer head is not held securely enough and can slip. This causes heat to be generated, which melts the plastic in the trimmer head. The gap occurs because the output shaft is slightly too long and makes contact with the shoulder on the trimmer head where the thread starts. To prevent this happening a washer must be fitted between the trimmer head and the driver. This only applies when the Trimmy SII is fitted to the 343R and 345Rx.

NOTE! The washer, part no. 537 29 96-01, must not be confused with the cup, part no. 537 29 24-01, that sits on the driver.

The washer will be supplied with the Trimmy SII. For machines where the washer, part no. 537 29 96-02, is missing it must be ordered separately.
