SERVICE  	 	7 B0400044
--	--	-----------------------------

SB, Rider, Articulated joint for hydrostatic wire, 2004-06

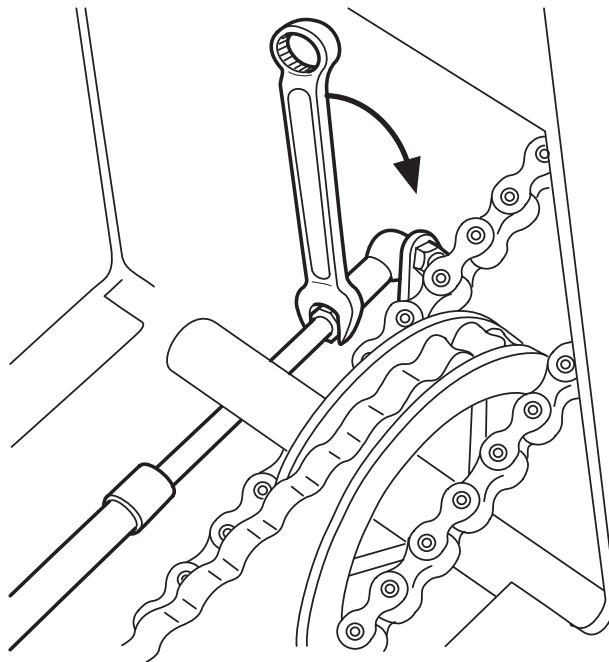
During checks at the assembly factory it has been found that the mounting for the front articulated joint for the hydrostatic wire may be fitted with too low a torque. This could result in play occurring in the hydrostatic wire.

The torque must be checked before delivery or when servicing is carried out.

The recommended torque is 5–7 Nm.
