## 154

### CRANKSHAFT END – CLUTCH

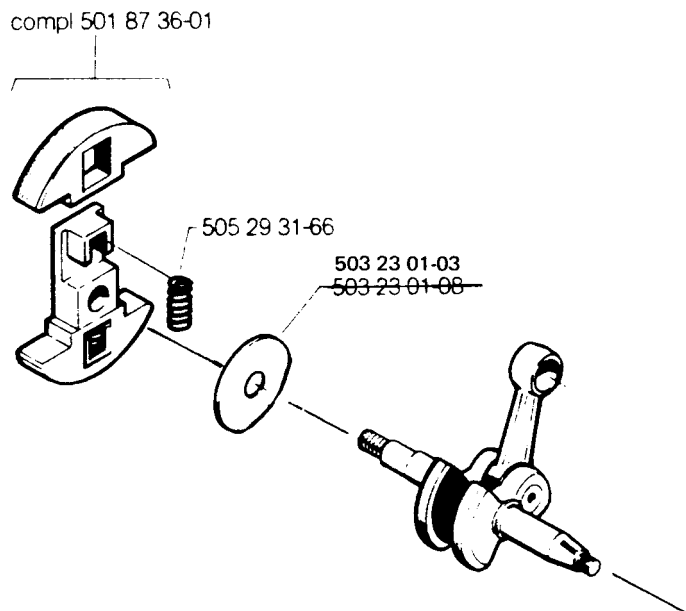
Our field reports tell about some broken off crankshaft ends on the clutch side.

By changing the washer, you will receive a better centering of the clutch and a better contact against the thrust on the crankshaft.

In order to prevent more of these failures, the following measure must be taken on all 154 saws in stock and on saws which are brought in for service and maintenance:

Washer 1 mm = 503 23 01-08 should be exchanged to washer 1.5 mm = 503 23 01-03.

Approved yellow marked clutch and 1.5 mm washer were introduced in our production from serial number:

154 SE	5233801
154 SG	5360529
