<b>SERVICE</b>

<b>8</b>
		X 87.106-26

MODEL **40**

THROTTLE CABLE

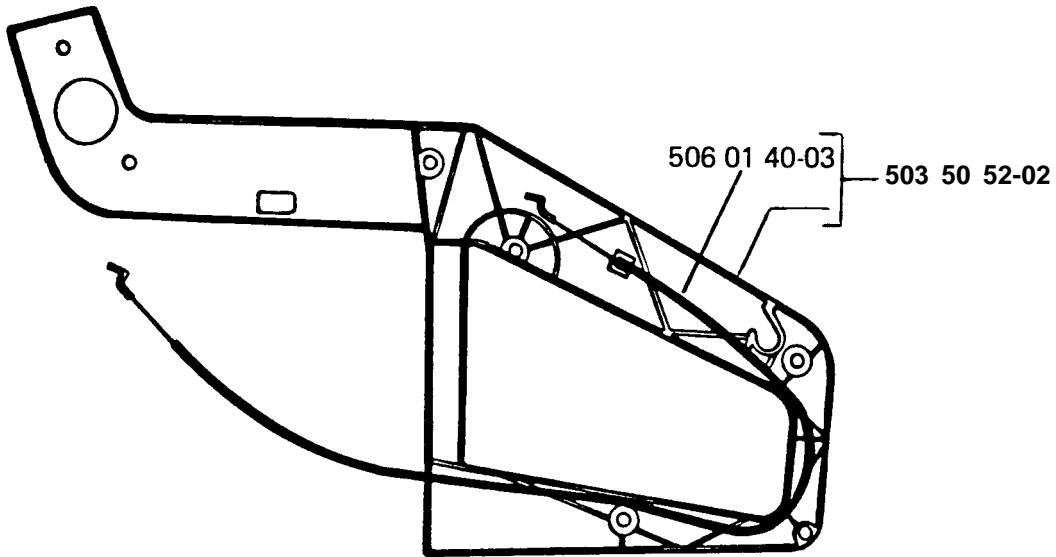
In order to prevent water to penetrate down between cable and cover, which in extreme cases may cause the cable to freeze, the attachment to the throttle cable is changed in the rear handle. At the same time the throttle cable receives an extended cover.

<u>New Ref. No.</u>	<u>Description</u>	<u>Excluded Ref. No.</u>	<u>Remark</u>
503 50 52-02	Handle half with throttle cable compl.	503 10 53-01	
506 01 40-03	Throttle cable compl.	506 01 40-02	Remains as a spare part

The change was introduced from serial number 7121299.
