RIDER 850 - THE 1988 MODEL

7: X 88.008-26 1.15 5-88

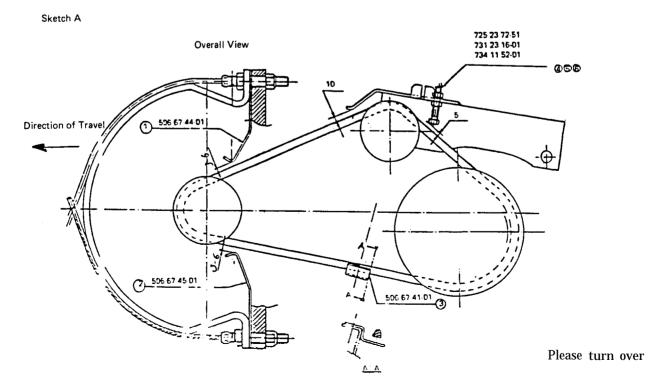
The 1988 model of the Rider 850 features a new gearbox. Since the gearbox has now been reinforced, and has four carrier keys where the old gearbox had only two, the friction in the gear shift mechanism is greater. This can sometimes make it difficult to disengage a gear, especially on a slope. The drive belt tries to become circular when the gears are disengaged, and is thus touching the drive wheels of both the engine and the gearbox. This results in the gear shift mechanism becoming "prestresses" and makes it difficult to engage the next gear.

How to remedy the problem: Fit belt guides as shown in Sketch A. The plates (1) and (2) should be fitted to the fastenings in the steering spindle for the steering cables, A further plate (3) should be fixed to the fastening for the clutch cable as shown in Sketch B. The bolt (4) should be fitted in the groove in the disengagement arm, and then adjusted so that the distance between the head of the bolt and the belt is 5 mm when a gear is engaged. The bolt should be at the same height as the belt.

Fitting these belt guides produces complete disengagement of the gearbox drive wheel, and makes the gears easy to change.

Sketches C and D show the plates that should be fitted to the fastenings in the steering spindle.
