SERVICE 		3
		X 89.123-26

MODELS: **40, 45**

SUPPLEMENT TO SB X 89.121-26

IGNITION MODULE, FLYWHEEL, CRANKSHAFT

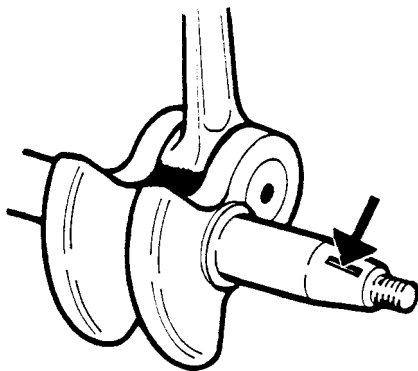
503 11 21-01

On both models the conventional location of a key in a keyway on the crankshaft is replaced by a flywheel with a cast-in key. This means a new type of recess in the crankshaft (see ill.).

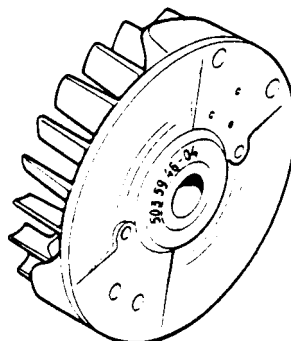
On the model 40, a Phelon-ignition module is placed, whereas the model 45 keeps its ignition module. This means two different flywheels, which when mounted on a saw are separated by the different design of the ignition modules. Identification of not mounted flywheels is done by the casted-in Ref. No. (see ill.).

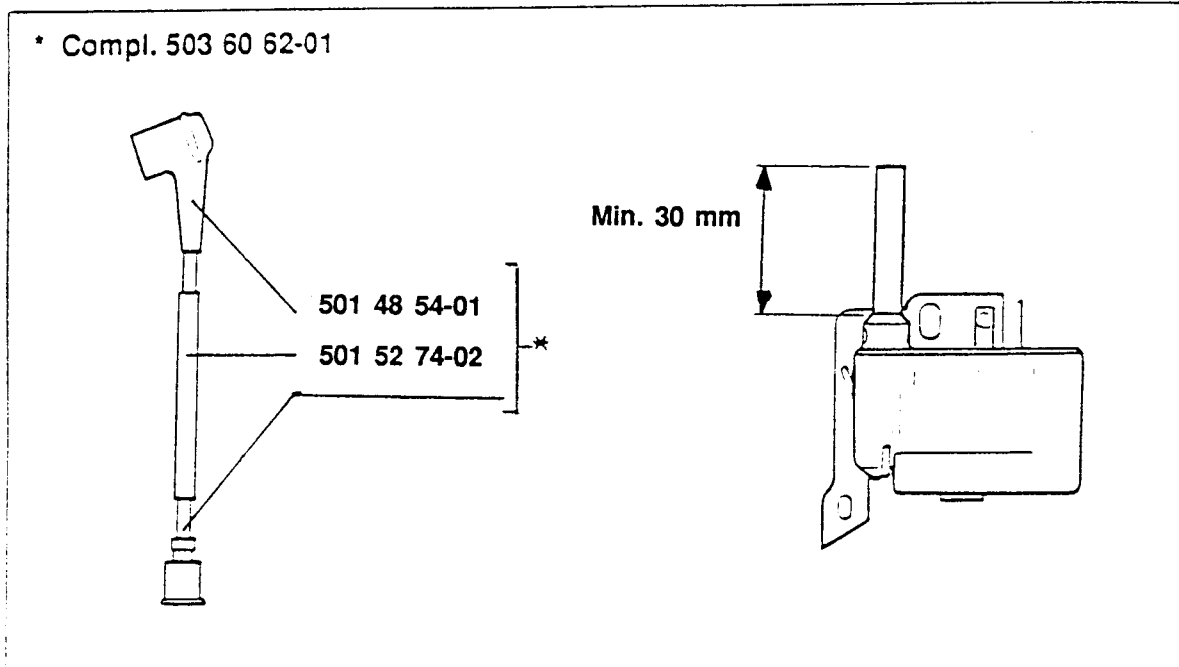
The new ignition module on the model 40 Ref. No. 503 58 05-01 has a thicker ignition lead than the lead on the model 45 Ref. No. 506 02 72-01. The ignition lead on the model 40 is moulded to the module, whereas the ignition lead to the other ignition module is threaded.

In order to be able to repair a damaged ignition lead on the Phelon-module, we have introduced a repair kit Ref. No. 503 60 62-01 (see ill.)
