## Model Royal 48S

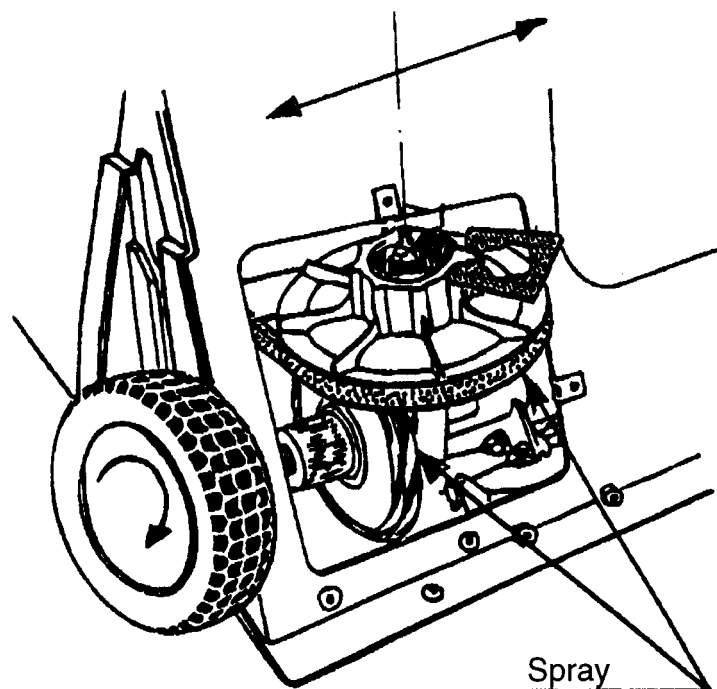
There are a small number of 1995's Royal 48S machines where the drive system does not disengage when the clutch lever is released. The reason for the fault is the drive shaft seizes in the bearing retainer. The fault is corrected as follows:

1. Dismantle the cover plate so that the transmission is accessible.
2. Apply rust removing lubricant spray as shown in the diagram.
3. Rotate the drive shaft using the rear wheels. If this is not possible, dismantle the rear wheels and rotate the rear axle using a screwdriver in the key slot. NOTE! Take care not to create burrs on the slot with the screwdriver,
4. Turn the bearing retainer axially at the same time as the drive shaft is turned.
5. When the bearing retainer can be turned axially, the wheels are refitted. Run the lawn mower for a maximum of 5 minutes, varying the speed of the variator.
