**MODEL: 335 XPT**

## **SUBJECT: Chain Lubrication**

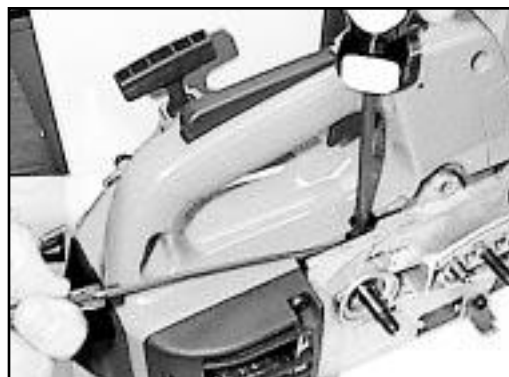
### **Step 2**

It has been reported that the oiler does not oil or that it takes a long time to get the oil to the bar. We have found that the Loctite used to insert the oil feed line nipple into the crankcase has clogged the oil supply hole. Sometimes this Loctite hardens and will not let the oil flow through or after the saw has run for several minutes it will begin to oil at a restricted rate. Husqvarna Sweden is in the process of correcting this. For the ones already in the field and until the changes have been made in assembly, you can eliminate this by following this procedure. We find this is a simple repair that will save you time and keep your customer's saw in good running order.

- Use a small stiff screw driver placed between the crankcase and oil adjust screw. Pry the screw over so you can take a second screw driver to back the oil adjust screw out until the oil pump piston is free and can slide to the rear of the saw.
- Once this is done you can use a small piece of stiff wire and clean the bar oil supply hole in the crankcase.
