SERVICE BULLETIN 405 4 CYCLE

SUBJECT: OHV16 thru 17 Falters Due To Lean Fuel Mixture (With fuel shut-off solenoid)

MODELS AFFECTED: OHV16 thru 17 Specification Nos. 204216D, 204217D, 204224D, 204228D, 204604A, 204605A, D.O.M. (Date of Manufacture) Affected 6280 - 7091 Located on ID Tag.

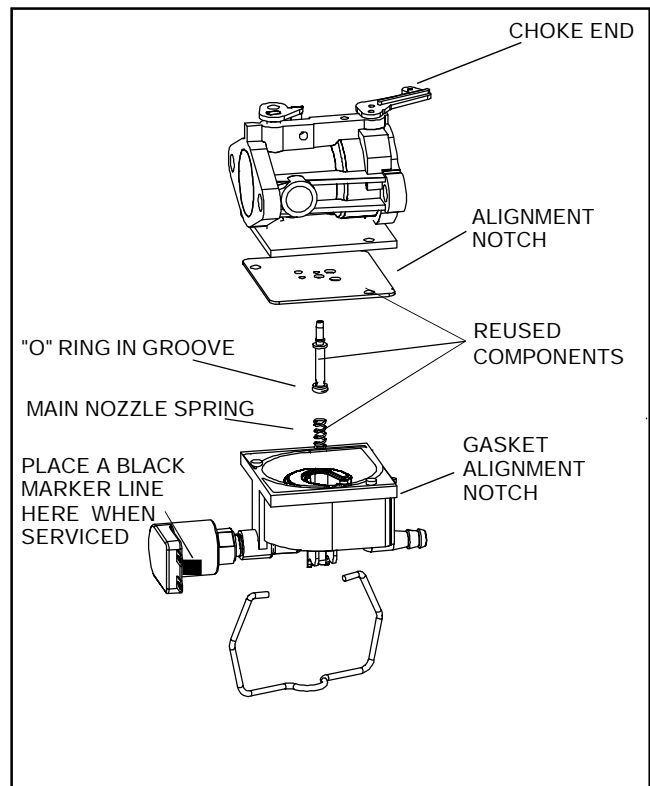
We have received field comments regarding faltering or a lean condition on OHV16 thru 17 HP engines equipped with fuel shut-off solenoids. The manufacturers affected are Ariens and MTD products.

The engineering department has investigated this concern and verified this could occur after 20 - 30 minutes of warm up under the following conditions:

1. Winter/Spring fuel blends which are sensitive to warmer temperatures.
2. Under no load or light cutting conditions.

Install the bowl kit with transferred parts as noted in Item 6 above. NOTE the gasket has a notch which lines up with the "V" mark on the fuel bowl. The bowl must be reinstalled as shown with the locating pins properly engaged into the carburetor body. To identify repaired units look for or place a permanent black magic marker line across the flat steel portion of the solenoid facing out as shown. (See Illustration)
