Service Bulletin

W-101

Model: 146Z836P190 & 145Z836P190 (GT-205)

Subject: ENGINE OVERHEATS AND VAPOR LOCKS

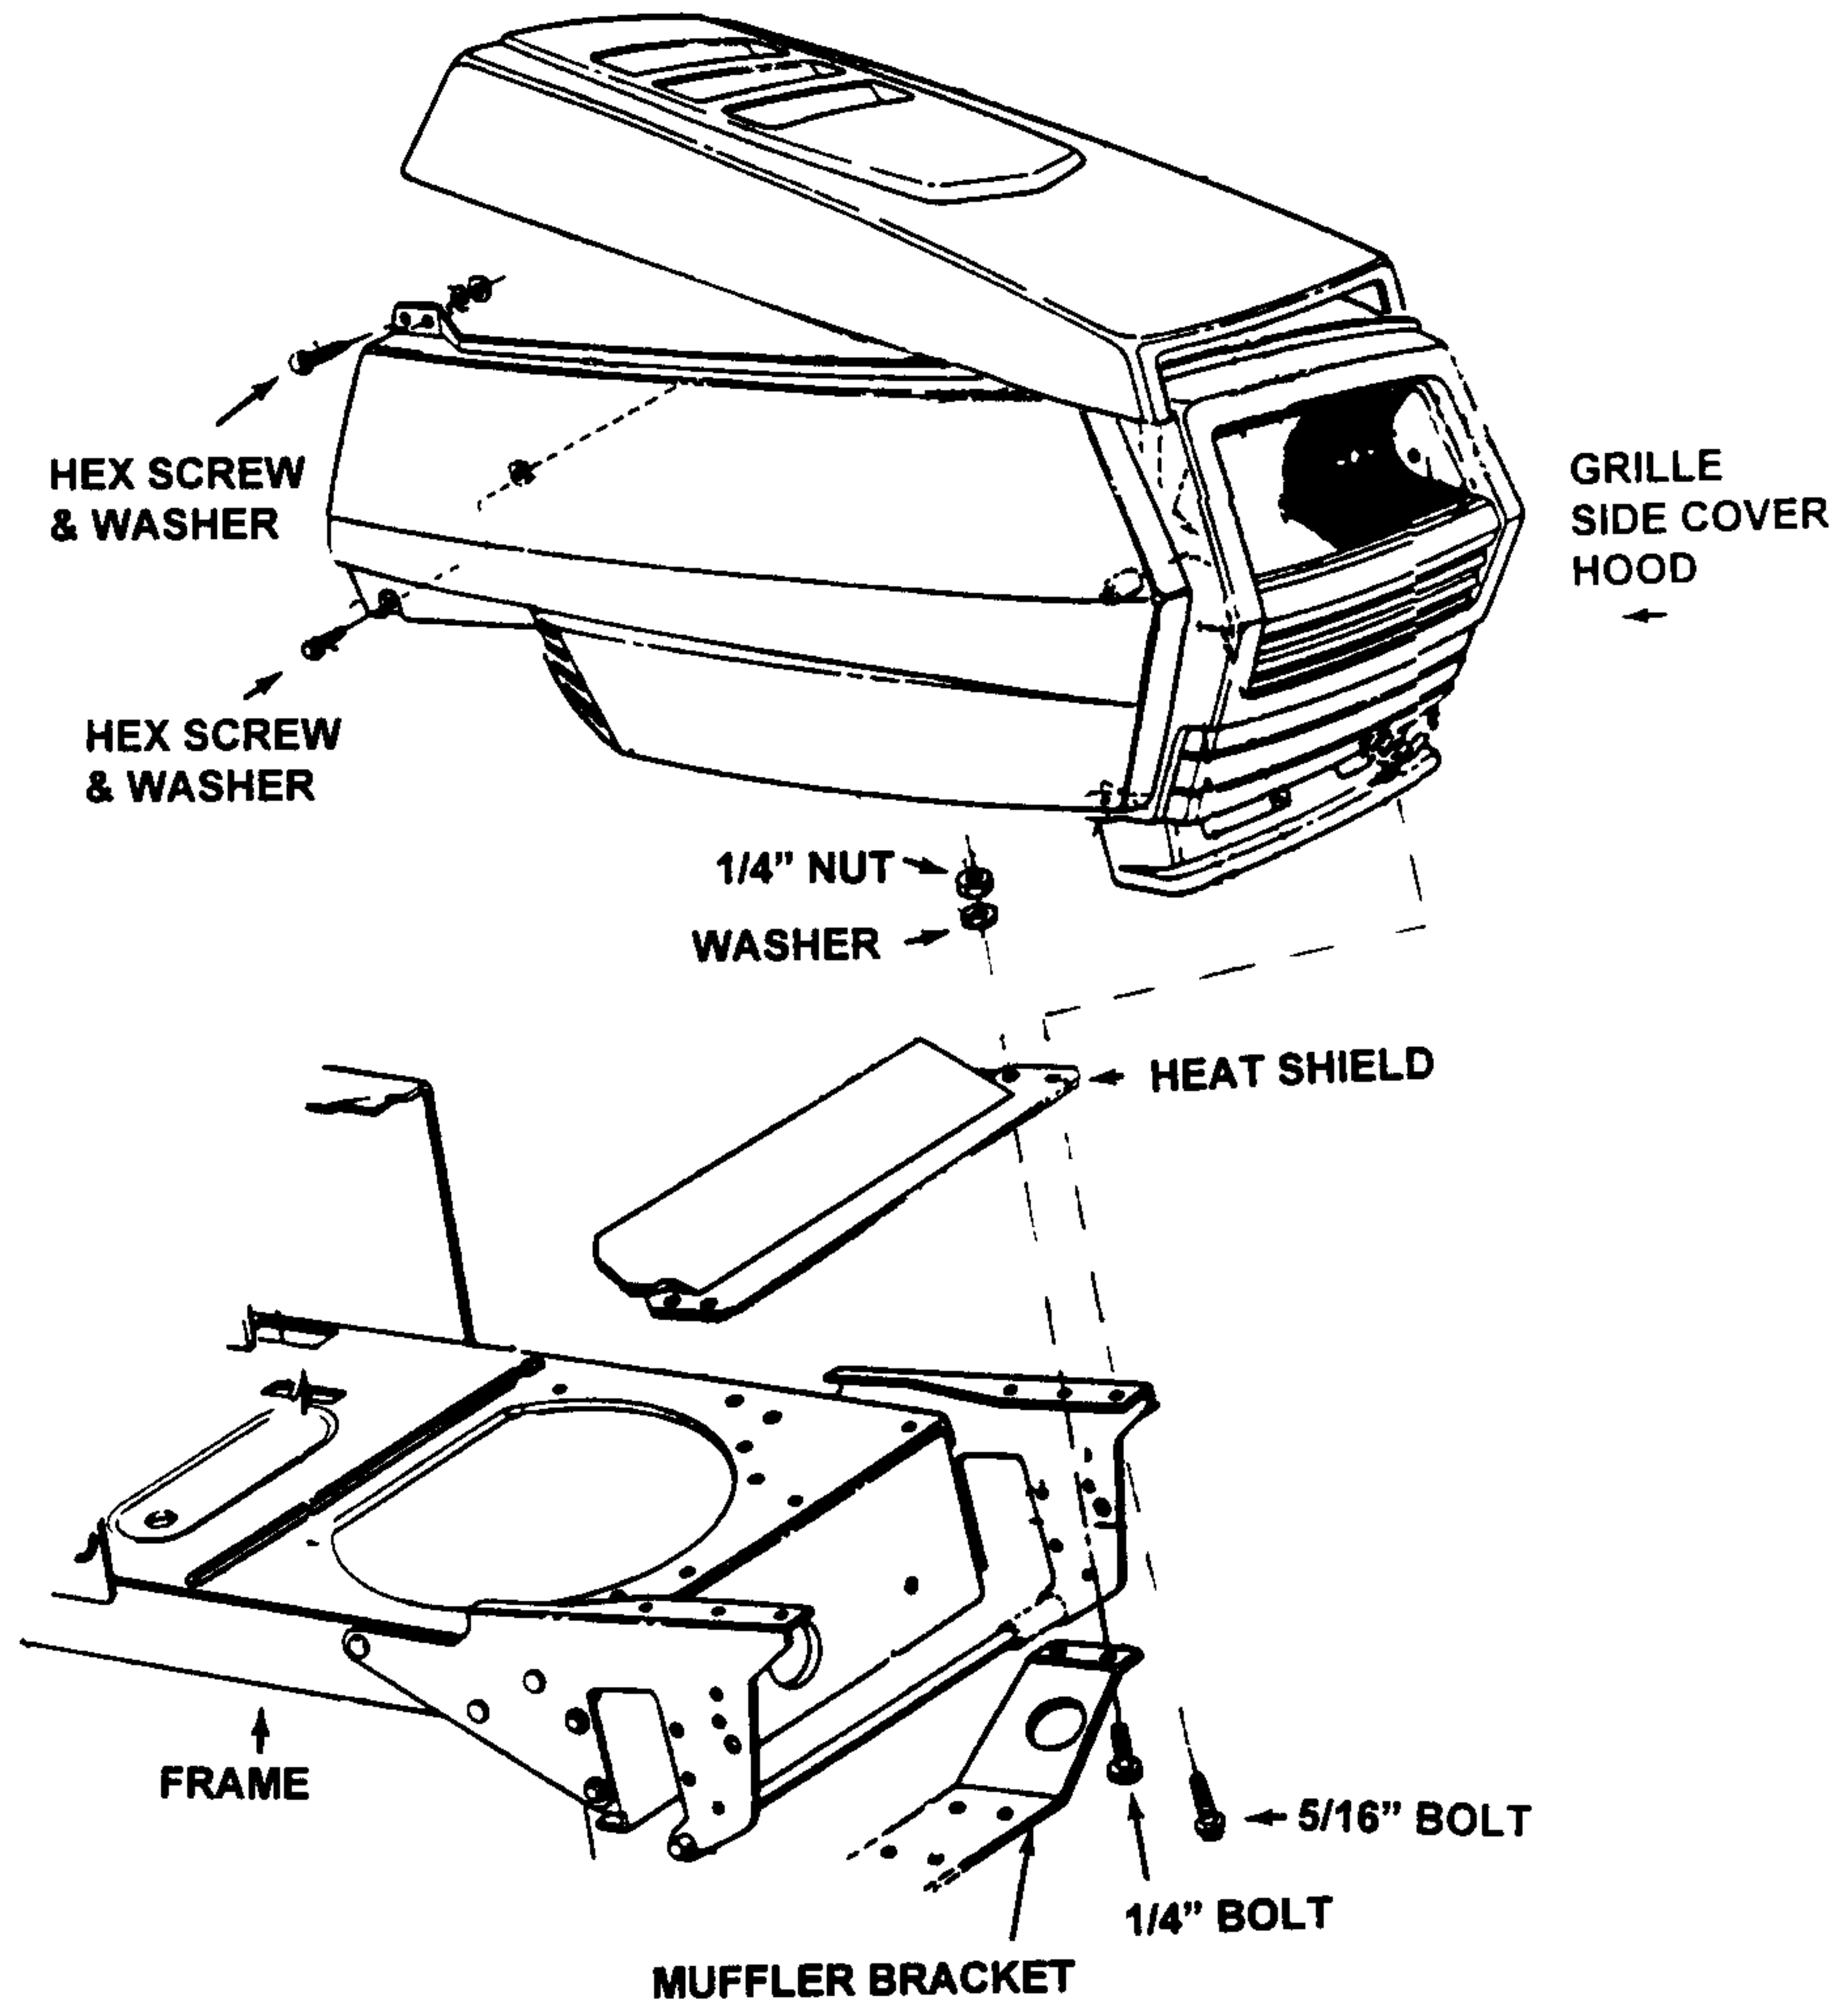
PROBLEM: Grass clippings or debris plug the air intake or blower housing causing the engine to overheat and vapor lock.

SOLUTION: Order and install 783-0394 heat shield. Tractors built for the 1997 model year will have the heat shield.

5. Locate the four 1/4 inch hex nuts and bolts securing muffler mounting bracket to the frame. Remove the two forward 1/4 inch hex nuts and washers from the frame. Do not remove the 1/4 inch bolts.

6. Position heat shield on the frame as shown on back of this bulletin and secure with two 1/4 inch nuts and washers in step 5.
7. Reassemble. Note: The hex bolt in step 1 must be 5/16-18 X 1 inch. If not, obtain locally.
