Service Advisory

W-117

Model: GT-2550 14AZ816P190

Subject: DECK HANGER FOR 50-INCH DECK

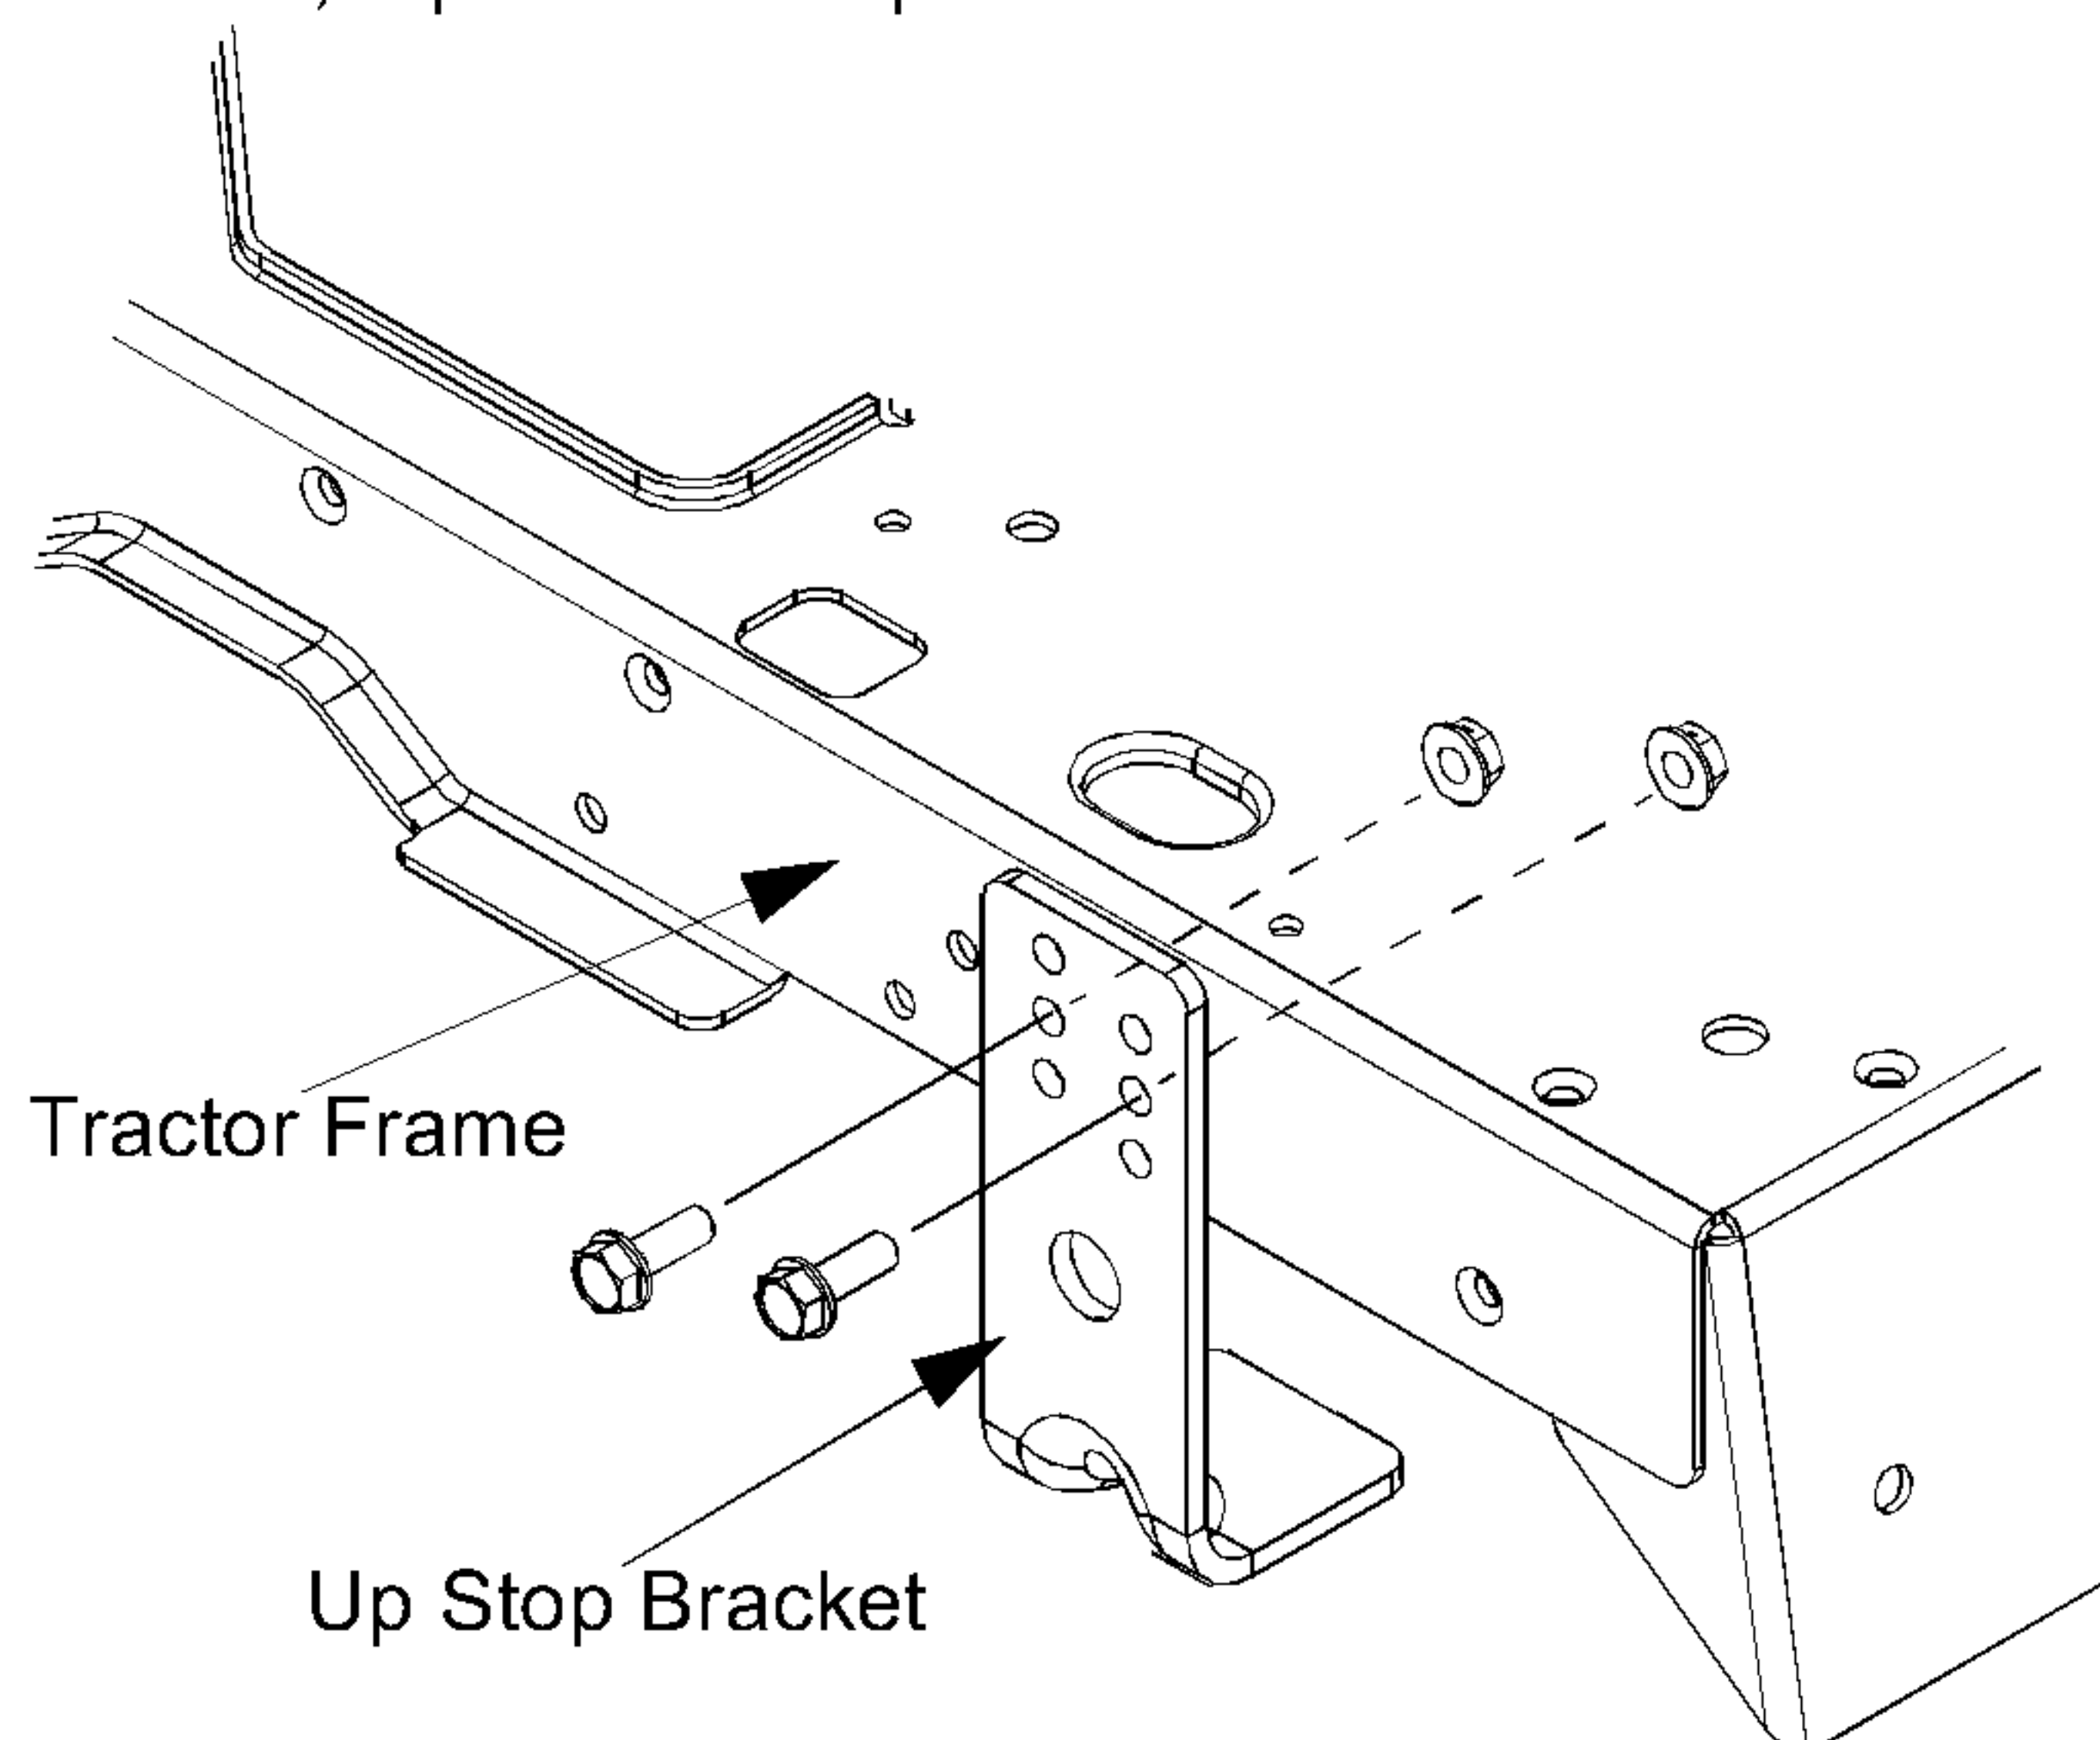
Figure 1

Service Advisory W-117 applies to garden tractor model GT-2550 (14AZ816P190). This Advisory should be used in cases where the deck is difficult to raise into the upper cutting heights due to interference with the up-stop bracket once the deck has been leveled correctly.

1. Locate the **up stop bracket** on the right side of the **tractor frame** in front of the deck. See Figure 1.
2. Make sure it is mounted using the center set of holes as shown. See Figure 1.
3. If the bracket on your tractor does not have three sets of holes, replace it with part number 783-0891B.

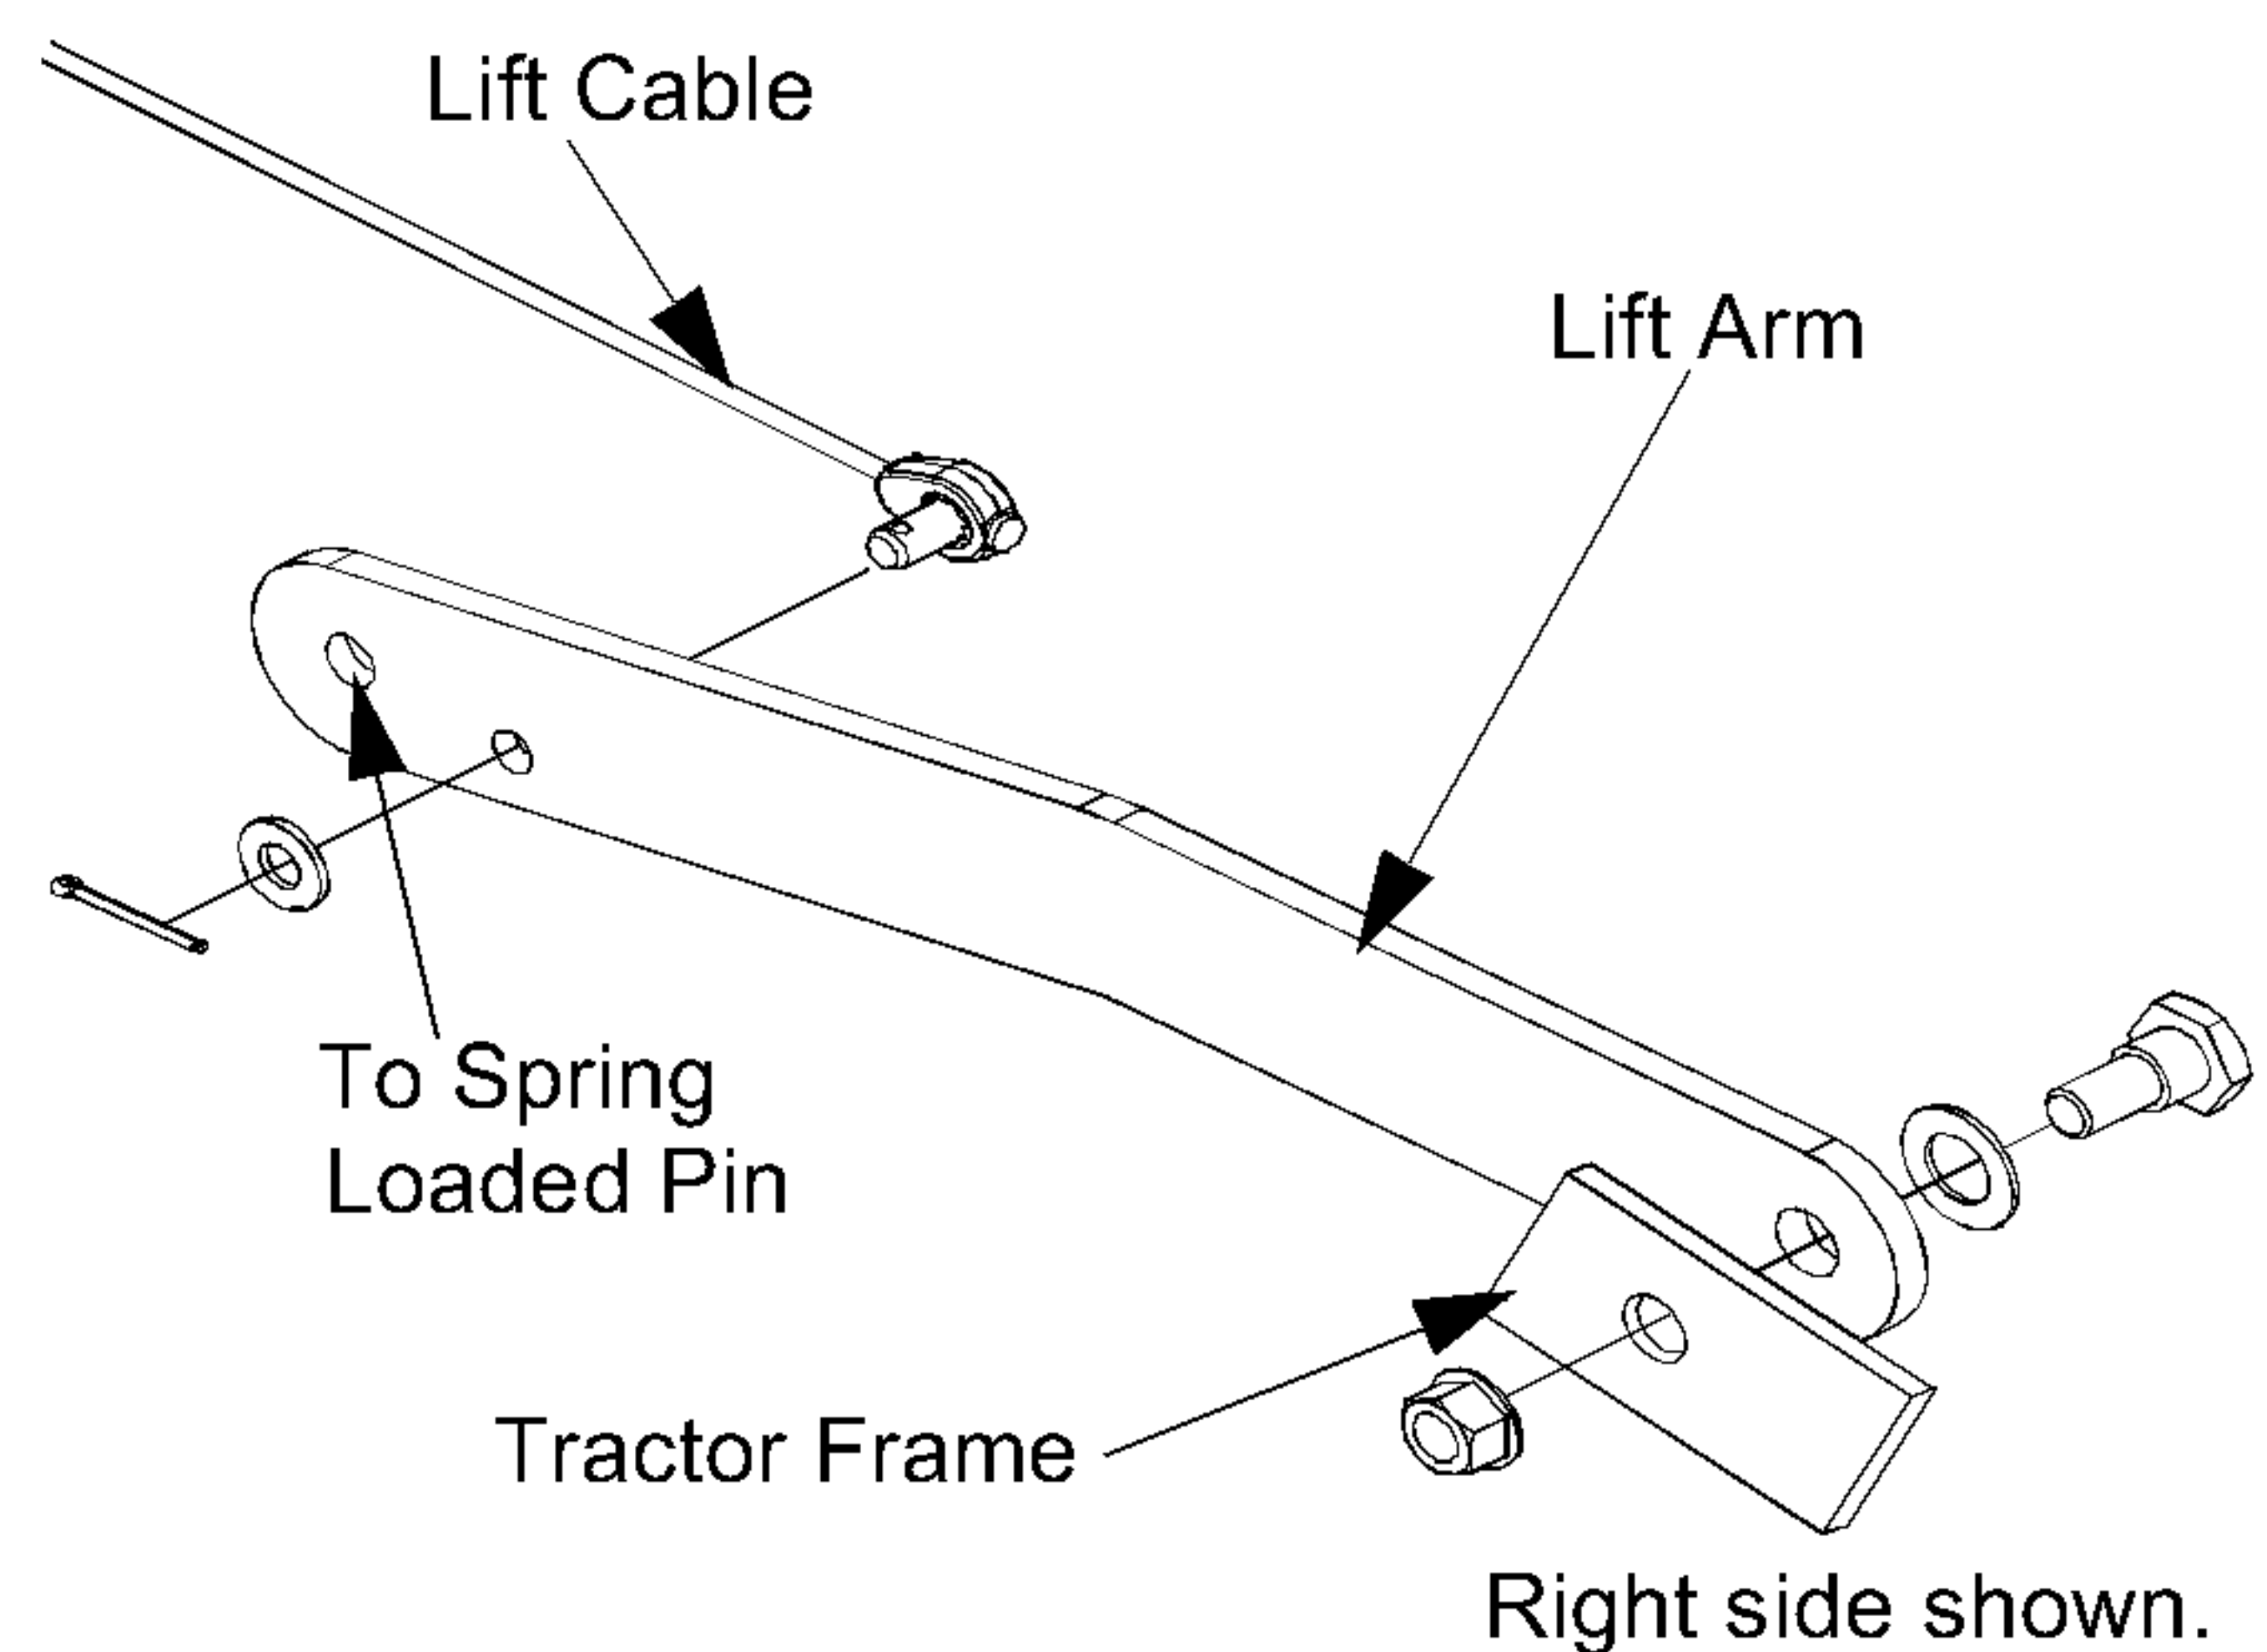
Figure 2

If, with the deck leveled and the up stop bracket installed correctly, there is still interference between the deck and bracket in the upper cutting heights, proceed with the *lift arm modification*.

1. Remove the **lift arms** from both sides of the tractor by disconnecting them from the spring loaded pins at the rear of the deck, the **lift cables**, and the **tractor frame**. See Figure 2.
