Supplement Sheet

Subject: Torque Bracket Rework

Models Affected: See below - "Is my unit applicable to this rework?"

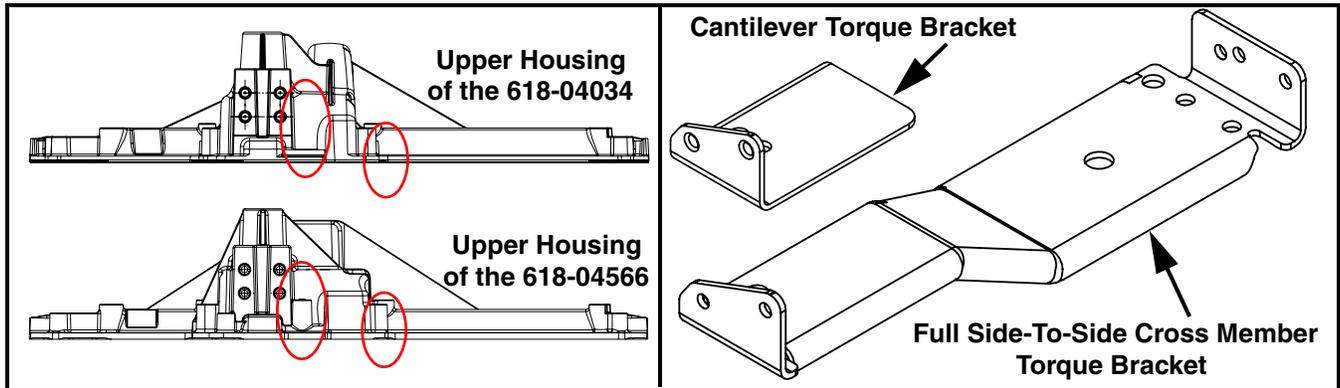
FIGURE 1

The configuration of the upper housing of the new 618-04566 transmission (See Figure 1) will interfere with the cross member torque bracket at two points. This results in the transmission not seating onto the frame at it's mounting points.

1. Lawn tractor is a 600 Series AutoDrive, Transmatic or Shift-On-the-Go (non-hydrostatic transmissions) model
2. The existing transmission, being replaced, is a single speed 618-04034. See area of concern in Figure 1.
3. The existing torque bracket is a full side-to-side cross member style as shown in Figure 2.
