Service Bulletin

Bulletin No: 2007-1-08 Subject: Servomotor Clip

All 2007 F8, M8, and Crossfire Models

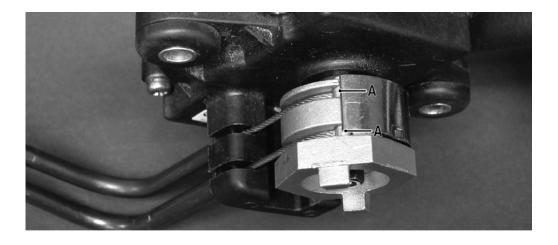
Fig. 1

Condition: In some cases, the production servomotor clip may come into contact with the

APV cables. If this condition should occur, the APV cables may become frayed

and eventually break.

Solution: Replace the production servomotor clip with updated Servomotor Clip (p/n

5606-208).

■ NOTE: When installing the new servomotor clip, be sure that the clip is positioned on the controller pulley with the wide end of the clip directly over the ends of the exhaust valve cables (A). See Fig. 1.
