SERVICE 		2
		B0200015

SB, 340, 345, 350, Crankcase, Ball bearing, 2002-02

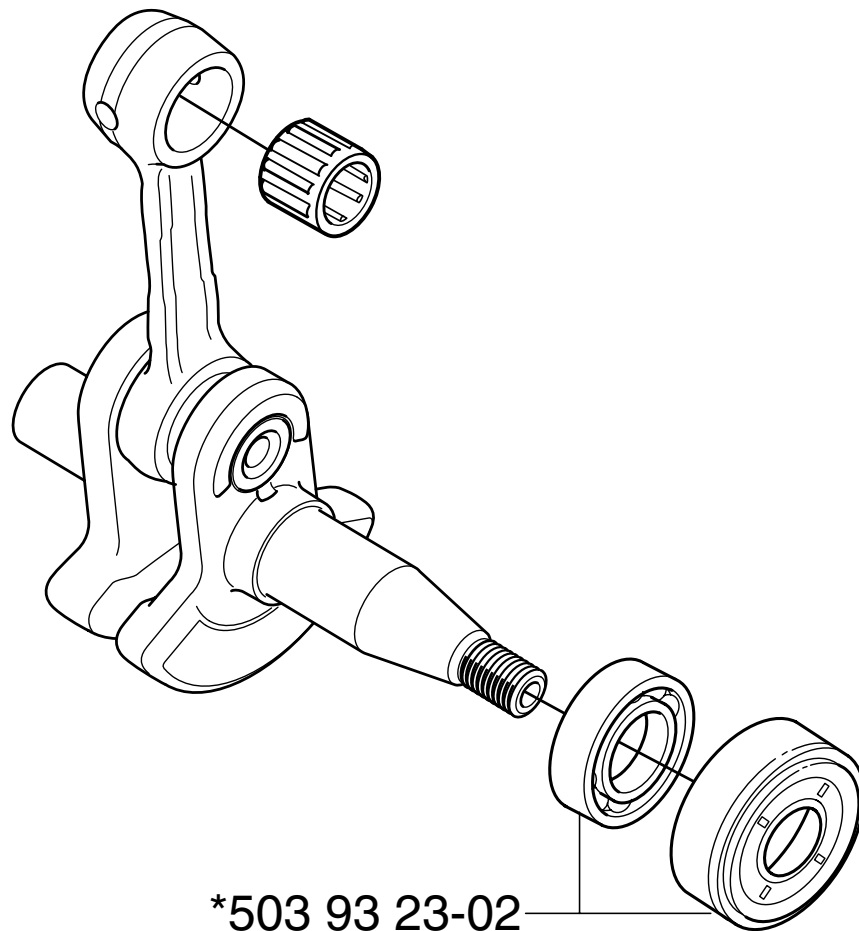
The fitting of the bearing and bearing holder has been improved. A modified fitting procedure prevents misalignment of the bearing. The bearing holder has been replaced with a more heat-resistant material (Viton). The bearing holder, which was previously black, is now brown.

Introduced from serial number:	340	012500001
	345	012500001
	350	012303701

New part no.	Description	Excl. part no.	Remark
503 93 23-02	Bearing holder	503 93 23-01

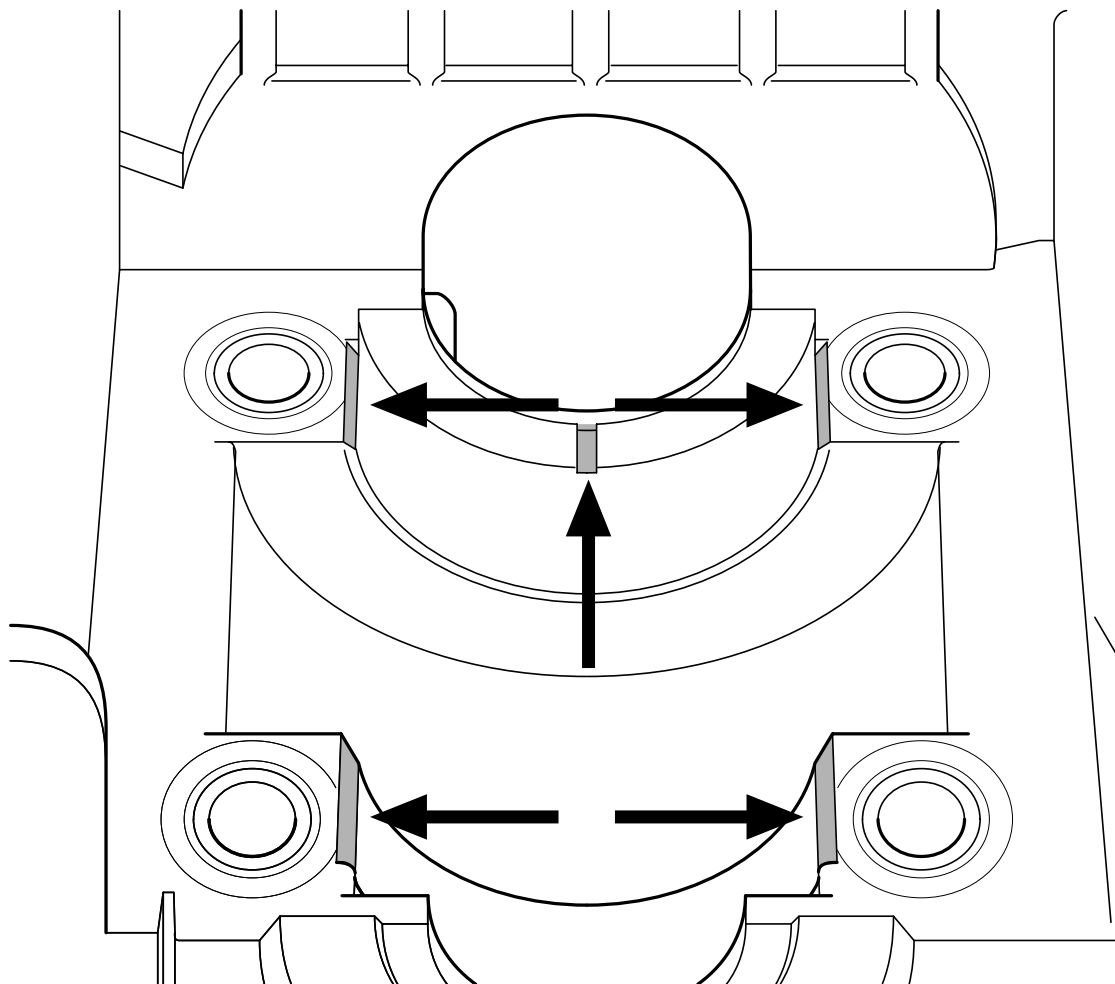
Increased space in the crankcase allows the rubber part of the bearing holder to expand.

Introduced from serial number:	340	012200961
	345	012203011
	350	012201261

New part no.	Description	Excl. part no.	Remark
537 17 20-01	Crankcase assy.	503 85 15-02

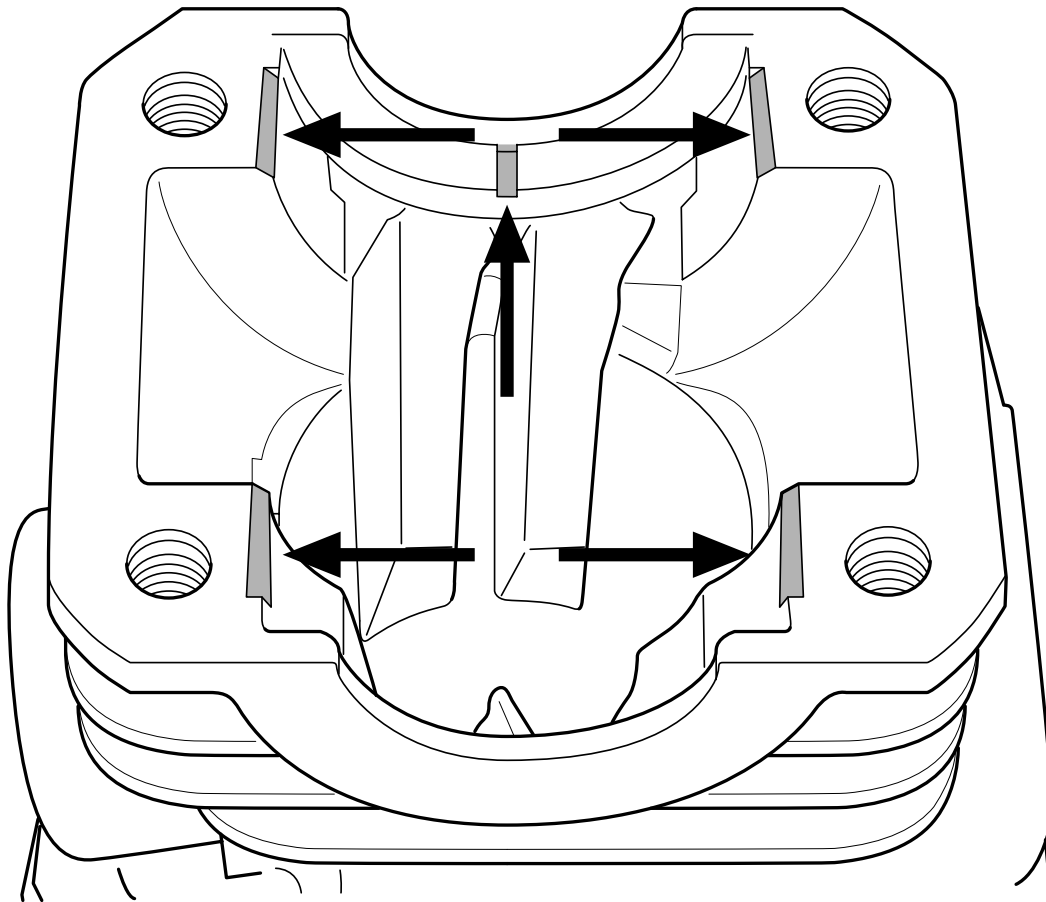
The bearing seats on the cylinders have been widened to provide additional space for the expansion of the rubber part of the bearing holders. This change means a further reduction in temperature.

Introduced from serial number: 340 014203601

New part no.	Description	Excl. part no.	Remark
503 87 00-76	Cylinder assy.	503 87 00-73	340
