<b>SERVICE</b> 		<b>10</b>
		<b>B0200050</b>

## SB, 322, 323, 325, 326 series, Drive shafts, 2002-06

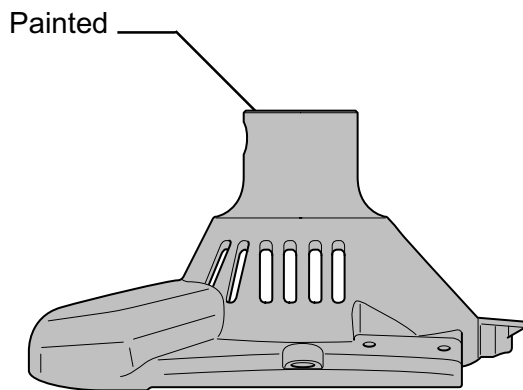
537 04 12-03

A new version of clutch cover has been introduced with a cut-out for the vibration damping element that has a larger radius, part number 537 04 12-03. The collar of the new clutch cover is painted to make identification easier.

Replace clutch cover with 537 04 12-03.
