SB, Riders, Steering column, 2003-04

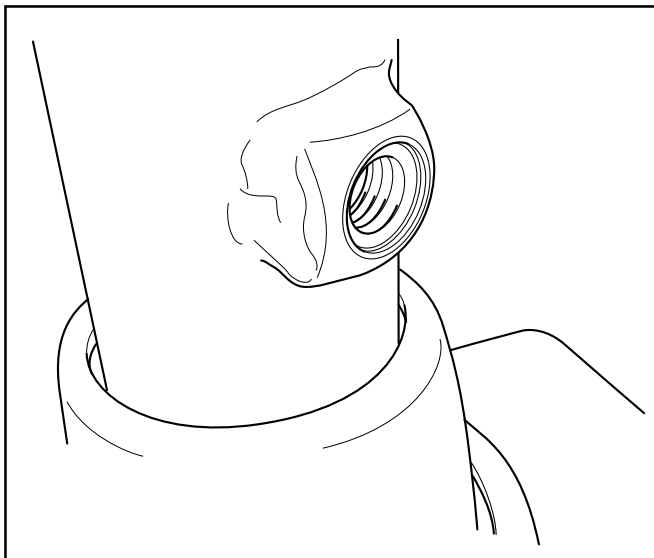
Diagram no. 1

For a short period, steering columns have been produced with mounting holes that have too large a thread tolerance. See diagram no. 1.

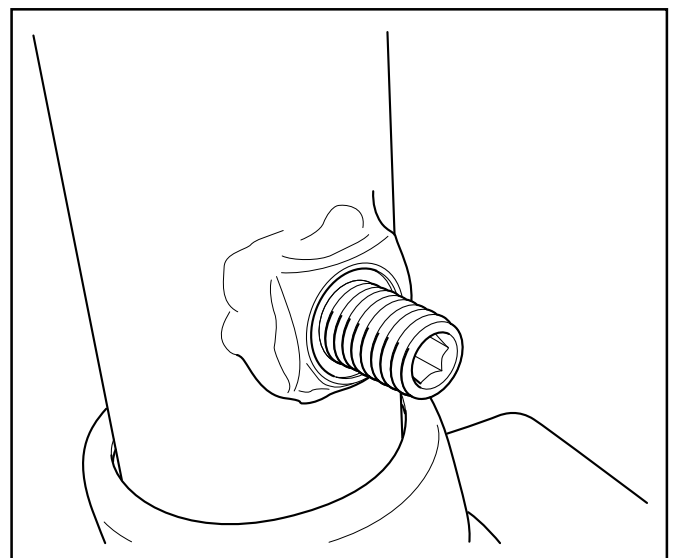
Diagram no. 2

This means that there is a risk that the threads on the mounting may be stripped if excessive torque is used when tightening the locking screws (728 74 55-05). See diagram no. 2.

If a thread is damaged it is recommended that an M8 Helicoil is fitted.
