Service
Note

N0001001

Model(s) Affected: 322 / 325 Series Trimmers

Subject: Broken Throttle Cable Levers

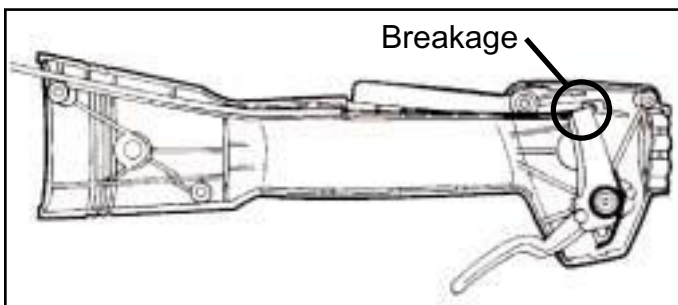
Figure A

We have found that in some cases, the travel of the trigger is greater than the travel of the carburetor throttle valve.

If the operator continues to squeeze the trigger, the excess force causes the trigger lever to break (Figure A).

If you experience this problem, please perform the following modification in addition to replacing the broken trigger lever.
