# **Husqvarna**

**S e r v i c e   N o t e**

**SUBJECT:** Steering may not turn full right or left. Spindle arms may interfere with cast iron axle due to lack of washers.

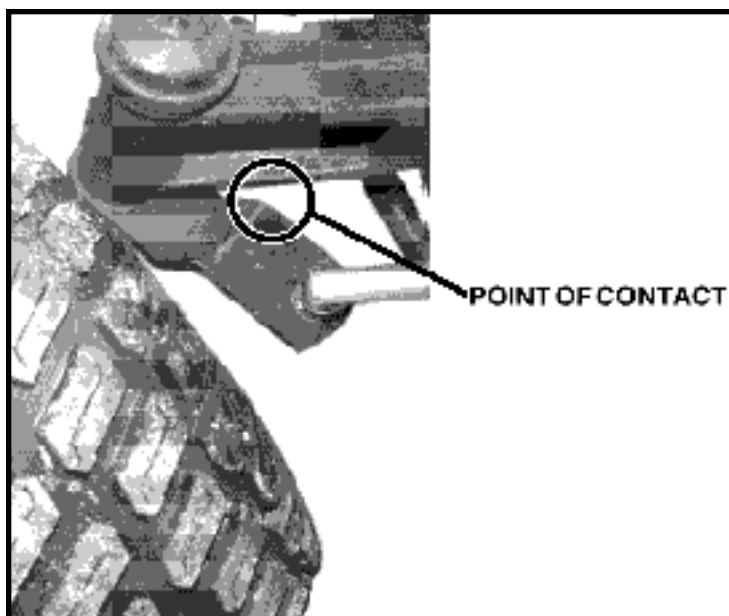
With the unit resting on a flat surface, turn the steering wheel for a full left and right hand turn. If either the left or right hand spindle arm interfere with the bottom of the axle, the unit must be reworked per the following instructions.
