Service
Note

N0203022

Subject: Steering Dampeners - Part Number 539102720

Effected Model Numbers: All Commercial Turf Care Mini and Large ZTH Riders (excluding the Gen One)

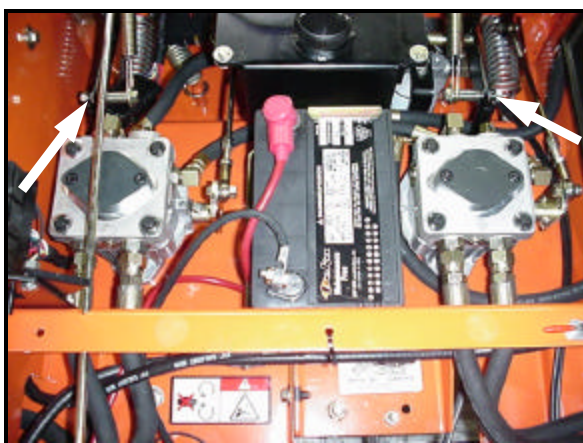
Gen II Compartment Facing Forward

It has been determined that the locknut on the bolts that retain the steering dampeners may be too tight. This places the dampener clevis in a bind, side loading the dampener. This side load may cause premature failure of the dampener seals.

**Upper Dampener
Attaching Points
(White Arrows)**

There must be 1/8" to 3/16" clearance at the dampener clevises, both on the upper and lower mount. Additionally, there must be no interference between the dampener shaft or body and any part of the frame or other fixed object.

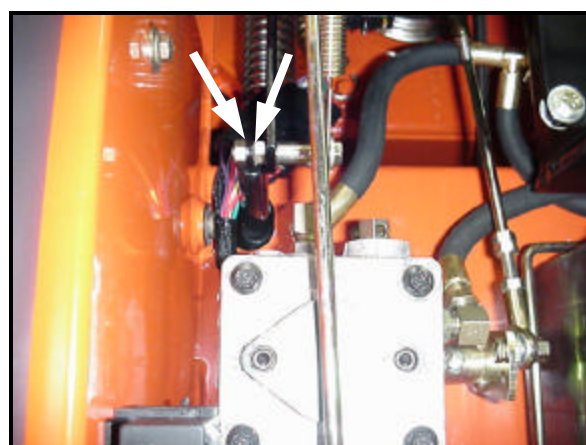
Gen II Upper Left Dampener Shown

**Dampener Clevis
Clearance
(White Arrows)**

During pre-delivery on any effected ZTH Rider, and any time a dampener is replaced, the recommended clevis clearance must be present at both ends of the dampener, and the dampener must not bind on anything throughout its' full forward/reverse stroke.
