SERVICE BULLETIN 121

Subject: Excessive Oil Usage

Models Effected: HM 80,90 and 100

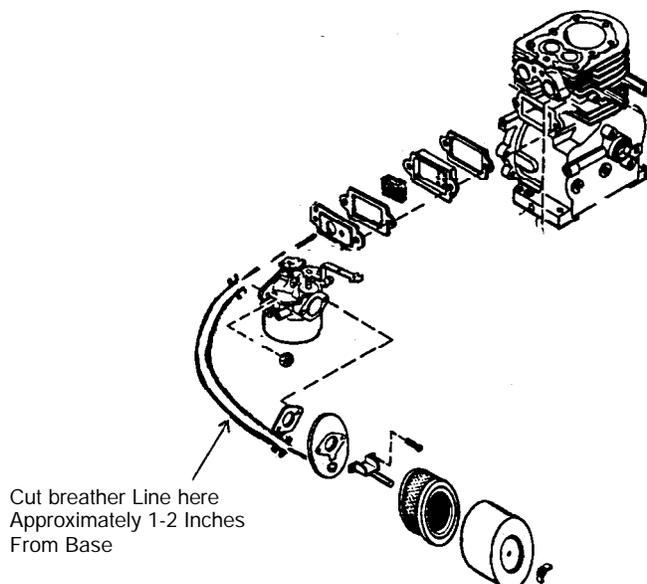
Those conditions are an ambient temperature below **35 degrees F**, combined with high humidity. When these conditions do exist they can cause the crankcase breather system to freeze up. This freeze up can block the tube causing excessive smoking from the muffler, oil leakage from the seals or gaskets and air filter damage.

This blockage of the breather system can cause **severe engine damage** if not addressed promptly. The procedure to correct this problem is as follows:

As a temporary fix you will need to cut the breather hose 1-2 inches (see illust. below) in front of the connection to the air filter, allowing it to vent to the atmosphere. This temporary modification will make the engine **Non-Compliant with the E.P.A.** (Environmental Protection Agency) regulation's covering this product. The engines crankcase breather system must be repaired using Tecumseh service part no. 730626 when the temperature stays above 35 Degrees F. This repair part will be made available at no charge to the customer.

Warning; This modification if not repaired will severely damage the engine.
