Service Advisory W-116

Model: Z16, Z180, Z200, Z180L
Date: September 16, 1998 (REVISED 10/12/98 - Destroy previous copy)
Subject: DECLUTCHING CABLE KIT 759-3874

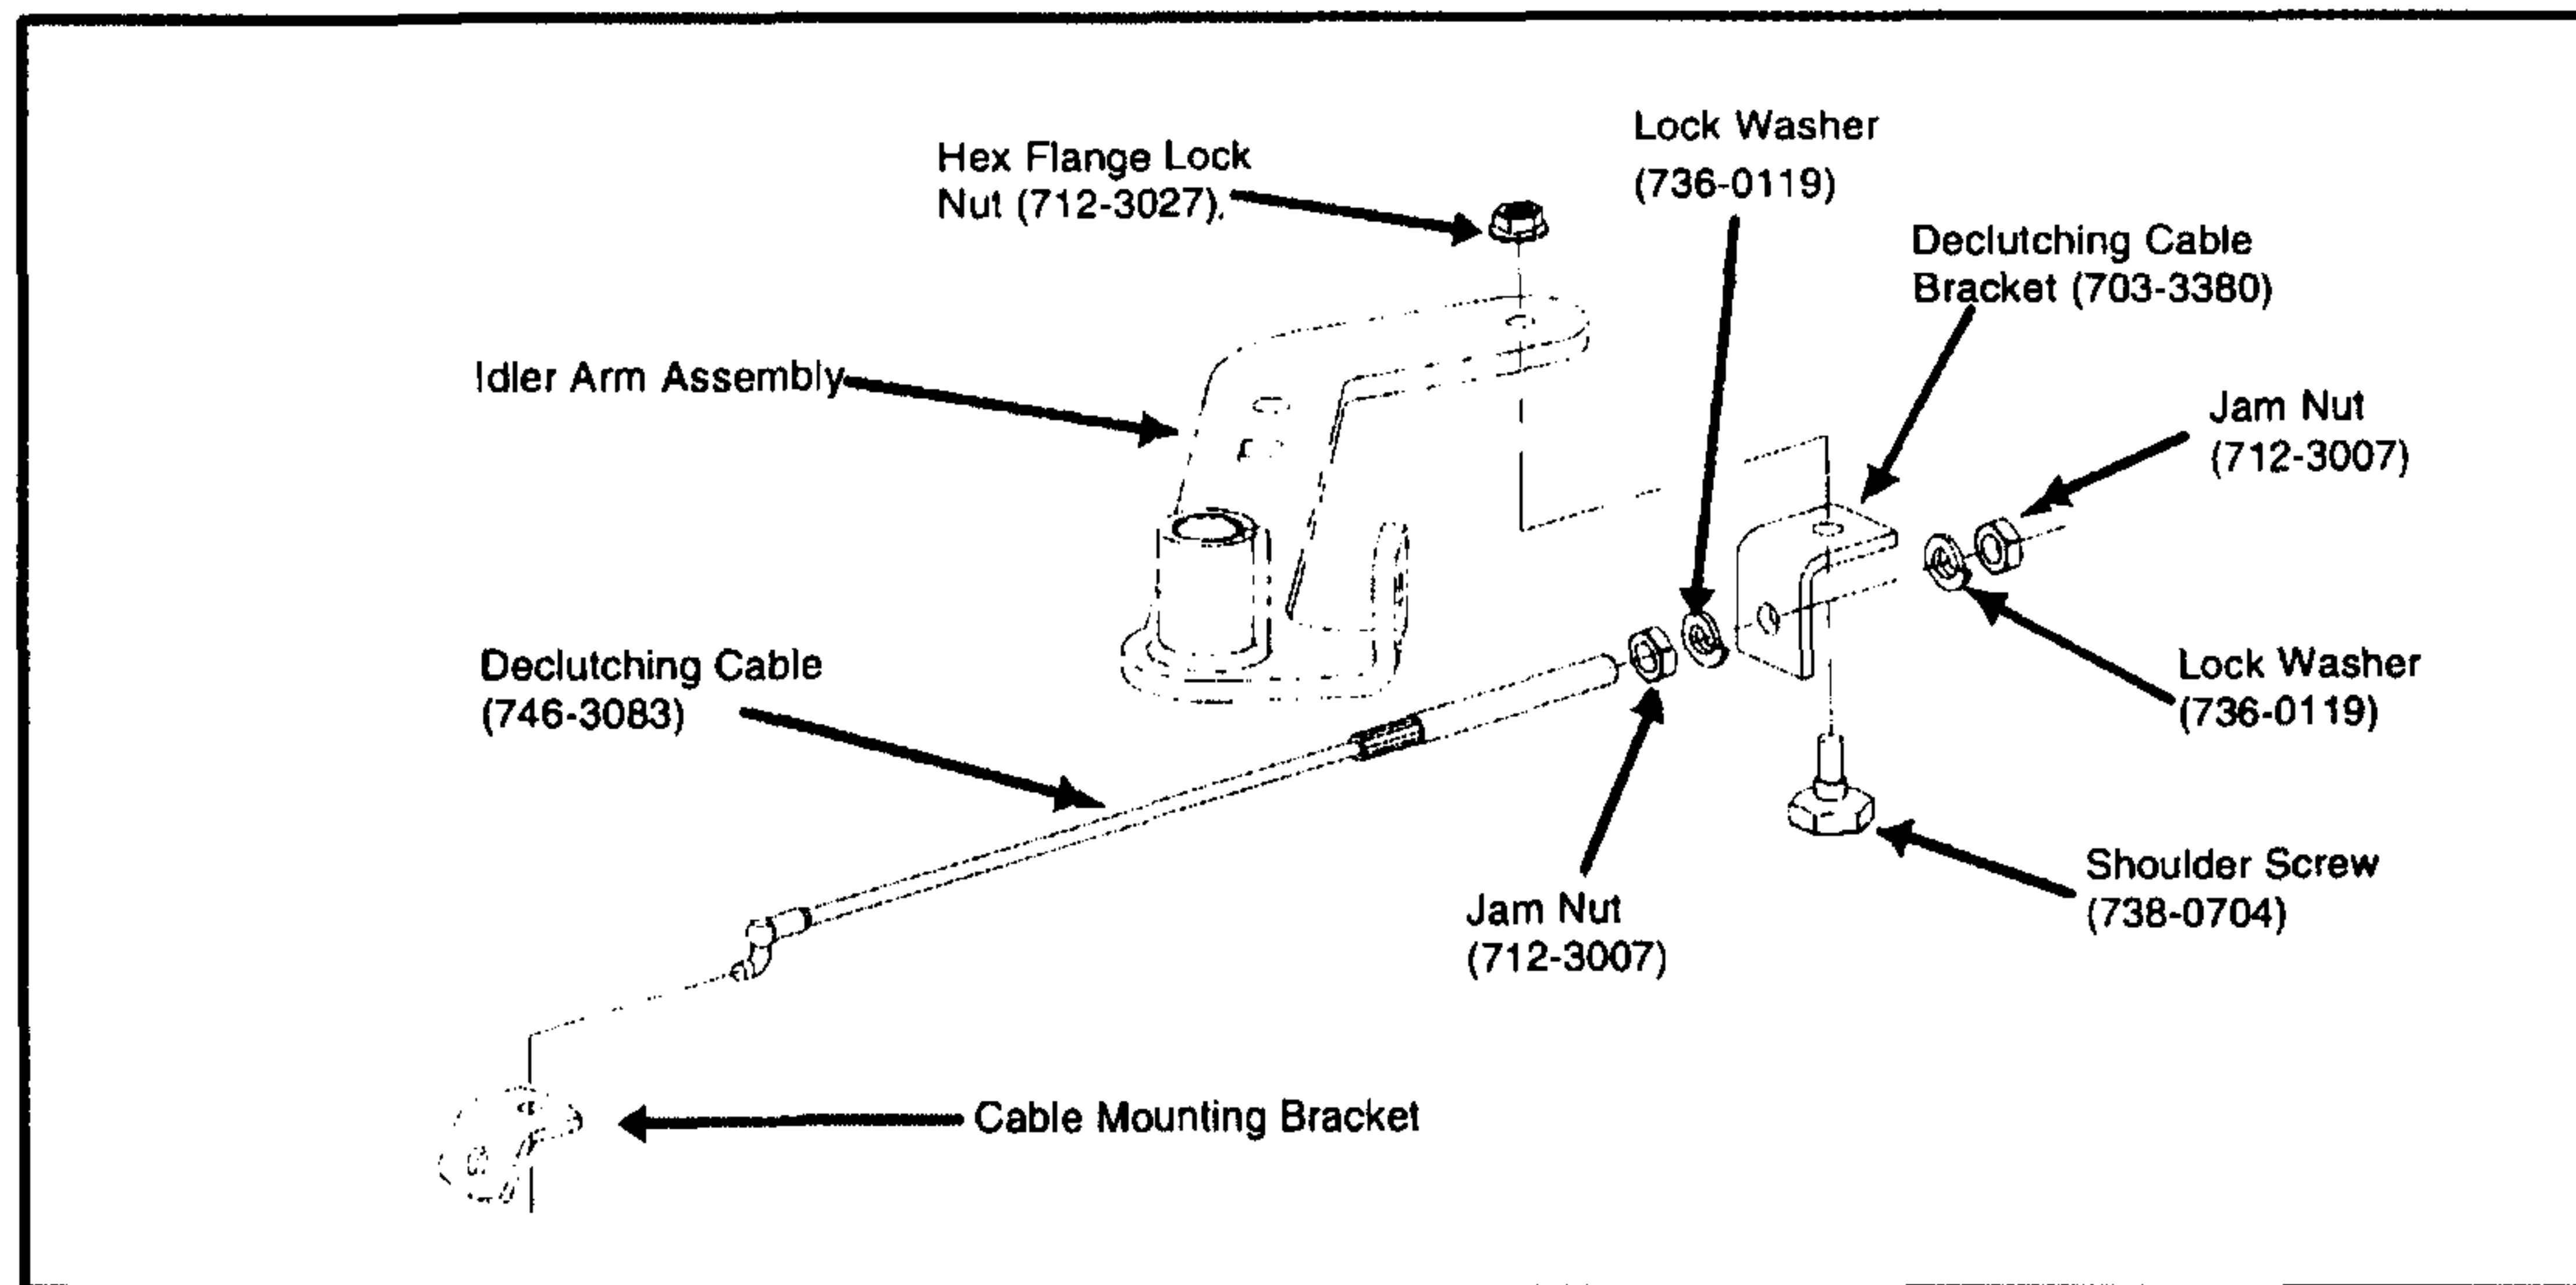
Some Z Series Mowers are experiencing traction problems resulting from the inability of the transmission drive belt to remain tight against the idler pulley. A product improvement has been made by adding a threaded end to the declutching cable and passing this through a bracket allowing the cable to be adjusted to compensate for belt stretching and wear. A product update kit has been developed with the necessary parts and instructions. Parts ordering and warranty information can be found below.

Warranty Allowance: If a customer experiences the above problem, order and install part number **759-3874 Declutching Cable Kit**. The kit will be available from **Shelby Parts Distribution at NO CHARGE**. Submit a warranty claim in the usual manner for .3 of an hour labor and memo part number **759-3874** at no charge. **NOTE:** Installation of the no charge kit and labor will be allowed for any unit in dealer's inventory.
