Service Advisory

W-140

Models Affected: LT 942G (13AX605G790)

Subject: **ANCHOR POINT FAILURE ON DECK**

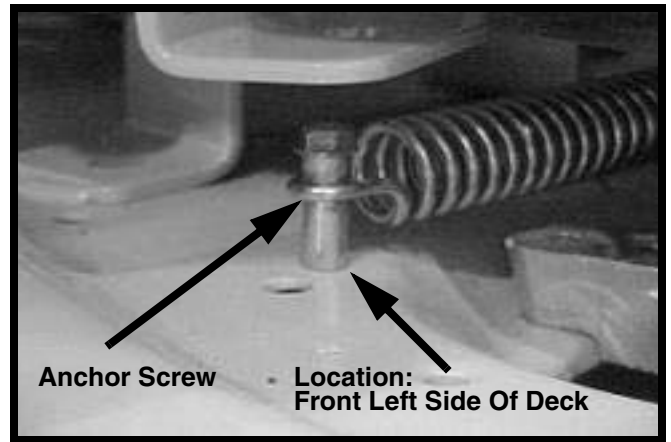
FIGURE 1

3. Locate the spring anchor on the front left side of deck as shown in FIGURE 1. The original anchor consist of a 1/4” self tapping screw (710-0778) with a spacer sleeve (750-0566A) over the screw.

4. Remove the spring from the anchor screw and sleeve using a spring puller tool if anchor screw is still attached.
5. If anchor screw is still attached remove and discard 1/4” self tapping screw and spacer sleeve.

6. Use a 1/4” drill bit and drill to enlarge the hole that the 1/4” self tapping screw was removed or missing from.
7. Check the under side of the deck. It may be necessary to remove the deck extrusion material from around the hole by grinding. The surface at the mounting hole needs to flat on both top and bottom of the deck.

8. Install shoulder screw (738-0560) from the top with the flat washer (736-3090) and flange lock nut (712-04064) from the underside. Tighten securely.
