# Service Advisory

## TRACTORS

W-143

Subject: **UPPER TRANSMISSION DRIVE BELT PATH ALIGNMENT & CLEARANCE**

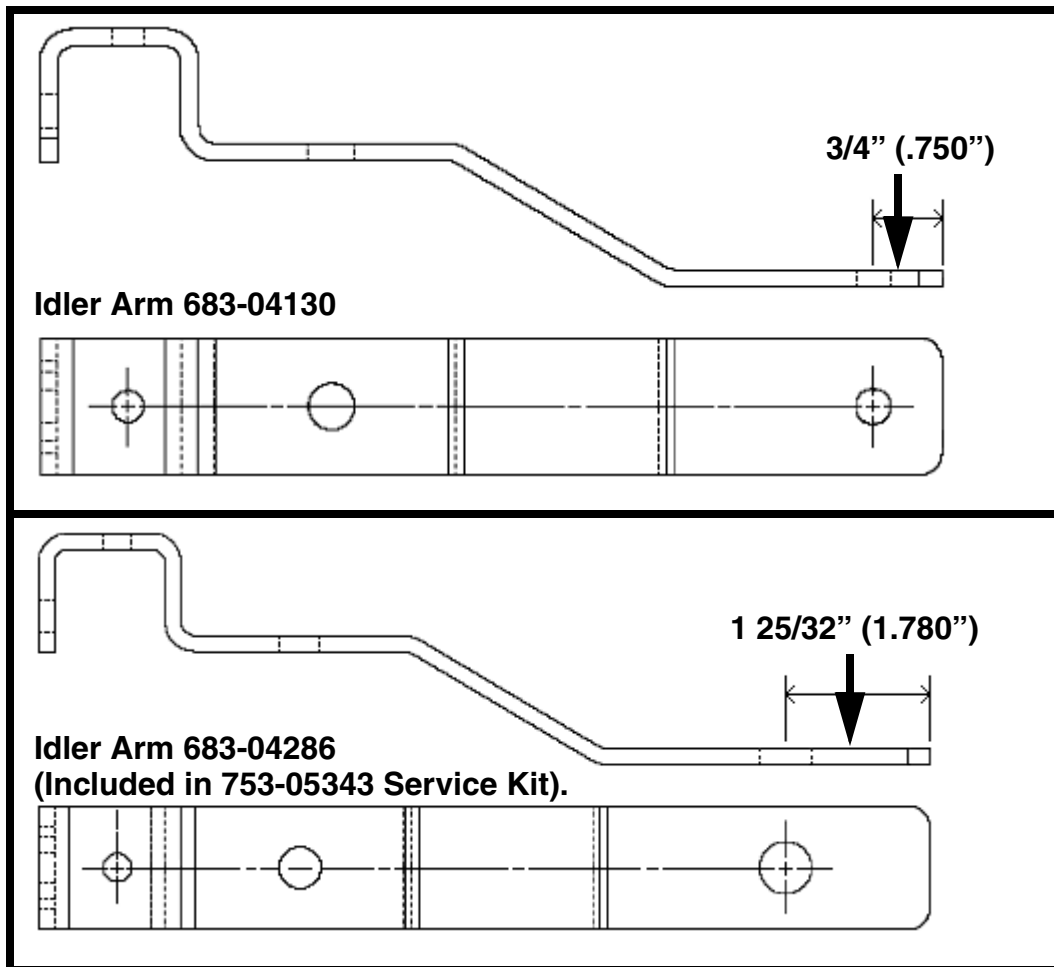
FIGURE 1

**#1.** The first issue is the transmission's upper drive belt will come off the tensioning idler pulley under certain operating conditions. This will result in the loss of drive & possible damage to the upper drive belt. This could be caused by the extension spring breaking or becoming unhooked. If the above occurs or the unit falls in the serial number range listed above order and install **Service Kit 753-05343**. If the Unit does not fall into the serial number range above & the above issue is present, compare the end of the idler bracket on the unit to the diagrams in figure 1. If the Idler arm measures  $3/4"$  (.750") from the center of the bolt pivot hole to the end of the idler arm & has a  $3/8"$  bolt for the pivot bolt, Install **Service Kit 753-05343**.

**PURPOSE:** This advisory is to notify dealers of **Service Kit 753-05343** which provides the latest transmission torque bracket & upper belt tensioning idler configuration. The new hardware reduces idler vertical movement providing an improved belt path alignment. The advisory also covers a possible clearance issue between frame & belt.

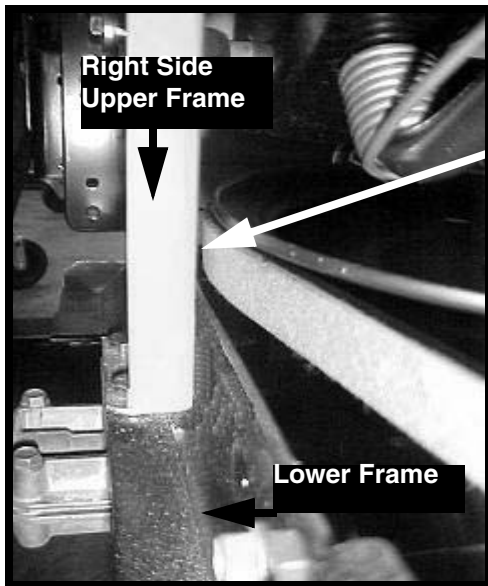
FIGURE 2

#2. The second issue is that the transmission's upper drive belt may wear excessively & break due to the belt & or transmission input pulley rubbing the right side of the upper frame. This may occur in some units.

Slide 736-0343 Flat Washer Here To Check Clearance.

Use a 736-0343 (.120"-.125") flat washer as a gauge to check the clearance between the upper right side frame & the transmission drive belt. If the 736-0343 flat washer is able to pass between the frame & the back side of the transmission drive belt, the clearance is good & no further action is required. Figure 2.
