# Service Advisory

MTD-085

**Models Affected:** White Outdoor Products 54" RZT - 17AK2ACK090; 17AK2ACK290 and 17BK2ACK090  
**Serial Number Range Affected:** 17AK2ACK090 - 1/02/2008 (Date Code"...A028...") thru 1/30/2008 (Date Code"...A308...")  
 17AK2ACK290 - 2/19/2008 (Date Code"...B198...") thru 3/17/2008 (Date Code"...C178...")  
 17BK2ACK090 - 12/20/2007 (Date Code"...L207...")

**Subject:** Product Update - 54" Deck Movable Idler Spring

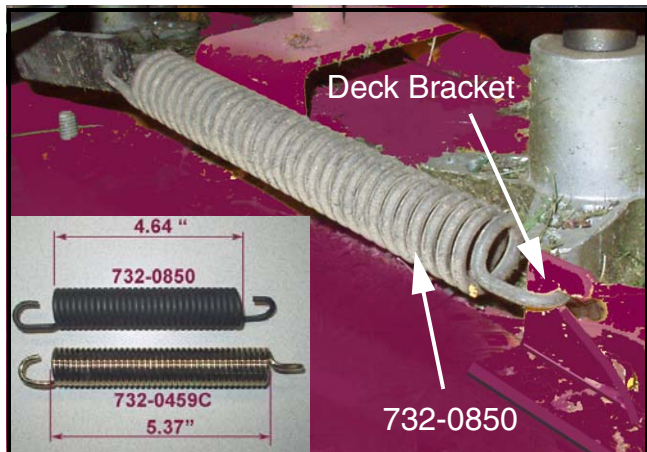
FIGURE 1

1. Place rider on a flat and level surface, disengage the PTO, turn off engine, remove ignition key and engage the parking brake ON.
2. Position the cutting deck to the lowest cutting height.
3. Inspect the deck idler tension spring. See Figure 1.

If the deck's idler spring is yellow/gold in color, the idler spring has already been updated to the **732-0459C**. **Stop Here**, this advisory has been addressed.

If the spring is black in color, (**732-0850**) see Figure 1, proceed to Step 4.

7. Unhook the black idler spring from the deck bracket, then unhook the spring from the idler bracket. Discard the spring.
8. Install the new **732-0459C** spring (yellow) and re-install the deck drive "V" belt in the reverse order of idler spring removal.
