# 2012 ATV and ROV Updates

# 2012 ATV and Prowler Update

# HDX Transmission Improvements

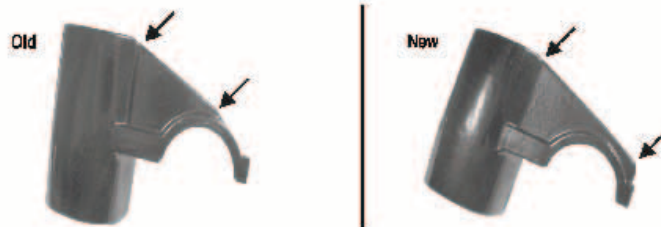
**Condition:** The windshield mounting brackets on the affected models may crack and break and should be replaced. Below are pictures of the old and the new mounting brackets.

■ **NOTE:** Please verify the affected ATV's need the update before ordering the kit as they may already be updated. See pictures below.

**Solution:** Install Cruiser Windshield Bracket Update Kit (p/n 1436-545) according to the instructions provided in the kit.

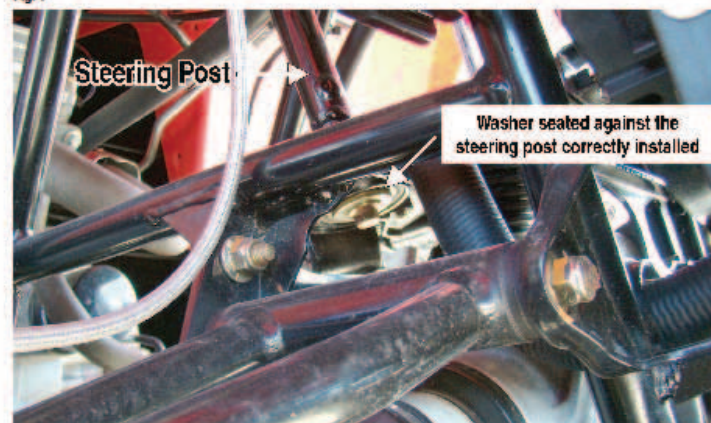
Fig. 1

On the affected models, the cap screw securing the bottom of the steering post may have been improperly torqued and must be inspected. If the cap screw and washer are tight, no further action is needed. See Fig. 1. If the cap screw and washer are loose, proceed to the solution below.

Apply a few drops of green Loctite #609 to the threads of the cap screw; then tighten the cap screw to 40 ft-lb using the instructions below.
