2012 ATV and ROV Updates

2012 ATV and Prowler Update

HDX Transmission Improvements

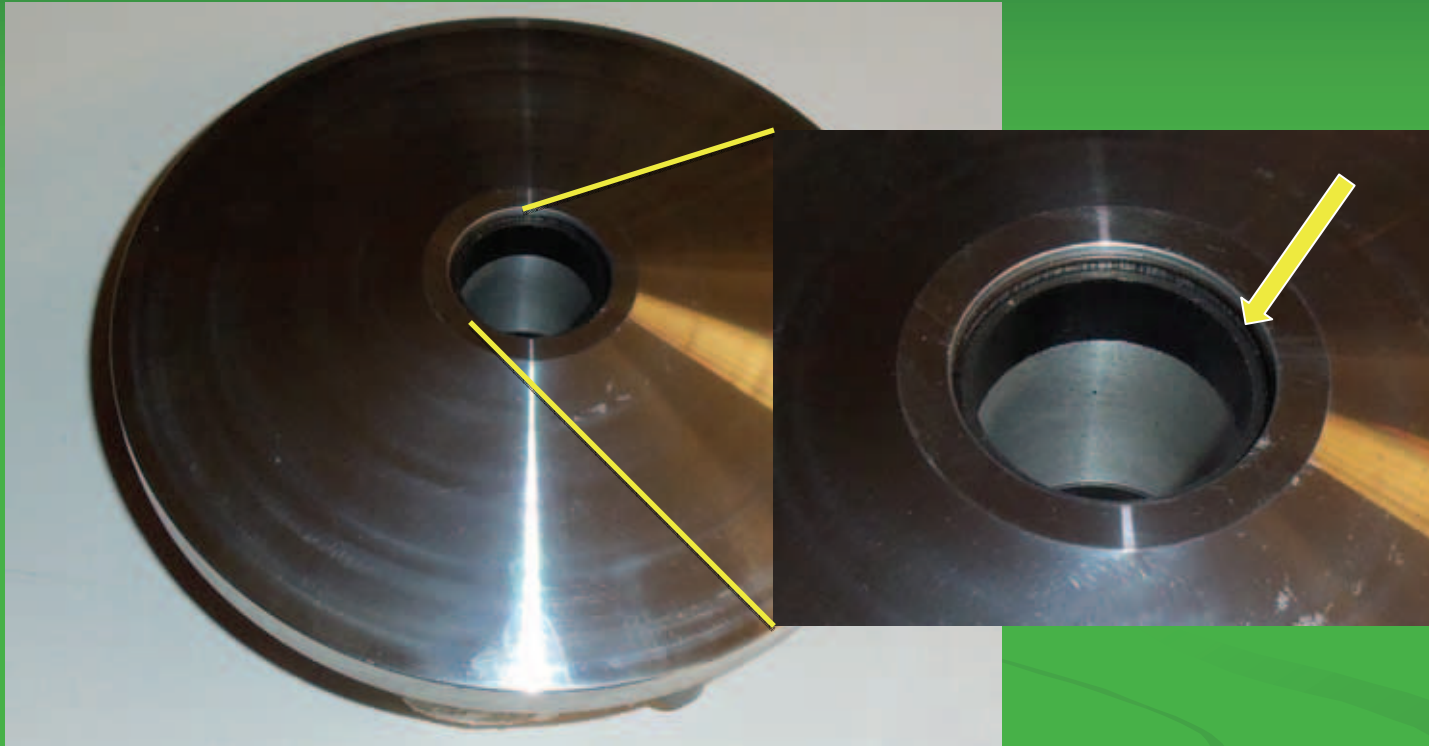
450 Belt Failure

The bushing may slip past the retaining ring causing the sheaves to stay apart and the drive belt to slip, producing heat, resulting in belt failure.

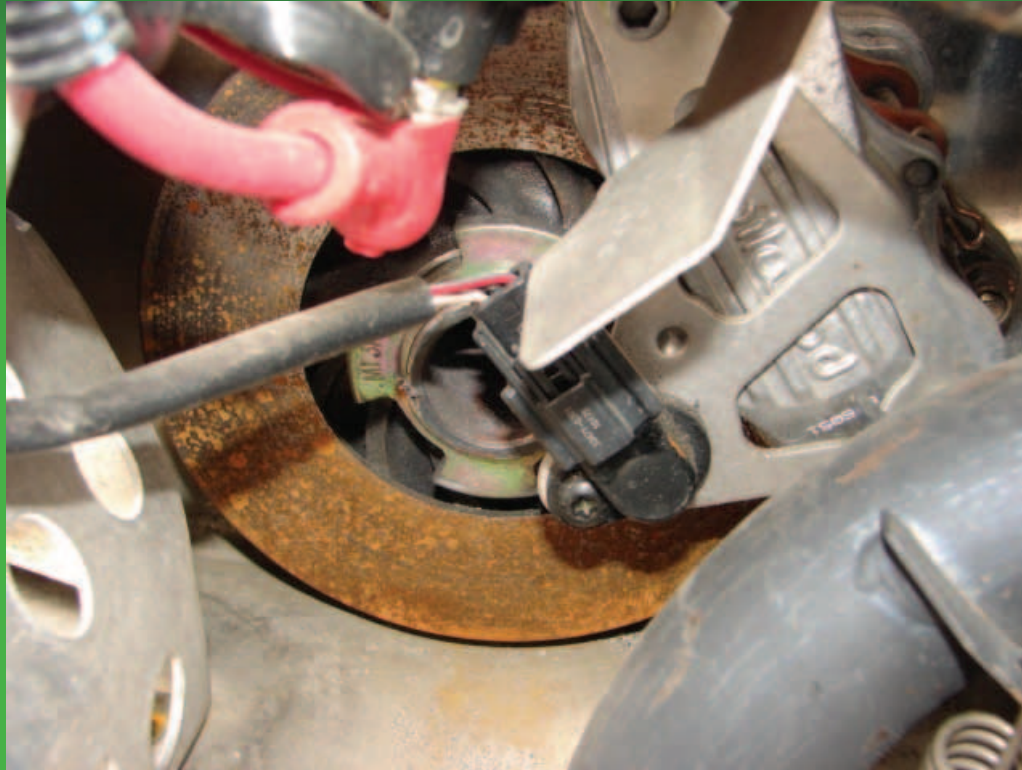
Speed Sensor Mounting Bracket

- New bracket that allows the sensor to be located further from the exhaust preventing failures due to heat. (Z1's Only)

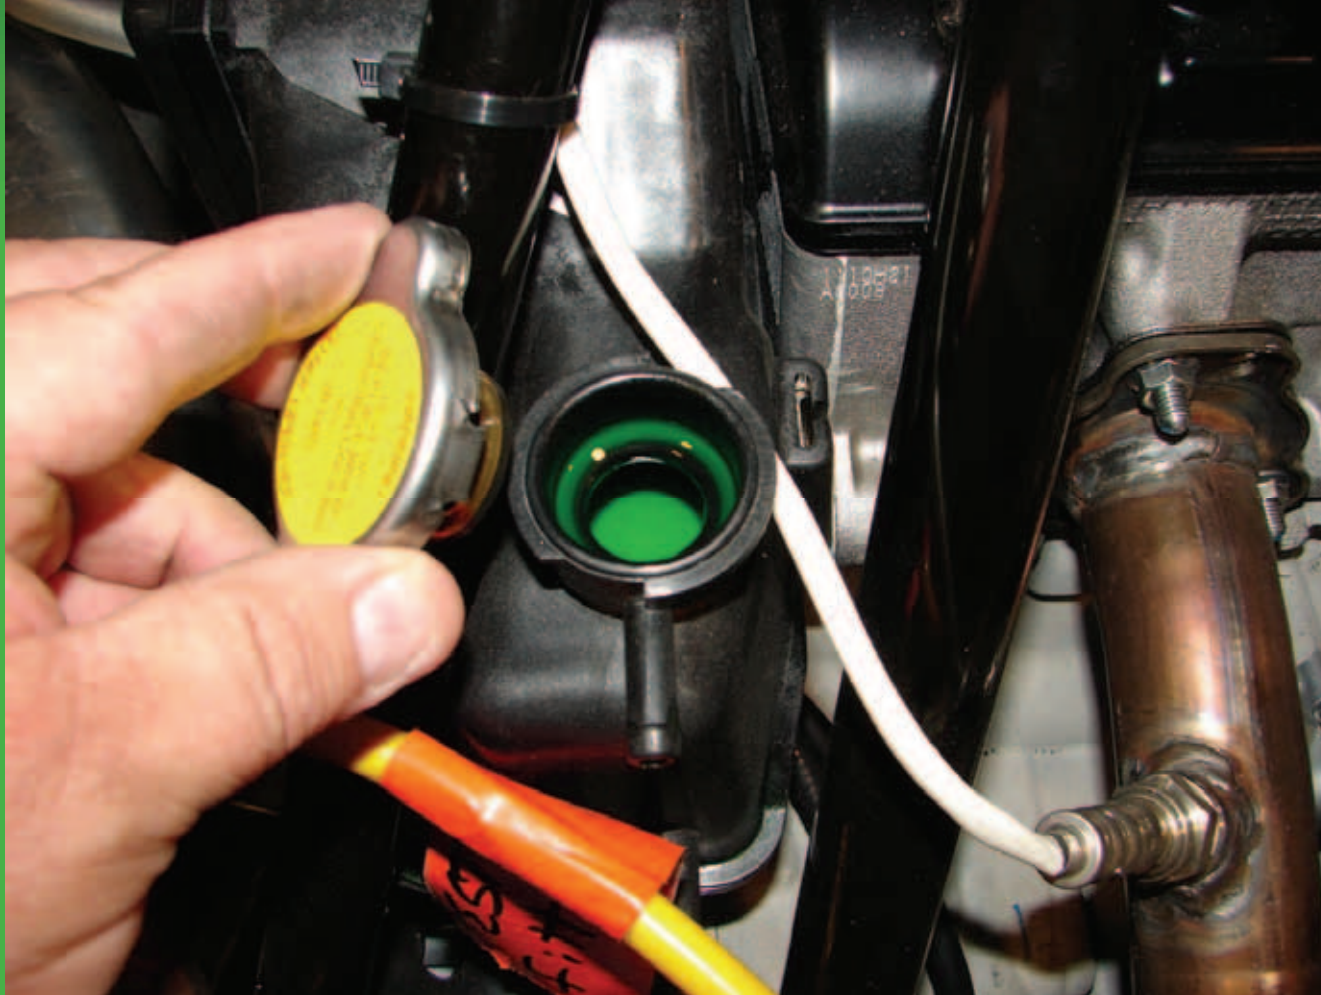
If bubbles are present when checking at the coolant reservoir, the head gasket has failed.

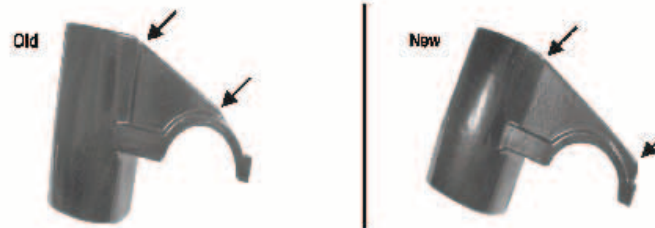
Condition: The windshield mounting brackets on the affected models may crack and break and should be replaced. Below are pictures of the old and the new mounting brackets.

■ **NOTE:** Please verify the affected ATV's need the update before ordering the kit as they may already be updated. See pictures below.

Solution: Install Cruiser Windshield Bracket Update Kit (p/n 1436-545) according to the instructions provided in the kit.

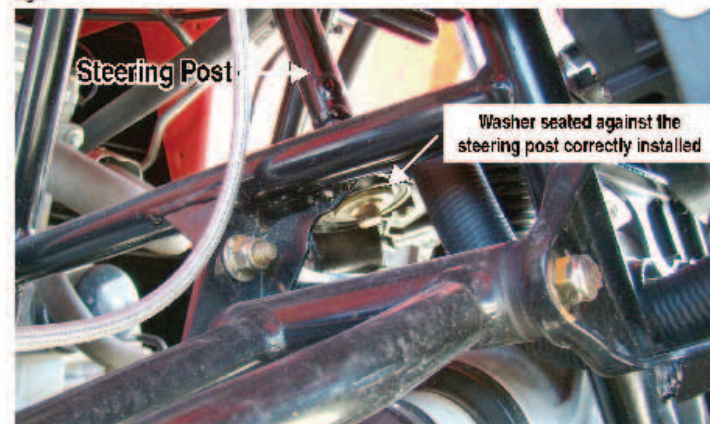
Fig. 1

On the affected models, the cap screw securing the bottom of the steering post may have been improperly torqued and must be inspected. If the cap screw and washer are tight, no further action is needed. See Fig. 1. If the cap screw and washer are loose, proceed to the solution below.

Apply a few drops of green Loctite #609 to the threads of the cap screw; then tighten the cap screw to 40 ft-lb using the instructions below.

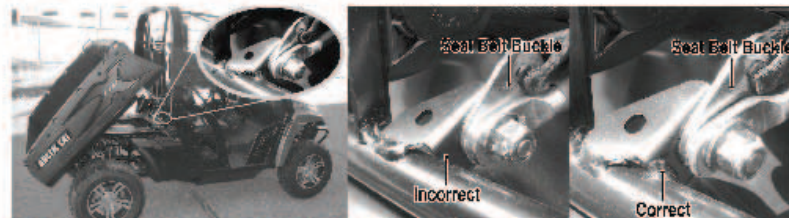
Condition: The rear ROPS support bracket on the affected Prowler has a weld missing and must be replaced. There must be three welds on the bracket where the seat belt assemblies are attached.

■ **NOTE:** Some Prowlers within the VIN range may need no service work. Raise the cargo box and inspect both inside and outside of each bracket (where seat belt assemblies are attached). If all three welds on each bracket (behind the seat) are in place, no service work is needed. See pictures below.

Solution: Install ROPS Support Bracket Update Kit (p/n 0437-075) according to the instructions provided in the kit.
