SUBJECT: Seeping Oil Drain Plug (below deck) AFFECTED MODELS: All LEV and OVRM Engines DOM'S (date of manufacture) AFFECTED: 0312 thru 1015 SERVICE KIT PART NUMBER: 730642

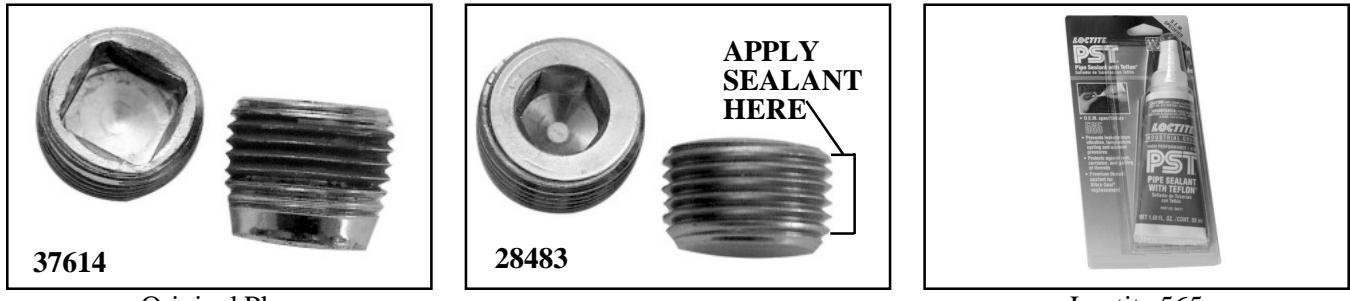
We have identified the potential for oil seepage from the drain plug on the above models with the DOM's listed. This seepage may cause concern by the customer.

We have performed repairs to many of the units at the manufacturers involved. However we believe some engines may have reached stores or may be in consumer's hands. Previously repaired units are easily identified by the new style plug which uses a 5/16 internal allen hex drive (see photo). The original plug used a standard 3/8 inch internal square drive (see photo).

Original Plug

New Plug

Loctite 565

- 1. Disconnect and ground the spark plug wire
- 2. Remove the old style plug using a 3/8 square ratchet
- 3. Wipe excess oil from the threads in the flange
- 4. Install the new plug using the Loctite number 565 sealant included in the kit, apply as shown
- 5. Torque the 5/16 internal allen hex plug to 150 inch lbs (17 Nm)
- 6. Re-install the plug wire
- 7. Allow one-hour cure time before adding oil to the engine
