Service Advisory

(Snow Throwers)

Models Affected:	2008 Model Year 500 and 600 Series
Serial Number Range Affected:	Snow Throwers Produced Prior to September 2, 2008 (Date Code "I028")
Date:	12/22/2008
Subject:	Extended Length Lower Chute, 731-06440, Dislodging from the Chute Adapter.

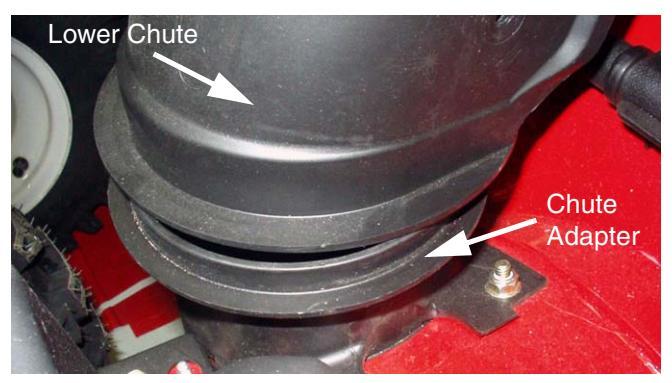
FIGURE 1

SYMPTOM(S): Under heavy snow throwing conditions where the snow may contain frozen chucks the lower chute may become dislodged from the chute adapter. See Figure 1.
