# Service Bulletin

**Bulletin No:** 2003-1-29

**Subject:** Hood Vent Foam (PTO-Side)

All 2003 Mountain Cat 570's

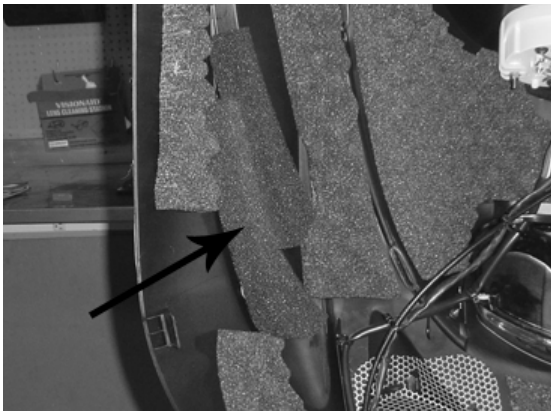
**Fig. 1**

**Condition:** Hood Vent Foam (p/n 0617-426) located on the PTO-side of the hood was designed to prevent snow from entering the clutch area. It has been determined, however, that the foam prevents the air from the engine fan to escape through the air-out duct. This condition may cause the air-out duct to overheat resulting in possible heat damage to the duct.

**Solution:** Remove Hood Vent Foam (p/n 0617-426). See Fig. 1 for the location of the foam to be removed. Please advise all owners of an affected snowmobile concerning this issue.
