Service Bulletin

Product Line: Snowmobile

Bulletin No: 2003-1-22

Subject: VEV Drain Hose Location

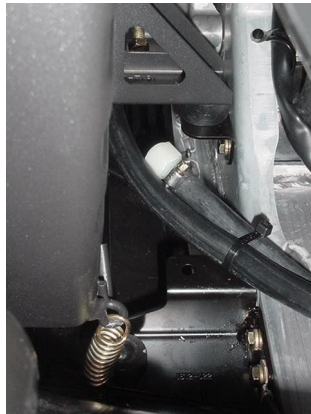
Condition: It has been determined that existing Variable Exhaust Valve (VEV) Drain Hose (p/n 0610-535) on the affected model may be positioned in the wrong location and may come into contact with the left side of the resonator. This condition may cause possible damage to the hose. See Fig. 1 for the incorrect location of the VEV drain hose.
