Service Advisory

Product Line: ATV

Advisoy No: SAA201

Subject: Manual Rear Brake Switch Plunger/
Brake Switch Stop

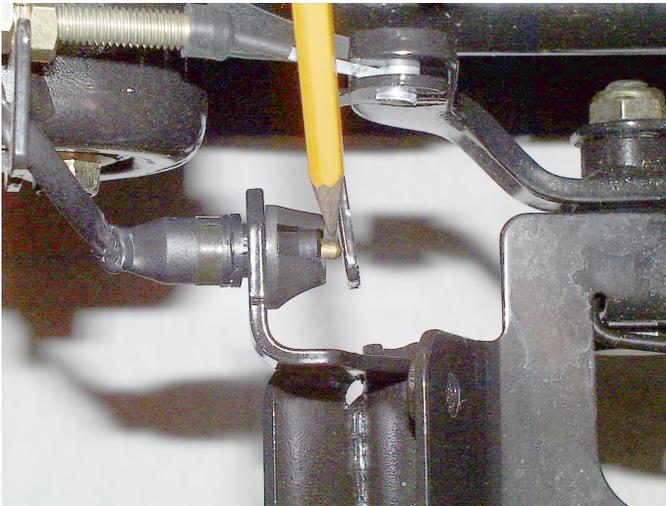
Fig. 1

It has been determined that while the brake pedal is in the rest position, there may be insufficient clearance between the brake switch stop and the manual rear brake switch plunger on affected models. In some cases, this condition will cause the switch plunger to bottom out. If the switch plunger is bottomed out while the brake is in the rest position, a short in the ignition switch circuit may occur resulting in a blown ignition switch fuse.

■ **NOTE:** When the brake pedal is in the rest position, the switch plunger must be exposed a minimum of 3.175 mm (1/8 in.). See Fig. 1.

Bend the brake stop switch tab forward approximately 3.175 mm (1/8 in.) to prevent the brake switch plunger from bottoming out.

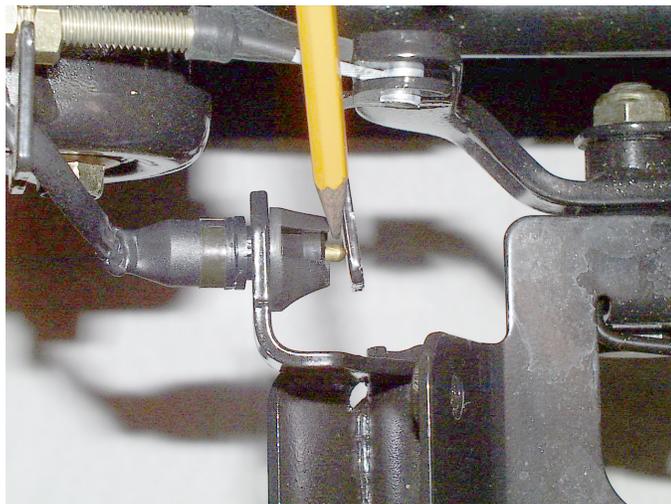
Fig. 1

Il a été déterminé que lorsque la pédale de freins est en arrêt, il peut y avoir un dégagement insuffisant entre l'interrupteur d'arrêt de freins et le plongeur de l'interrupteur de frein manuel arrière sur les modèles concernés. Si le plongeur s'enfonce alors que le frein est en position d'arrêt, un court-circuit dans l'interrupteur pourrait se produire et ainsi causer une interruption du fusible de l'interrupteur d'allumage.

■ **REMARQUE:** Lorsque la pédale de freins est en arrêt, le plongeur de l'interrupteur doit être exposé au moins à 3,175 mm (1/8 po). Voyez la fig.1

Pliez l'onglet de l'interrupteur d'arrêt de freins vers l'avant à approximativement 3,175 mm (1/8 po) afin de prévenir le plongeur d'arrêt de freins à s'enfoncer.
