6
		B0100024

SB, 265 RX, Starter, 2001-05

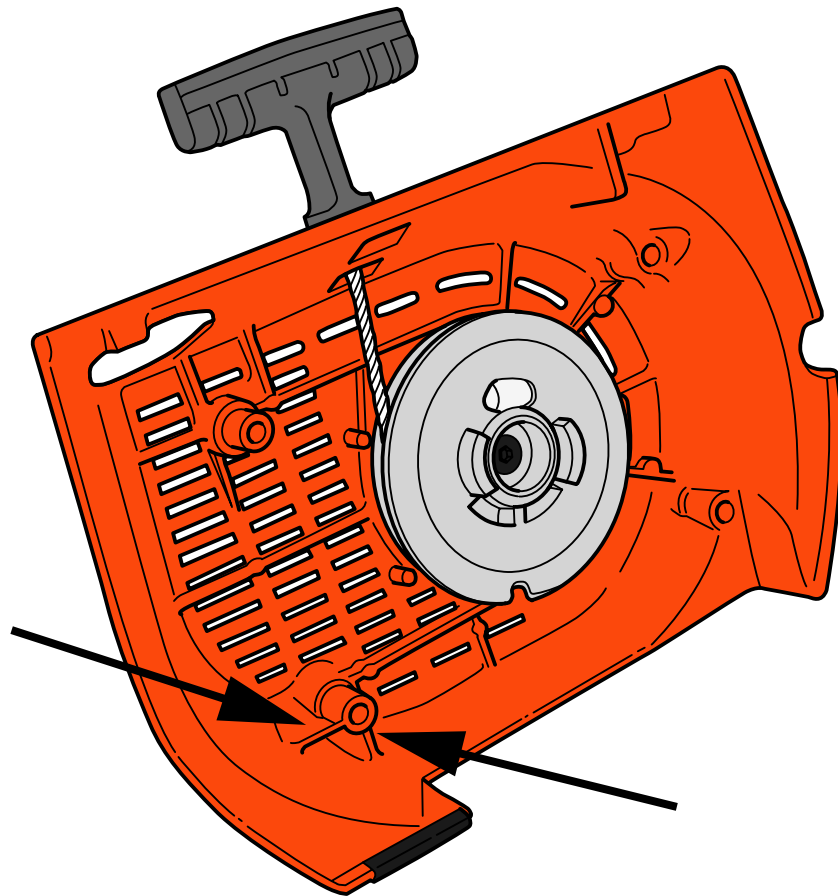
The area around the bottom right screw hole (viewed from outside) on the starter housing has been reinforced. See diagram. Problems have been experienced with cracking around this screw hole in certain situations, particularly when the screws that hold the starter housing were not correctly tightened.

The reinforced starter housing has improvement code Q.

The article number is the same as before, 502 00 15-02.

Introduced from serial number: 01.1200001
