SERVICE

SB, 325 HDA 55, Tube, 2001-09

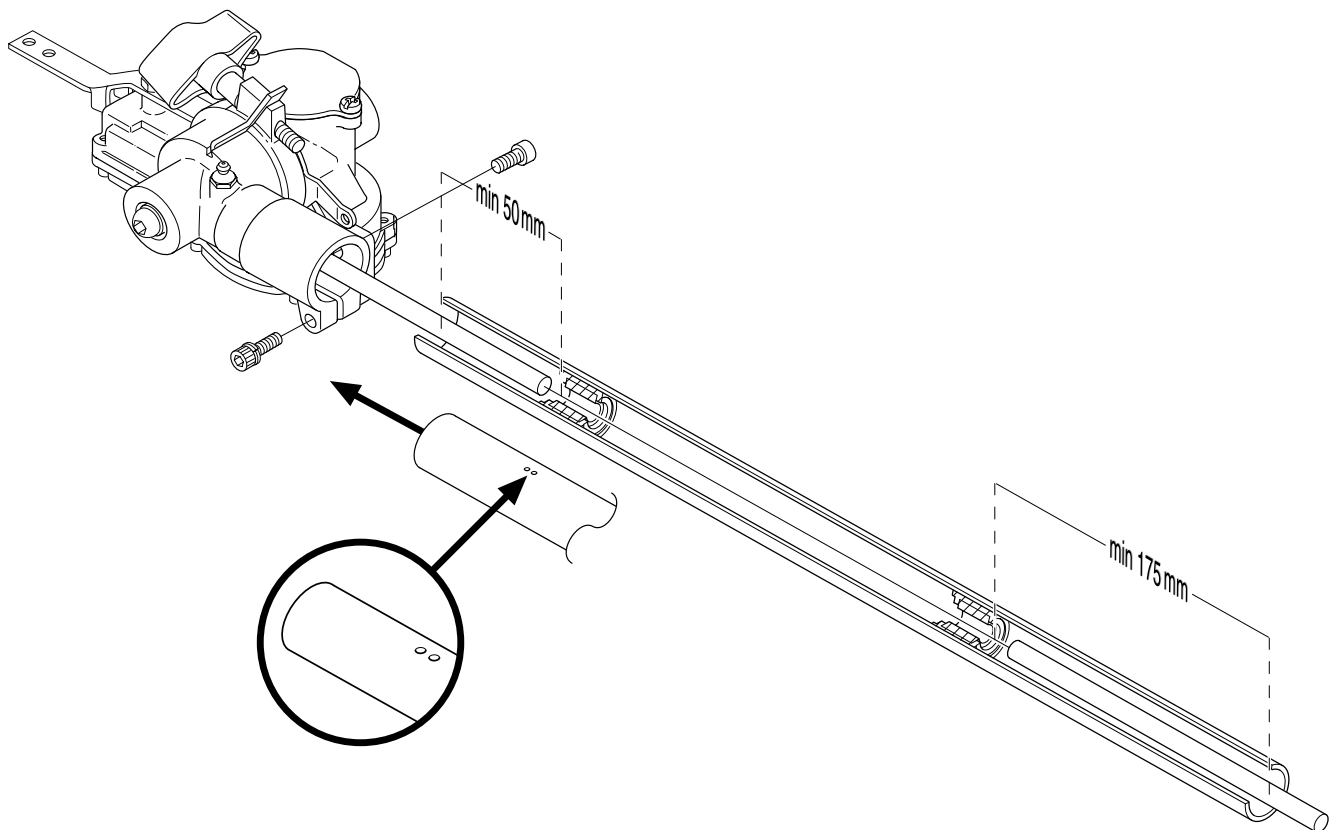
When fitting the tube to the 325HDA55 it is very important that it is fitted the right way round. Fitting the tube incorrectly will cause serious damage to the drive shaft.

The end that has the bearing closest to it must be fitted to the cutter bar. This end is identified by two dots that are marked on the tube.
