Service Bulletin	B0302001
	2003-04

Products: **5521CH**
 5521RS
 55B21HV
 55R21HV

Subject: **Troubleshooting Pinion/ Pawl Drive System**

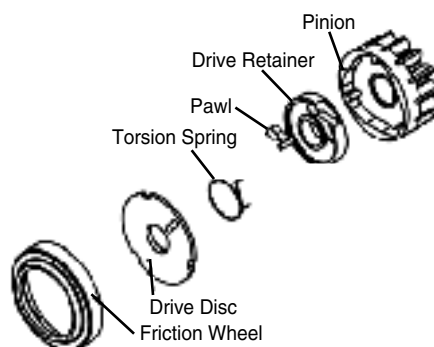
Pinion/ Pawl Drive Parts

The following pages provide troubleshooting information when dealing with drive issues on the above walk mowers.

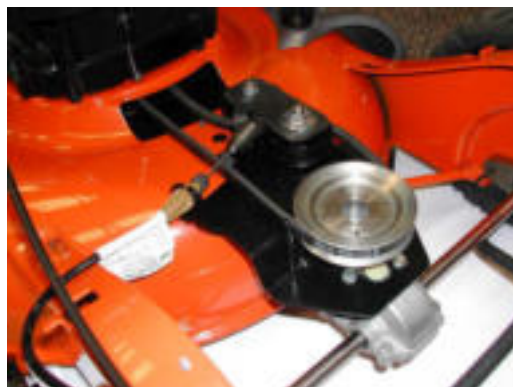
Step 2) Check for drive creep

Remove drive covers and verify that the driven pulley is not rotating or trying to rotate. If you see belt creep, continue to next steps.

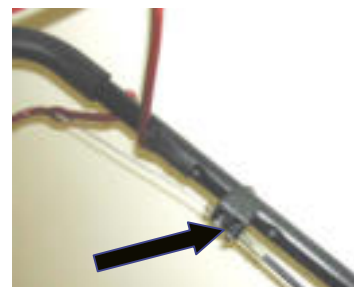
Readjust under bail control

Readjust under bail control to further reduce belt tension. Loosen the drive cable by rotating the adjustment clockwise.

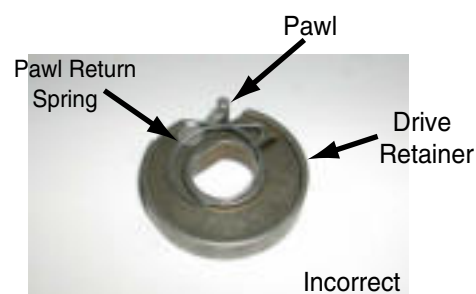
Step 7) Pawl return spring

The pawl return spring is not engaged, has slipped out of position or is missing.

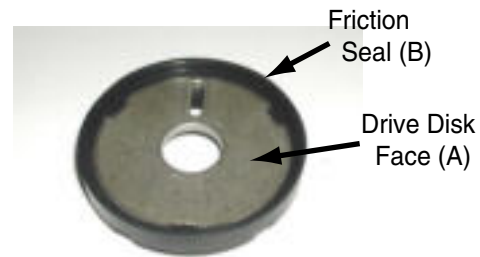
Pinion dragging against drive disk.

Check for smoothness of the drive disk face (A) and the pinion face. Replace parts as needed.

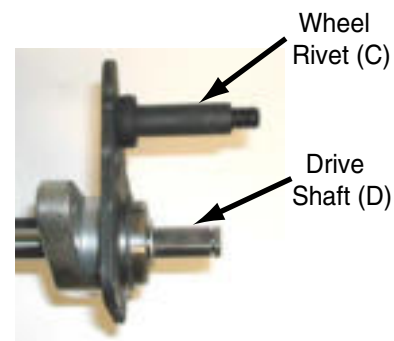
Pinion dragging against friction seal.

Seal rubbing inside of wheel.

Wheel rivet (C) is out of alignment with the drive shaft (D). Realign the drive rivet by inserting a steel tube onto the wheel rivet and bending it accordingly to restore proper alignment.

Check for any drag and remove any excess flash on friction seal (B) or replace parts.

If the wheel is damaged, replace it.

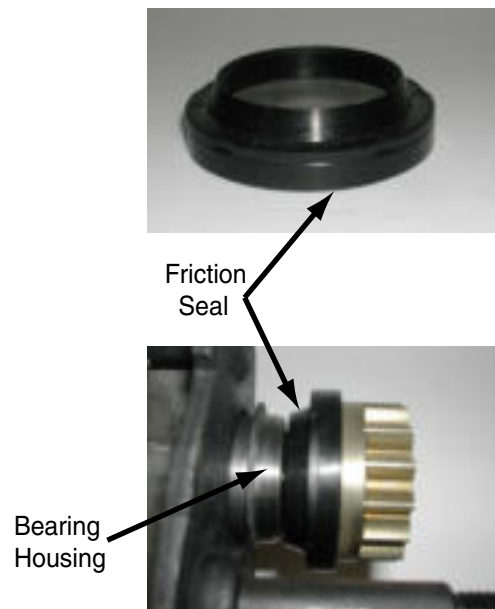
Step 9) Auto Walk Does Not Drive

If the Auto Walk system will not engage when the trigger or bail is pulled:

Friction seal is worn and must be replaced.

Friction seal is not engaging the bearing housing.

Pawl is not assembled correctly.

Control cable needs to be readjusted.
