5
		B0400026

## SB, 346 XP, 353, Air filter clip, 2004-03

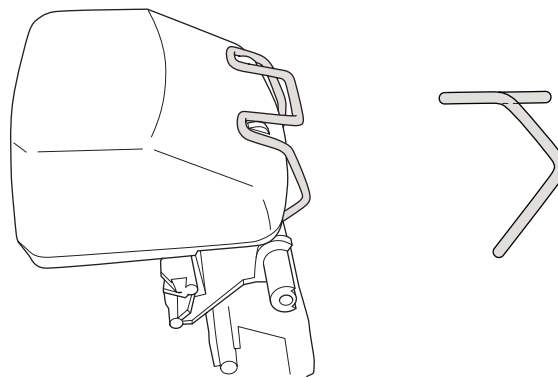
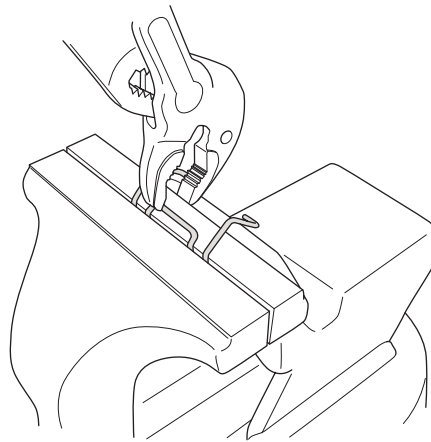
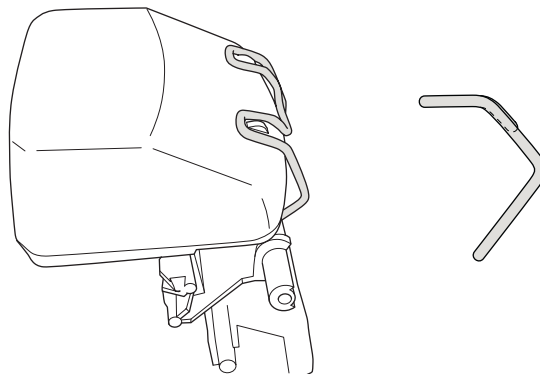
The clip that secures the air filter touches the cylinder cover, which can cause the clip to break. Modifications are being made in production and to the stock of spare parts, but in the meantime the clip (503 96 27-01) can be modified as shown in the diagram below.
