MODEL

HUSQVARNA 50**CHAIN GUIDE PLATE**

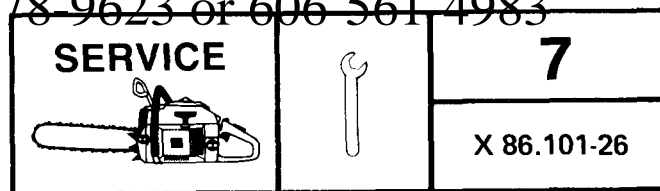
In order to reduce the risk of leakage between the oil groove on the chain guide plate and the recess on the bar, the lower part of the oil groove is moved up and the hole is reduced, according to the marking (*).

The same reference number as before.
