Service Bulletin

Product Line: OHUV

Bulletin No: 2006-6-03

Subject: Oil-Cooler Hose

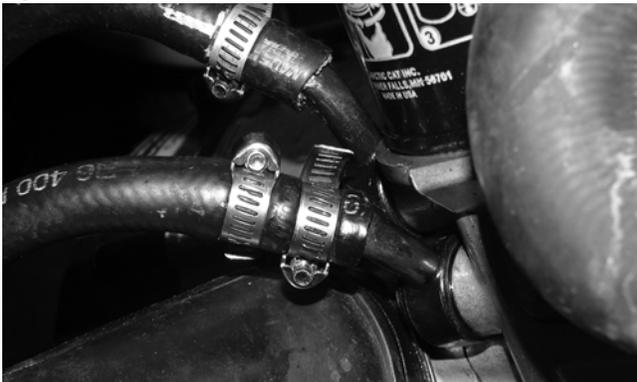
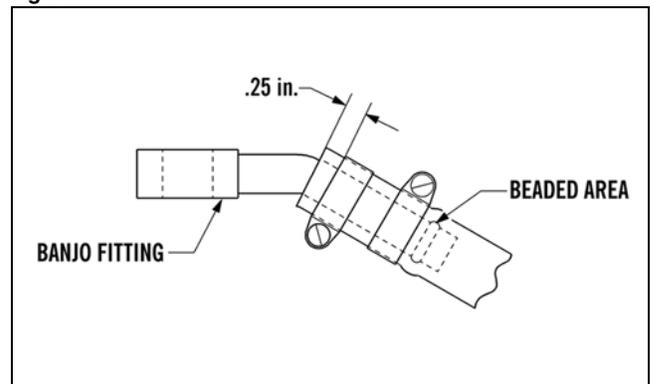
The clamps securing the lower oil-cooler hose to the lower rear engine fitting (left side of engine) and to the oil-cooler fittings (right and left side) may be improperly positioned and/or insufficiently tightened. If this condition exists, the hose may come loose from the engine fitting and/or from the cooler fittings resulting in loss of oil and damage to the engine.

1. Tilt the cargo box backward; then remove both seats, console, left seat base, and air-out duct. Disconnect the lift-support rod from the cargo box.
2. Locate the end of the lower oil-cooler hose (oil pump output) which is connected to the engine. Loosen the existing clamp securing the oil-cooler hose to the engine fitting. Make sure the hose on the engine hose fitting is properly located at the beginning of the elbow on the engine fitting; then position the existing clamp 1/4 in. from the end of the hose and tighten to 15 in.-lb. See Fig.1 and 2 for proper positioning of hose and clamp.

3. Install new Clamp (p/n 0623-028) onto the hose approximately 1/4 in. to the rear of the existing clamp making sure the clamp is positioned in front of the beaded area on the fitting. Never place the clamp on or to the rear of the beaded area on the fitting. With the clamp properly positioned, tighten to 15 in.-lb. See Fig. 1 & 2 for location of clamp and beaded area.

Properly position the existing hoses and clamps and tighten to 15 in.-lb. Install three additional Clamps (p/n 0623-028) and tighten to 15 in.-lb. See specific instructions enclosed with this bulletin.

■ **NOTE:** The clamps should be oriented so the clamp screws face in opposite directions.

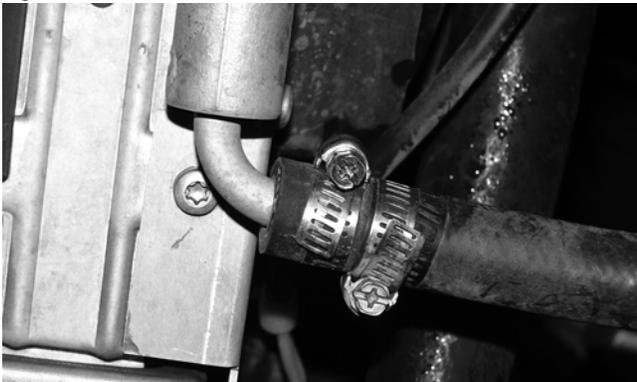
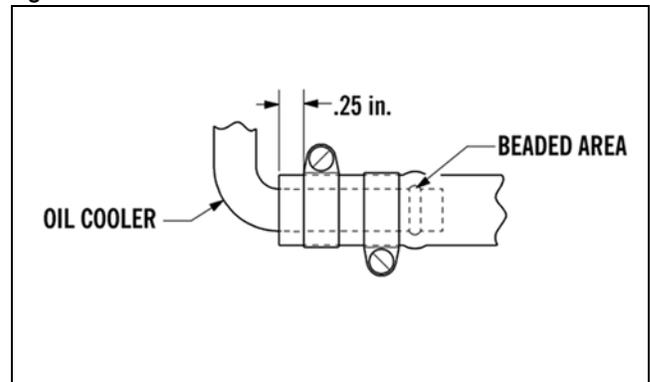
1. Loosen the existing clamp securing one of the oil-cooler hoses to the oil cooler fitting. Make sure the hose is properly positioned on the cooler hose fitting; then position the existing clamp 1/4 in. from the end of the hose and tighten to 15 in.-lb. See Fig. 3 & 4 for proper location of hose and clamp.
2. Install new Clamp (p/n 0623-028) onto the hose 1/4 in. to the rear of the existing clamp making sure the clamp is positioned in front of the beaded area on the fitting. Never place the clamp on or to the rear of the beaded area on the fitting. Tighten to 15 in.-lb. See Fig. 3 & 4 for location of clamp.

3. Repeat steps 1-2 for opposite-side oil-cooler hose clamp.
4. Install the air-out duct, left seat base, console, both seats, and the lift-support rod.
5. Place the cargo box in the down position and latch into place.
