# Product Safety Recall Bulletin

**Product Line:** Snowmobile

**Bulletin No:** 2007-1-01 (Conditions A-D)

**Subject:** Gasline Hose Outlet/  
Gas Tank Filler Neck

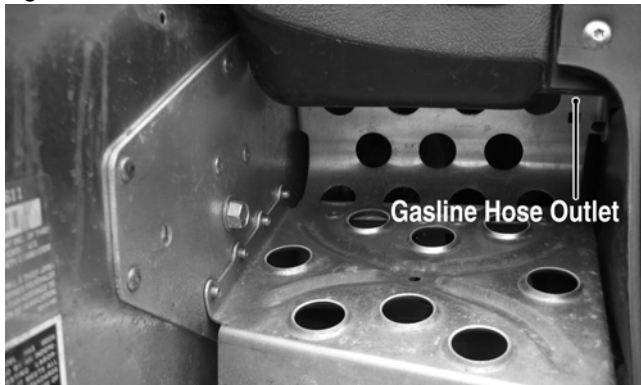
The gas tank may develop a gas leak in the gasline hose outlet area. Also, the gas tank may develop a crack near the base of the filler neck. If either condition were to occur, gas leakage could present a fire hazard.

**Condition A:** 1. Inspect the gasline hose outlet area for any signs of gas leakage. See Fig. 1 for location of gasline hose outlet fitting.

If either condition exists, the gas tank must be replaced.

**Solution A:** Order an appropriate number of Gas Tanks (p/n 0770-625) through normal parts-ordering channels.

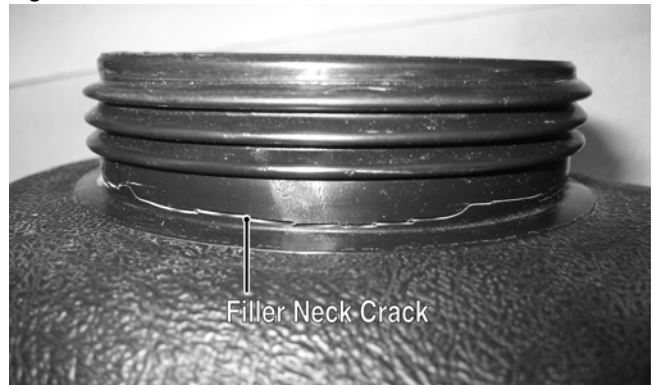
Fig. 2

2. Also inspect the filler neck for a crack near the base of the neck where it joins the gas tank body making sure to inspect the entire diameter of the neck. See Fig. 2.

If there is no sign of gas leakage in the gasoline hose outlet area, no further service is required and the snowmobile may be operated. If there is no visible sign of a crack in the filler neck, it is also safe to operate the snowmobile; however, Filler Neck Insert Kit (p/n 0637-299) or Filler Neck Insert Kit (p/n 0637-300) must be installed as soon as possible. Installation instructions will be included with each kit. See Solution B and C for ordering the proper kit.

■NOTE: The installation of the filler neck insert will prevent the possibility of a crack developing in the base of the filler neck.
