## **SB, Rider ProFlex 21, Repair kit for engine hood, 2001-06**

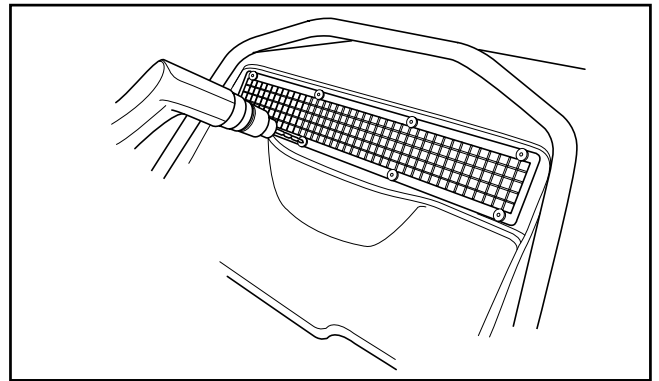
In certain situations it can happen that the fan grille on the engine can come in contact with the engine hood, which results in damage to the engine hood.

1. Drill out the pop rivets and remove the grille.
