Service Bulletin	B0302004
	2003-06

Products: **YTH1848XP with Kawasaki FH531V Engines**
 Kawasaki Engine Serial Numbers (E/no) A52938 and Lower

Subject: **Engines Running Rich**

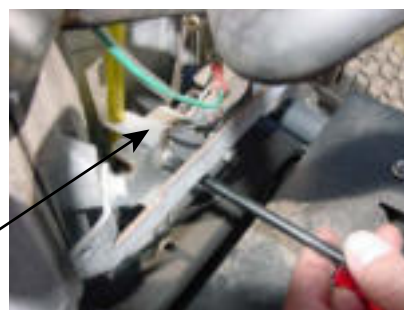
Bracket

1. Remove the air filter cover
2. Remove the air filter
3. Remove the air filter case (2 bolts & 2 screws)
4. Remove the old bracket from the control panel
5. Retighten the screw with the solenoid ground wire (green wire)

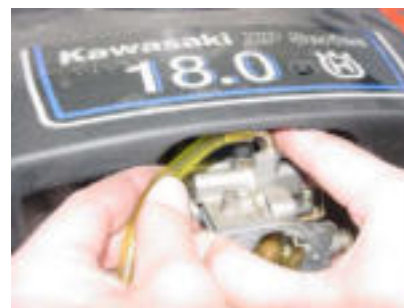
6. Remove the carburetor vent tube from the carburetor
7. Insert the new longer vent tube (from kit)

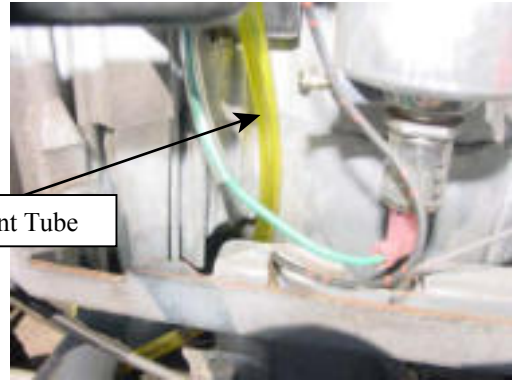
Vent Tube

8. Route the vent tube behind the control panel

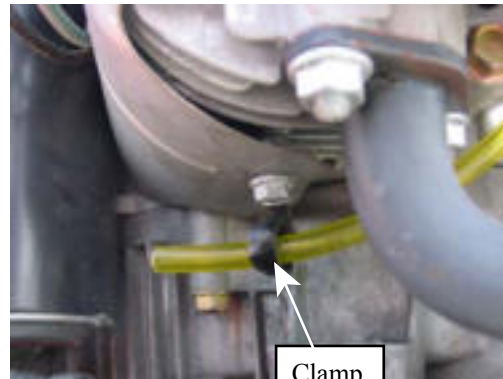
Clamp

9. Loosen the cylinder cover bolt (lower end)
10. Install the new vent tube clamp (from kit) using the cylinder cover bolt from step 9.
11. Fix the vent tube through the clamp (make sure the vent tube isn't restricted or pinched)
12. Make sure that the vent tube isn't in contact with the muffler or the muffler bolt

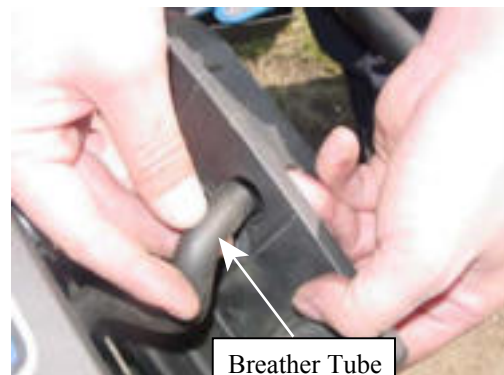
Breather Tube

13. Install the new air filter case gasket (from kit)
14. Reinstall the air filter case (Do not forget to reinstall the breather tube on the air filter)
15. Reinstall the air filter and the air filter cover.
