Service Bulletin	B0402006
	2004-07

Models: LTH18542 A - serial # 111303A001001 to 121503A002202
- serial # 010704D002203 to 012204D002837
- serial # 022304C002838 to 022304C003237
LTH18542 B - serial # 030304C001001 to 062204C003220

Subject: Fuel Line Clamp Chaffing Fuel Tank

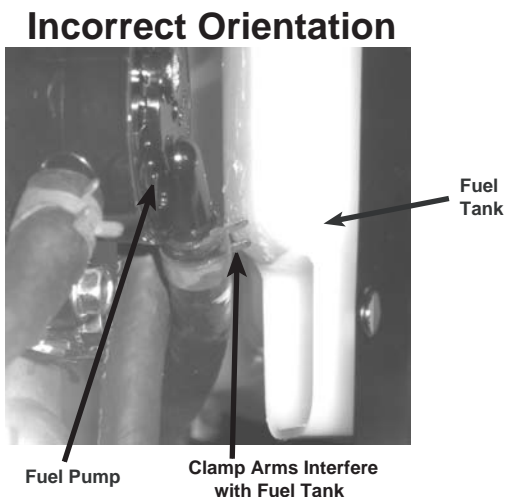
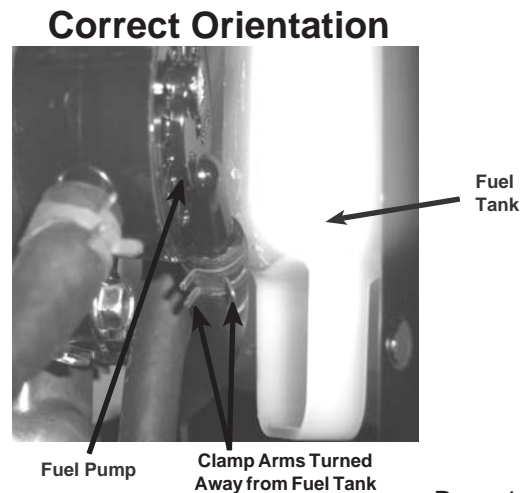
On some LTH18542 tractors, the fuel line clamp (on the lower fuel line to the fuel pump), may be positioned in such a way that it rubs against the fuel tank during operation, causing chaffing of the fuel tank.

For units on the sales floor, raise the hood and check the orientation of the hose clamp. If the tabs of the clamp are near or are touching the fuel tank, use pliers to rotate it so that it's clear of the fuel tank.

Note: If the fuel tank has already been damaged by the clamp arms, please replace it under warranty.

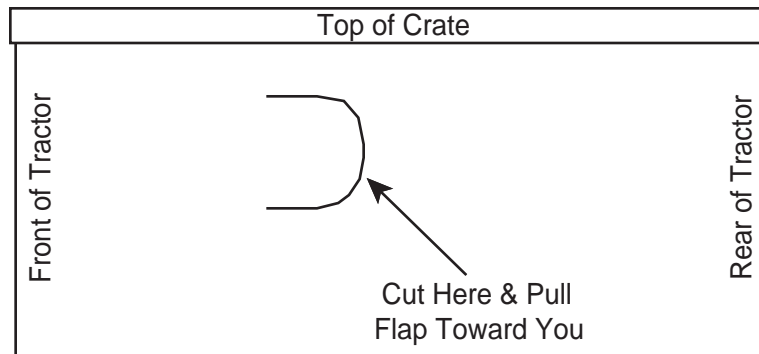
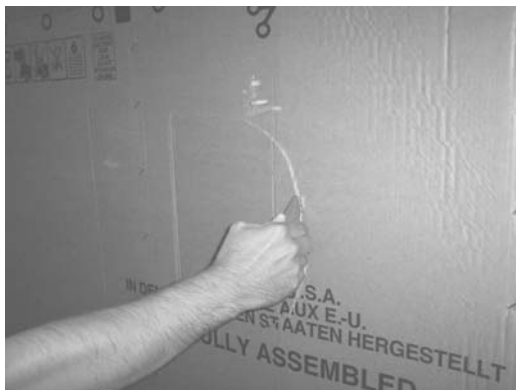
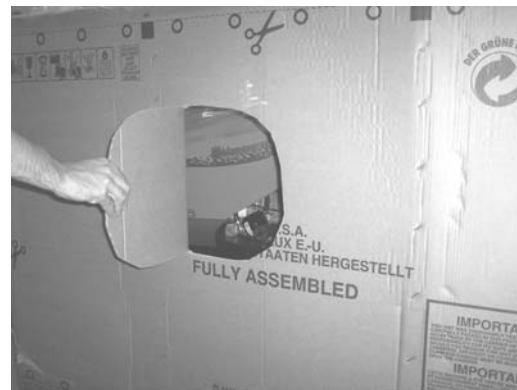
Units Still in the Crate

Carefully cut a slit in the box to determine the orientation of the unit in the crate. Locate the location of the left-front corner of the tractor. Roughly measure about one-third the length down the side of the box and about one-third down from the top. Using a utility knife, cut a large 12" D-shaped hole in the carton and pull the flap out toward you.

This opening should allow you to access the hood and fuel tank area to perform the update. Lift the hood up a few inches and use a flashlight and pliers to locate and reposition the fuel line clamp away from the fuel tank.

Be sure the clamp is positioned correctly and securely and lower the hood back into position. Push the flap back into the carton. If preferred, you may want to use tape to secure the flap closed.
