<b>SERVICE</b>	<b>B0403001</b>
<b>BULLETIN</b>	<b>2004-02</b>

Subject: Consumer Z Steering cable connectors

Models Affected: 968999219, /CZ4815AA, 968999220/CZ4817KOA  
Consumer Zero Turn Mower, all serial numbers

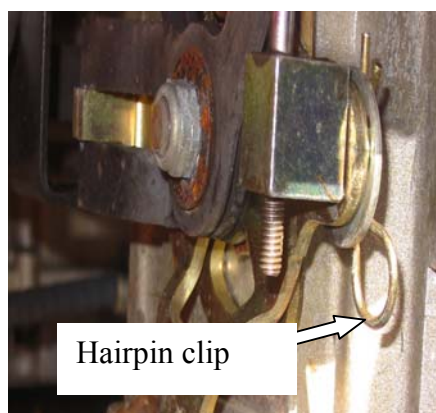
Figure 1 (lower swivel in IZT unit)

Locate the lower swivel where it connects to the IZT power unit underneath the frame (see figure 1). There is one for each side. Remove the hairpin clip and pull the swivel straight out. The protruding pin should be on the lower end of the block (see arrow in figure THREE) and completely bottomed out. The swivel has a counter-bore on the topside, which should slide onto the cable first. The swivel must then be threaded all the way up until the counter-bore bottoms out. Figure 2 shows an incorrectly installed swivel (notice the difference in pin position and amount of threads showing from figure two to figure three). If your unit has the swivel installed correctly reassemble the swivel and put the hairpin back in place. If your cable swivel is installed incorrectly please refer to bulletin 0303022. which covers all aspects of cable adjustment.

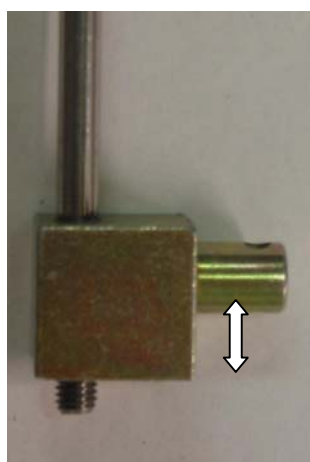
Figure 2 (incorrect)

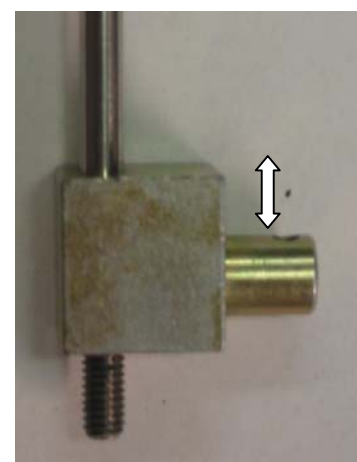
Figure 3 (CORRECT)
