<b>SERVICE</b>

## RIDER 850 - model 1987

### SUPPORT BRACKET

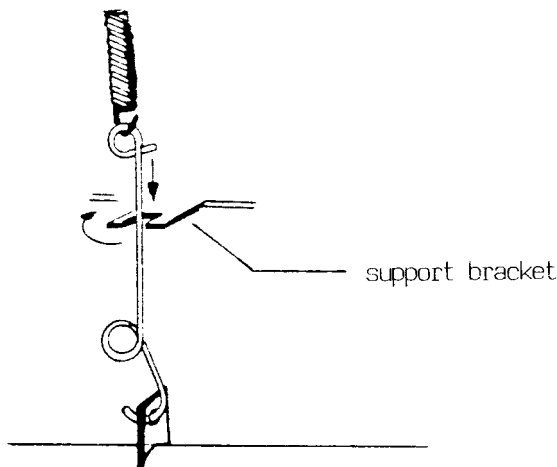
A for many well-known phenomenon which can happen on broken grounds is that the cutting unit can fall down too low. This occurs if you pass a rise in the lawn or a top and if the support wire (A) does not run in its groove on the bracket. Then when the unit touches flat ground again, the cutting unit will be pushed upwards. The bumper may then press the fender covers up so they break.

On the 1988 models, the support bracket and wire are replaced by rigid steel supports which are welded on the lifting frame. These supports can also be welded on to the 1987 model.

Put the front wheels on 30 mm high blocks and let the support rollers of the cutting unit rest against the floor. It should now be 10-15 mm play between the loop on the wire and the old bracket. This extra play secures a better function of the new support brackets. Fit the new supports according to the illustration. Remove them again and grind off the paint on the lifting frame where they are supposed to be welded. Again fit them and weld. Then remove the old support bracket Ref. No. 506 54 71-01, but let the spring and wire remain as before.
