Model 240RBD

Flexible shaft coating

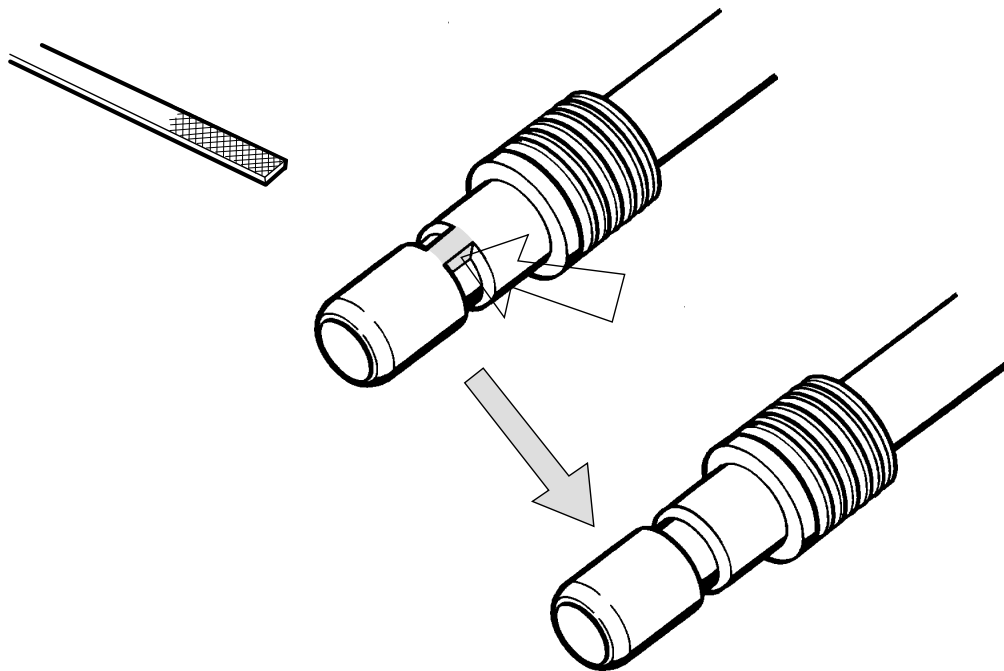
We have decided to remove the rotating stop on the flexible shaft coating to improve manoeuvrability and at the same time increase the service life of the coating. This has been done at the end of the coating located by the throttle. Tilting of the cutting tool has been significantly improved by this measure.

On older machines it's easy to file off the stop in the coating's groove, see fig. below.

However, you must be attentive to the cabling holding the throttle cable and the short-circuiting cables so that these do not wrap around the flexible coating.

The throttle cable can be stretched and cause unintentional acceleration.

This modification will be introduced into production during week 33; i.e. from serial number 633.
