TECUMSEH

Update 2006

FACTORY TRAINING

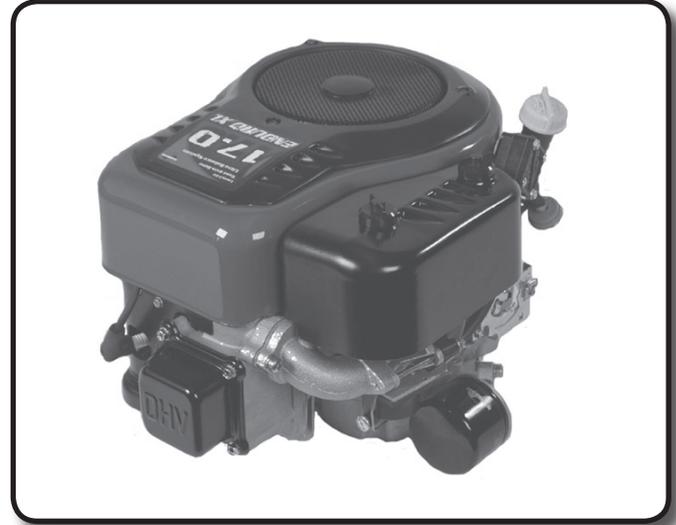
We continue our efforts to build an engine with performance standards that are unmatched in the industry. Tecumseh has made a number of changes to the OV490 engine that significantly reduce vibration. These efforts include a new lightweight piston with a redesigned skirt profile, a dynamically balanced crankshaft and balanced dual countershafts.

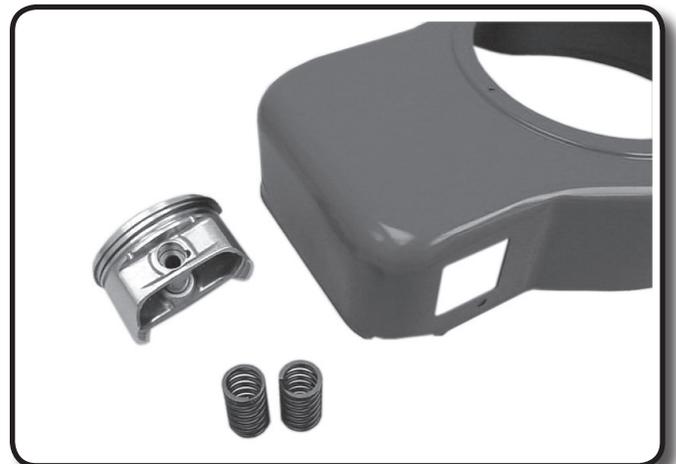
Sound Improvements OV490

We have also made improvements to help lower the noise being emitted by both internal and external components of the engine. The blower housing is made of a laminated steel which reduces its harmonic vibration and dampens engine noise. The lightweight piston with its profiled skirt and lighter valve springs also to help reduce noise levels.

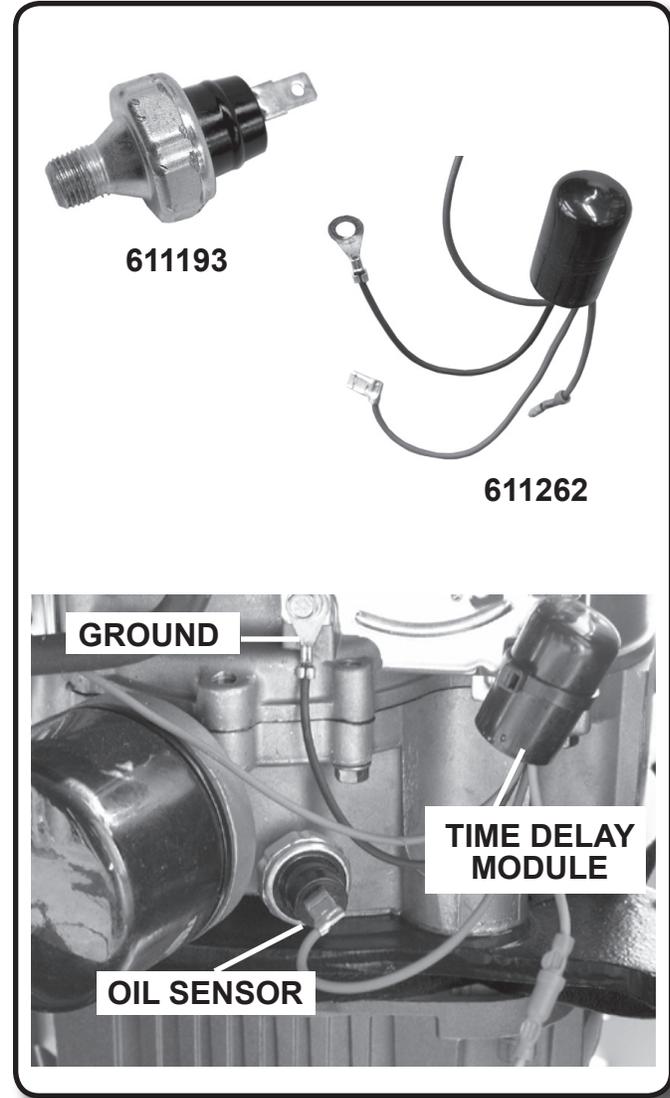
Time Delay Module

Many engines designed to run for extended periods of time use some type of oil level or pressure detection system to protect the engine. One of the systems we use today incorporates a time delay module. This system requires an oil sensor, which detects oil pressure in the engine. In this type of system it is necessary to delay the sensors ability to shut the engine down at start up until the oil pressure is significant enough to be measured. This requires a time delay system which operates for five to twenty seconds at 1500 RPM, before the sensor is activated. There are three tests that can be preformed on the components of this system to trouble shoot the unit. To TEST THE SYSTEM disconnect the red wire from the oil sensor and the black wire from the ground and check the ignition spark. If the engine has spark, continue to test the individual components. To test the TIME DELAY MODULE, disconnect the red wire from the oil sensor. Start and run the engine at low speed (about 1500 to 1750 RPM). Use a jumper wire with insulated alligator clips to connect the red wire to the engine block. These are live wires and caution should be taken to avoid contacting them. The engine should stop running in about 5 to 20 seconds. If the engine does not stop, replace the delay module, the part number for the module is **611262**. If it does stop, test the oil sensor. To TEST THE OIL SENSOR, disconnect the red wire from the oil sensor and connect an ohmmeter between the engine frame and the terminal on the oil sensor. While the engine is off, the ohmmeter should indicate closed contacts (low resistance). Start the engine, and with the engine running, the ohmmeter should indicate open contacts (infinite resistance). If the oil's sensor fails either of these tests, replace the oil sensor, part number **611193**.

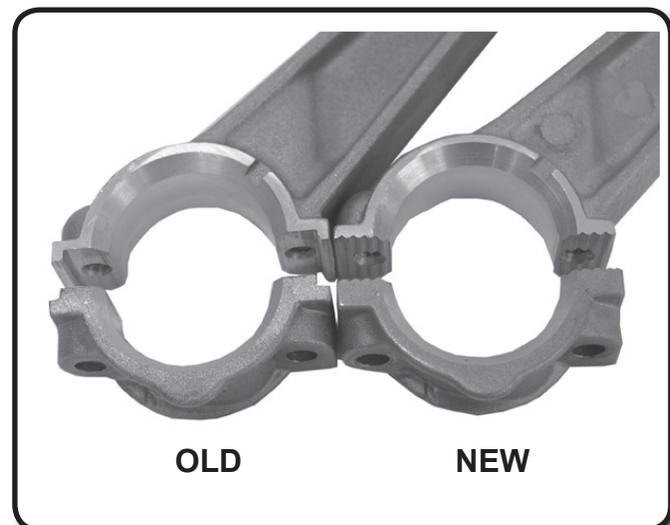
OV195EA Rod Change

The OV195EA is changing the style of the joint between the connecting rod and rod cap. This was done to standardize the process in machining and assembly for LV and OV195 engines. The OV195 rod will be changing from a stepped joint to a serrated joint. Always remember that it is critical that the match marks on the rod and cap must face each other and face out toward the technician when they are assembled. The torque spec on the OV195 rod for both the stepped joint and the serrated will remain at 50-60 in. lbs. (5 - 6 Nm).

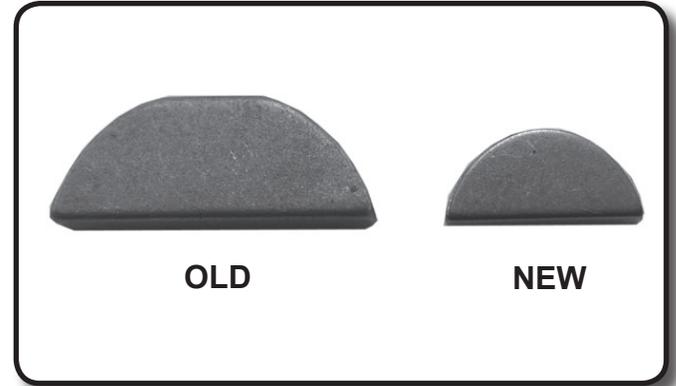
OV195 Flywheel Key Standardized

The current field population of riding lawn mowers built with the OV195 engines is less than one thousand. These engines use a flywheel key different than the one used on rotary lawn mower engines. Because the flywheel key requirements on riding mowers are satisfied by the rotary mower key, it was decided to eliminate the need to carry both keys and crankshafts, and standardize on the key used to comply with rotary lawn mower regulations. This will not negatively affect rider applications. Because keys seldom need replacement on rider applications service will carry just one key. If a replacement is needed contact your source of parts supply.

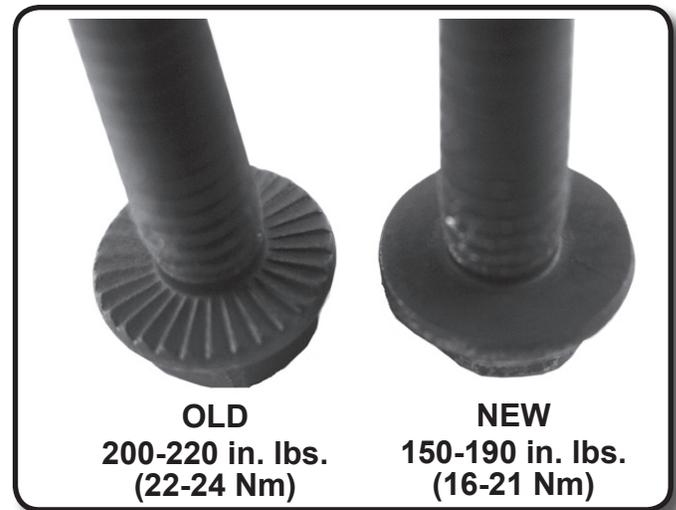
New Rod Bolt Design/Torque Spec to Change

For LH/OH318, LH/OH358, OV358 and TVM220 the rod bolts will no longer have serrations on the bottom side of the head of the bolt. Extensive testing has been done on these models, and it has been found that there was significant increase in torque retention without the serrations. In a situation where serrated rod bolts have been removed it is acceptable to use non-serrated rod bolts to replace the original bolts. The torque specifications will be changing from, 200-220 in. lbs. (22-24 Nm) to 150-190 in. lbs. (16-21 Nm).

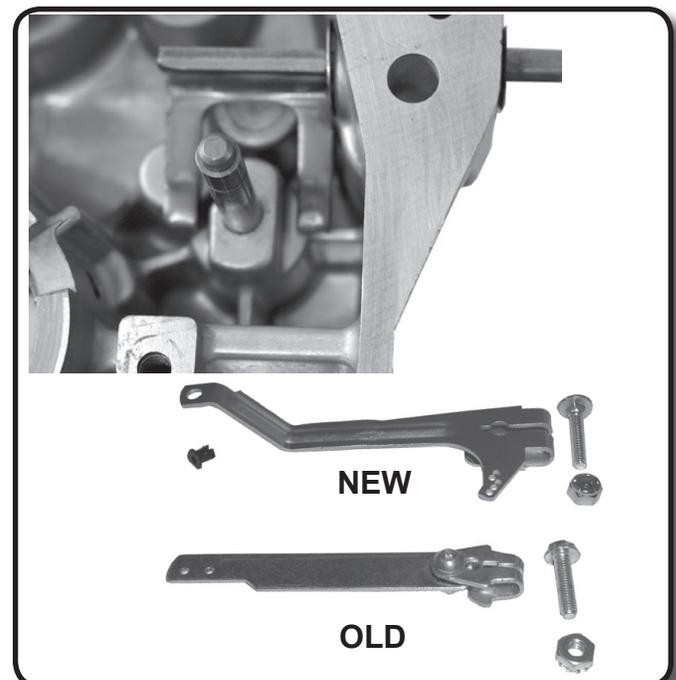
New Governor Shaft, Linkage & Cylinder Cover

The LH318, LH358 & OH318 will have a newly designed yoke style governor system. This design rests evenly on both sides of the governor spool and provides quick governor response and a more consistent speed control. A new one piece governor lever has also been incorporated simplifying the adjustment procedure. This eliminates the smaller lever section that attached directly to the governor shaft. The cylinder cover crankshaft bearing area has been beefed up to give added support and strength to the entire cover.

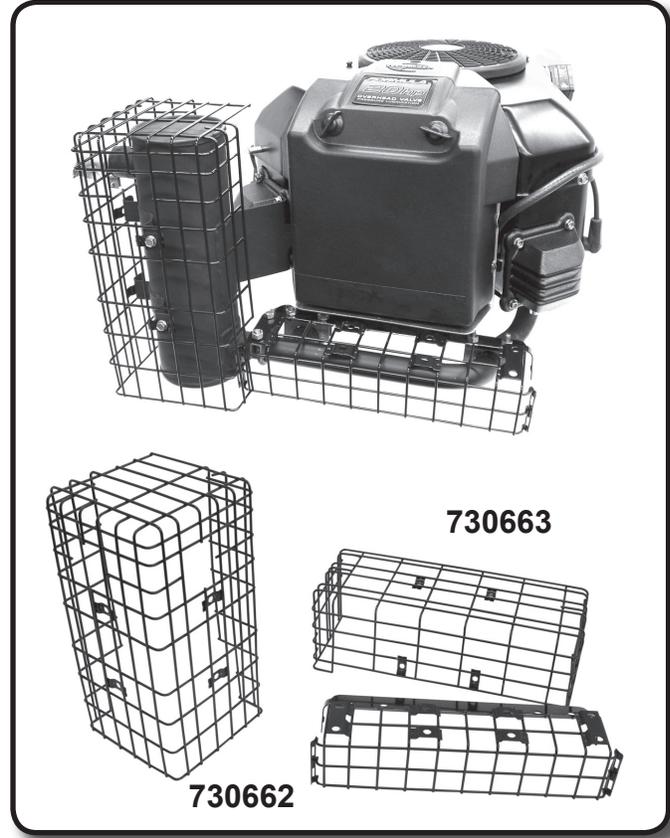
Muffler Guards for OV691 Twins

Muffler guards are now available for all the twin muffler systems. These guards will cover both the Muffler and Exhaust Manifold. They are designed to give the equipment operator that added safety feature to prevent unintended mishaps. The horizontal guard part number **730663** accommodates both left and right discharge. The **730662** kit is a two piece kit that includes a guard for the crossover pipe and adapts to left and right discharge.

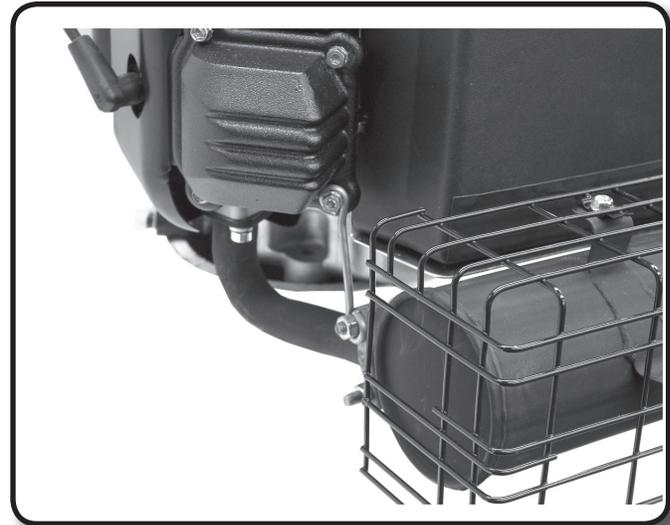
Twin Muffler Kit 730660 & 730661 Added Support

There will be two wire support brackets added to these horizontal muffler kits for twin cylinder engines. These brackets will go from the lower insider rocker box bolt to the muffler clamp on the crossover pipe. These brackets have been added to give the muffler greater support and stability.

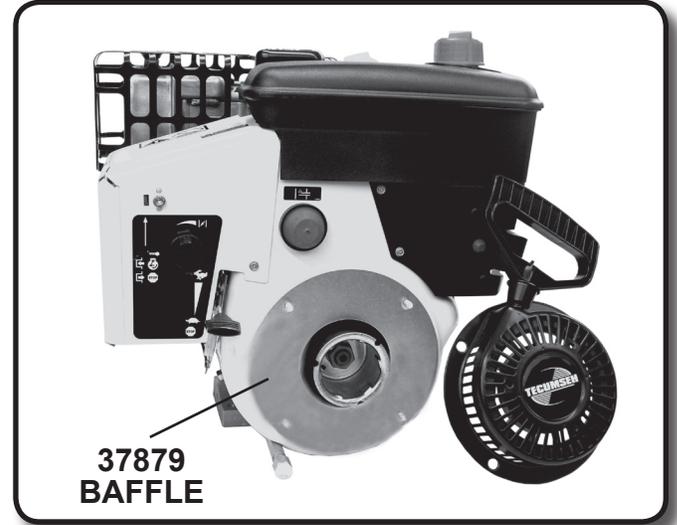
OH318SA Baffle

A baffle is being added to the OH318SA Snow King engine to prevent the potential for freeze ups to occur in the carburetor. This baffle part number **37879** helps the heater box generate sufficient heat to warm the air around the carburetor to prevent moisture from accumulating and freezing. The restrictor baffle is placed between the recoil and the blower housing. The kit will retrofit on existing OH318SA's, but should only be used where there has been a persistent icing problem. This information can also be found on **Service Bulletin 129**.

We have received reports from our service network that under certain weather conditions the OH318SA Snow King engine can experience carburetor icing.

Our engineering department has been able to duplicate the symptoms during field tests, and have designed an Air Restrictor Baffle to prevent this from occurring. The restrictor baffle (**part number 37879**) was designed to help the heater box generate sufficient heat to warm the air around the carburetor preventing moisture from accumulating and freezing.

Simply remove the recoil assembly from the engine, place the air restrictor plate over the recoil-mounting studs. Install the recoil assembly onto the blower housing of the engine and torque the nuts to 80 inch lbs. (9Nm).

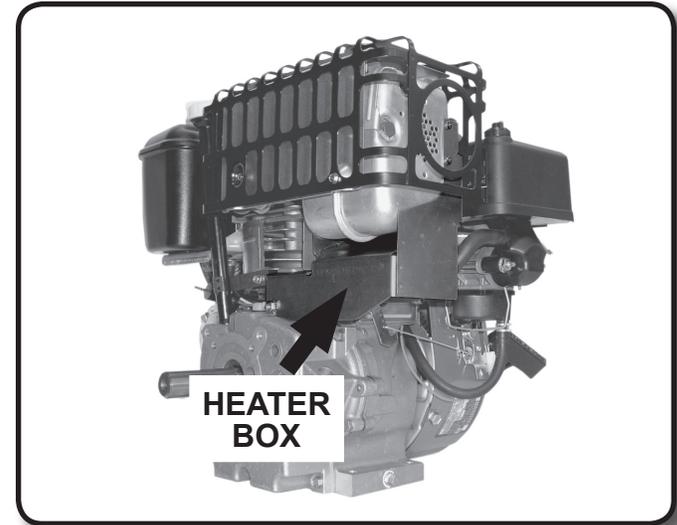
Ariens Power Brush Carburetor Icing

We have received field reports of carburetor icing on the OHM90 & OH318EA (Non-Snow King) engines equipped on Ariens power brush equipment. This typically occurs in conditions of high humidity and a temperature of below 40° F (4° C). Because this engine runs in both summer and winter a new heater box has been designed, (part number **730273**) which directs warmer air from under the muffler straight into the air cleaner intake snorkel when the air cleaner cover is in the winter position. The air cleaner cover position must still be changed for operation based on ambient temperatures. This new heater box only needs to be installed on units, which have exhibited this concern. **Bulletin 131** gives all of the details on any necessary procedures to follow.

We have received field reports of carburetor icing on the OHM90 & OH318EA (Non-Snow King) engines equipped on Ariens power brush equipment. This occurrence has only been duplicated under conditions of high humidity and a temperature of below 40° F (4° C).

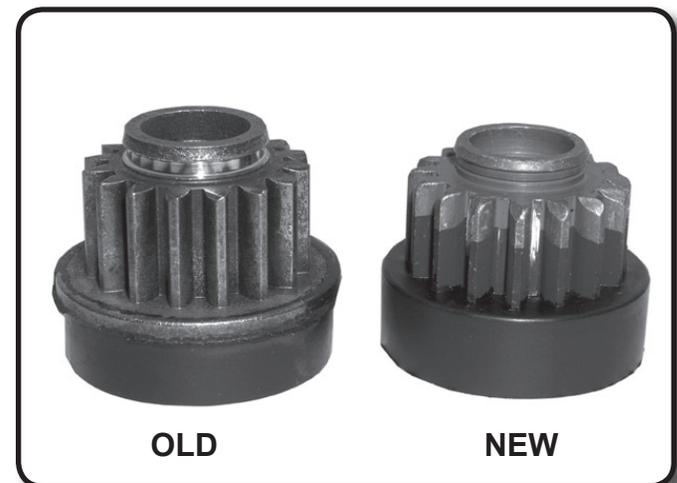
120 Volt Snow King Starter Pinion

Tecumseh Power uses several different starters on 8-13 HP engines. We have received field reports regarding damaged pinion gears over the past year on one starter in particular, part number 37000. Test results indicate a combination of two changes resolve the matter. The use of a steel cut pinion gear with a slightly different profile has corrected the problem. The pinion gear comes in a kit part number 37052A. This kit includes a number of parts, but the most critical are the pinion and the cap. The old cap will not work with the new pinion. It is recommended to use all of the components in the service kit when making this repair. Do not reuse any of the old parts.

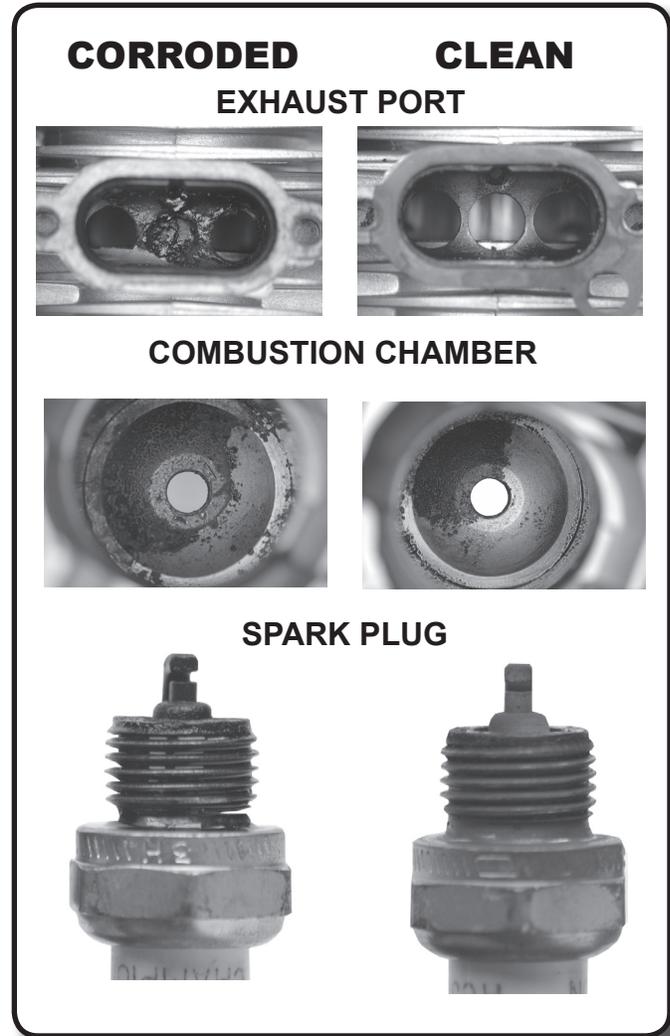
Oil Update

The following pictures depict two different two cycle engines run under identical conditions. One engine was run using a standard, mineral based two cycle oil, and the other with Tecumseh's synthetic blend. These photos illustrate that using Tecumseh synthetic blended oil provides longer life and reduced emissions. With fuel stabilizer already added the upside to the consumer is a plus. These benefits can be experienced in other engines not manufactured by Tecumseh simply by using part number **730227D**. Prove it to yourself. We have included a wall poster in this booklet for you to display in your customer service area to help promote the Tecumseh difference.

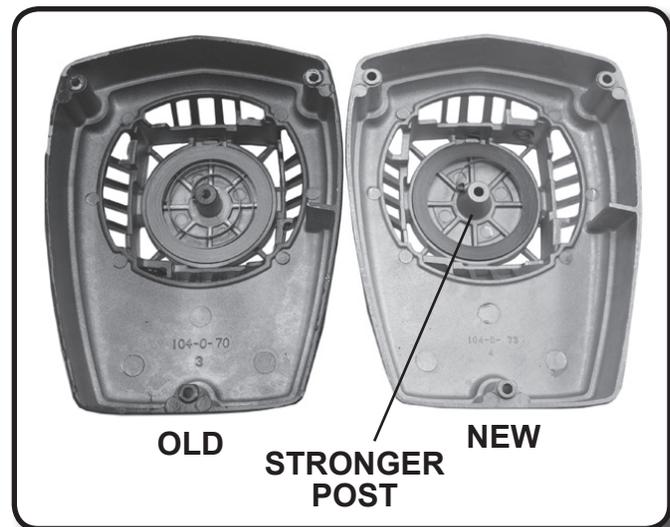
TM049 Recoil Change

In our quest for product improvement, we have increased the dimension of the center post on the TM049 recoil housing. These changes have made it necessary to also change the components which make up the assembly. The pulley has been changed to accommodate the increased size on the housing post. This dimension change will occur at the bottom of the pulley and will not affect the fit on any existing housings. However, when a new style pulley is used it will require a new recoil spring be used. The new spring is thinner and will allow the recoil rope to extend fully when the rope is pulled. Remember it will now be necessary to replace both components for the recoil to operate properly.

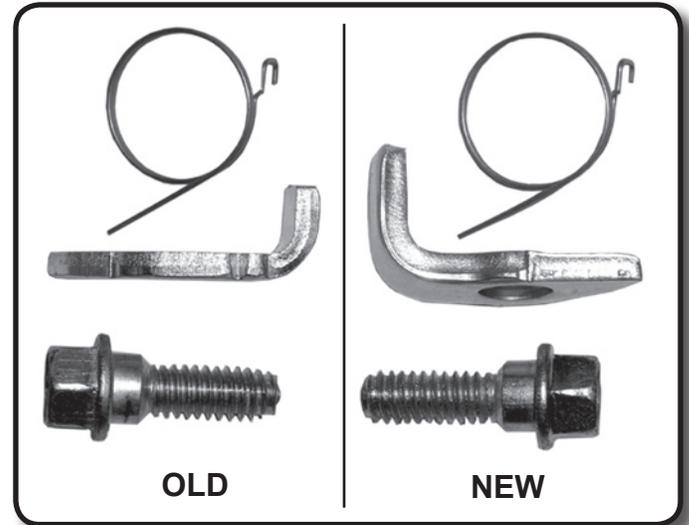
TM049 Starter Dog Change

The spring loaded starter dogs used on the TM049 have been changed to give some additional strength to help increase cold weather durability. These parts have been thickened which means the space on the tang of the spring had to be widened and the depth on the shoulder of the screw changed to accommodate for that upgrade. These parts will only be sold as a kit (part number **590779**) and will supersede any of the individual component parts from the original spec. The kit will retro fit any existing flywheel that uses these components. Included in the kit are, pawl springs, starter pawls, shoulder screws, recoil spring, starter pulley, washer and two of each, 10-24 x 1-3/8" screws and 10-24 x 13/16" screws.

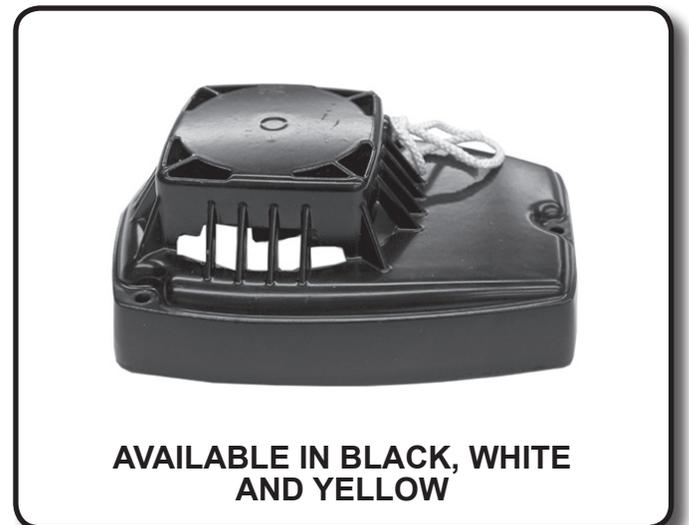
Along with the changes made to the internal starter parts on the TM/TC recoils, we are also making available three painted recoil assemblies: They are completely assembled and painted in the more popular colors used on this engine.

AVAILABLE IN BLACK, WHITE AND YELLOW

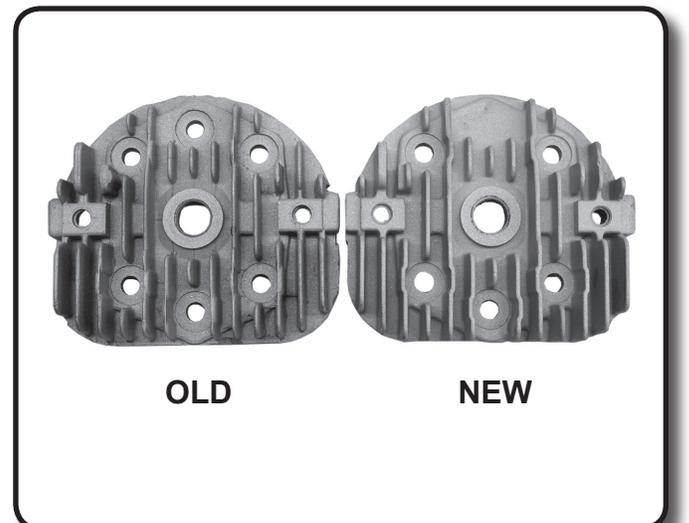
TH098SA 5 Bolt Head

Here is a heads up (no pun intended) for you dealers, who question things when they do not appear the same as they were. The TV085/AV520 has been built with a five bolt head for many years. The success of using this bolt pattern has prompted our engineering staff to change from a 6 to a 5 bolt head on the TH098SA/HSK600. If you have a block that was built with a six bolt pattern and have to order a new head, you may receive a head with a 5 bolt pattern. It will seal properly and not affect the engines performance, even if you have a gasket with six holes.

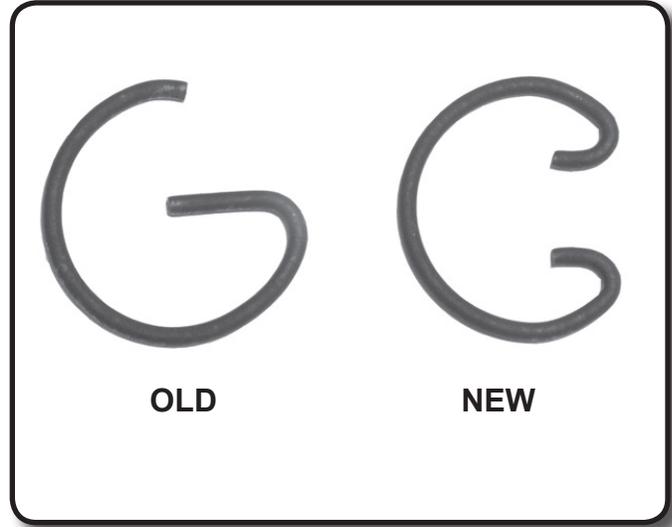
Piston Wrist Pin Circlip

The wrist pin circlip on the TV085, TH098 and TH139 is being changed from a "G" shape to a "U" shape design. The "U" shaped clip will make it much easier to remove and install the circlip into the piston wrist pin area when servicing the engine. This will reduce the possibility of scratching the piston skirt and causing damage to the cylinder bore.

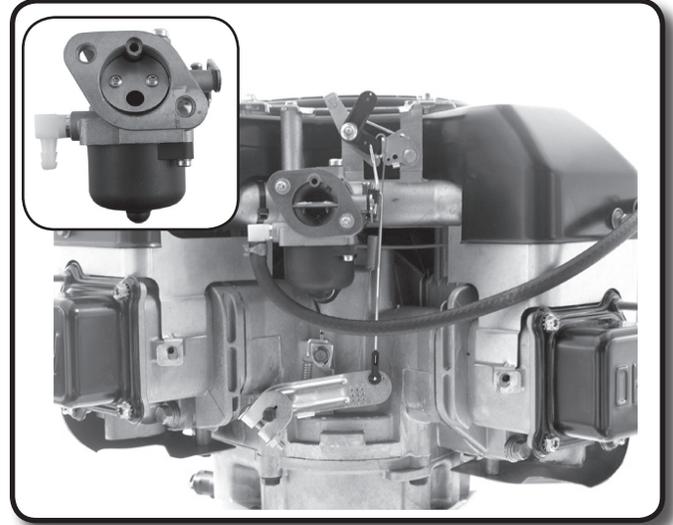
Series "14" Single Carbureted Twin

The series 14 carburetor will be available this year on some of the OV691 engine's as an option. On those selected models this single carburetor feature will be used in place of the proven dual, series "7". It is configured as a horizontal choke and throttle plate operation with an easily serviced composite fuel bowl. None of the critical adjustments such as static governor setting or RPM adjustments have changed, so service is simple.

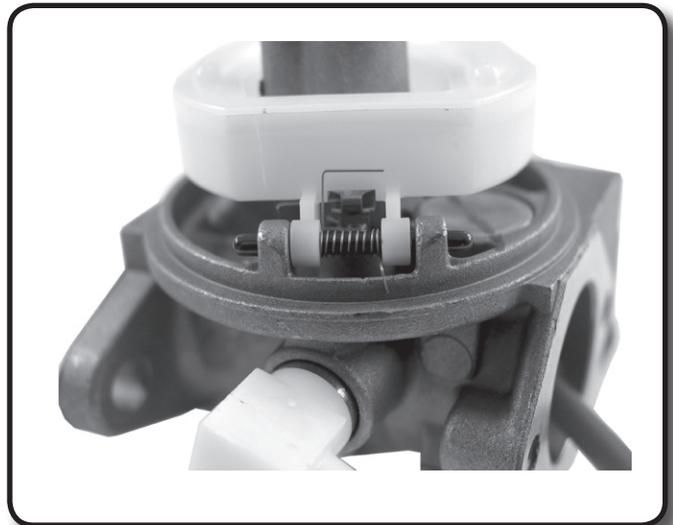
Composite Float Dampening Spring

The original design of the composite float prevented the use of a dampening spring. There is a new composite float that will accommodate a dampening spring for those applications that need additional float stability. The float and spring assembly comes in a kit part number **632019A**. If individual part numbers are needed for repair or replacement use the number **632815** for the dampening spring and **632816** for the float. The kit or individual parts will retro fit any application that currently has a composite or brass float.

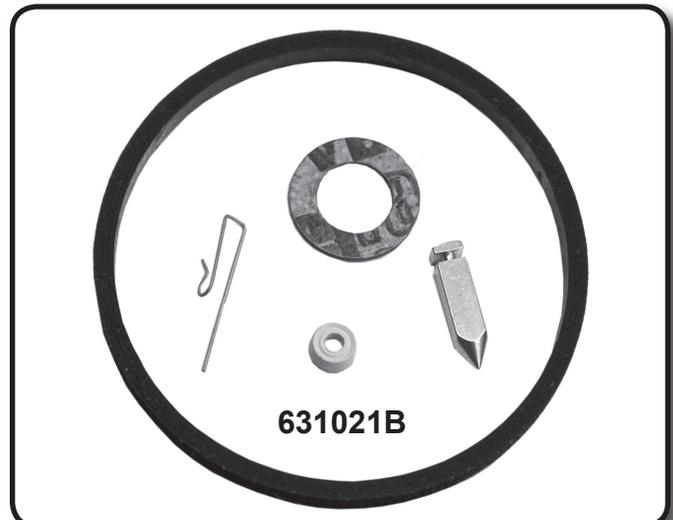
Carburetor Kit Lite

There is a reduced size carburetor kit that is now available in the service system. This basic kit, part number **631021B** provides the most common parts needed to guarantee the integrity of the carburetor when you drop the bowl of a metal bowl carburetor for a quick inspection, carburetor tune up or minor repair. The basic kit includes the inlet needle seat, inlet needle, inlet needle clip, float bowl gasket and bowl nut gasket. When a complete rebuild is needed on a metal bowl Tecumseh carburetor, the universal repair kit part number **632760B** contains all the internal parts needed to complete the job. The **631021B** gives you a basic kit to guarantee the integrity of the inspection or repair without the cost.

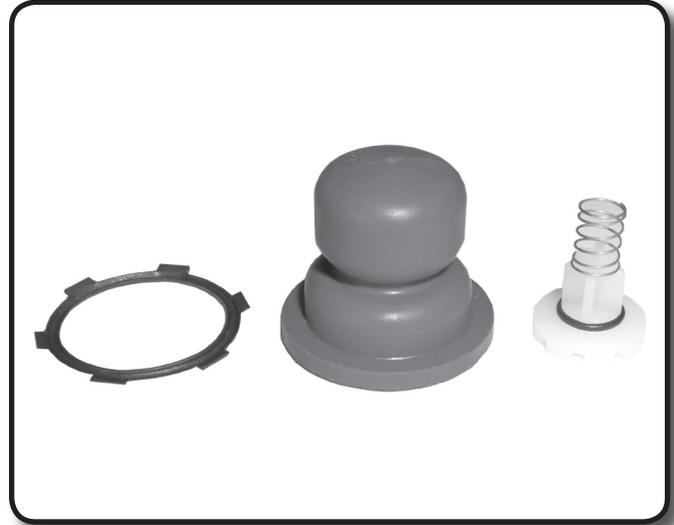
Carburetor Cleaning Reminder

Last year Tecumseh introduced the “Accu-Prime” primer system for use on our small vertical shaft engines. As a reminder, we recommend when cleaning any Tecumseh carburetor, to remove all non – metallic parts. This includes the plunger on the Accu-Prime system located under the Primer bulb. For the past several years we have also recommended not to soak the carburetor in carburetor cleaner, because of the use of non-metallic jetting in some internal passages. Using a spray cleaner such as Tecumseh’s “**696410**” carburetor cleaner, tag wire and compressed air is the recommended procedure.

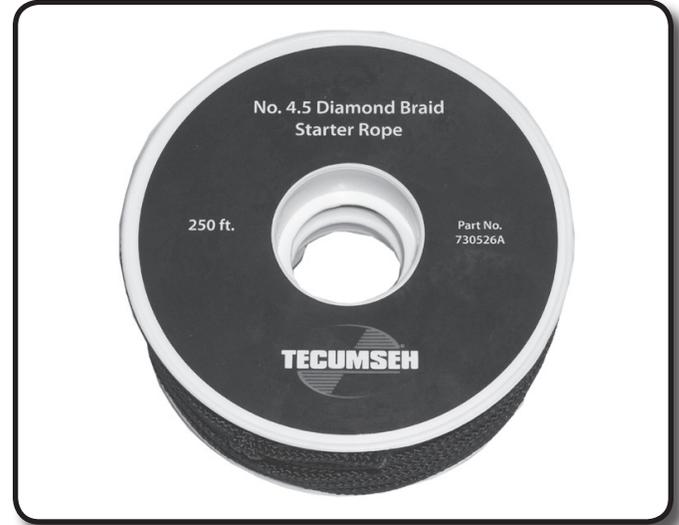
Recoil Rope Change

The bulk rope 4.5 mm used for service replacement has been changed in both strength and spool size. Identified by its black color this 250 ft. spool boasts of a 25% increase in strength over the bulk service rope we currently offer. That allows it to be used on all 4 cycle engines through 13 HP. This can only be used on recoils that have the larger diameter pulleys, which covers most engines built for the last 10 years. The part number **730526** will supersede to an “A” as stock is depleted.

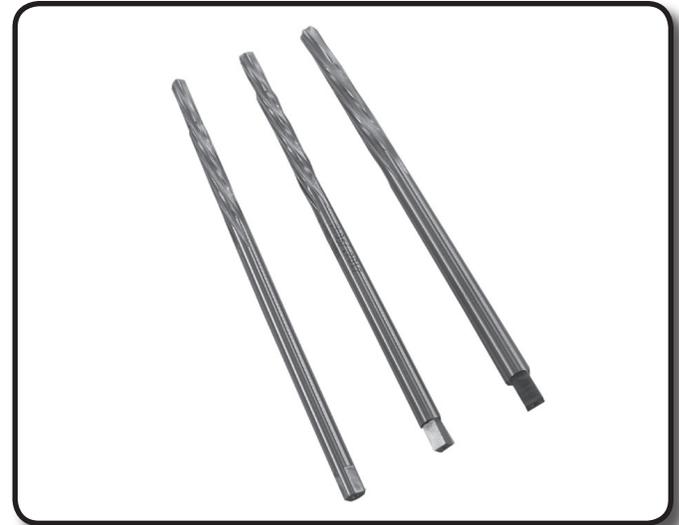
Clean Up Valve Guide Reamer

Tecumseh is introducing several clean up reamers. These reamers are designed to recondition the valve guide with out over sizing the guide. This should help with the occasional sticking valve and could be used as part of the tune up procedure for off season maintenance. The three new sizes that are available are, **670395** = .250 (6.350 mm), **670396** = .248 (6.299 mm), and **670397** = .312 (7.937 mm).

This list shows all of the available valve guide reamers and their sizes.

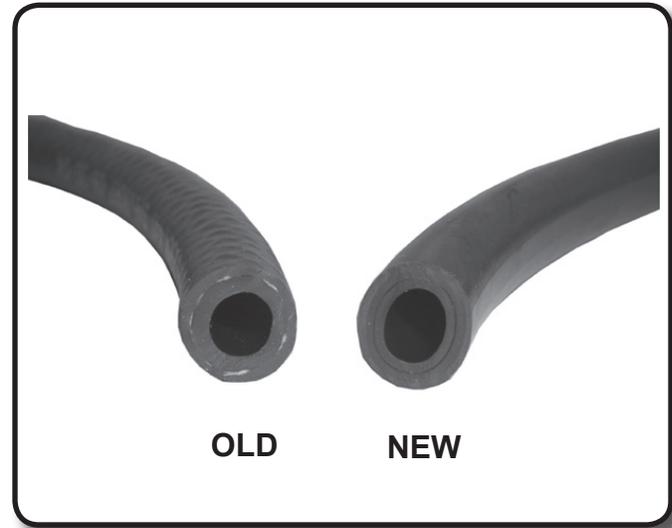
Low Perm Fuel Line

Fuel line has now been designed to meet emissions compliance standards. This regulation takes effect on January 1st, 2006 on production engines sold in California. This new design has a thin membrane of low permeation material molded into the fuel line. This liner eliminates the potential for vapors to permeate the outer layer of the fuel line, and evaporate into the atmosphere. Tecumseh has taken the extreme step to provide this fuel line through our service network to guarantee that our dealer network can meet these standards and avoid any possibility of violating federal regulations. All Tecumseh engines built after October 1st, 2005 will come equipped with low perm fuel line. When servicing any compliance built engine, the repair components must also meet emission standards. It is absolutely imperative that the service replacement part be ordered using the part number listed on the parts list to remain in compliance. Installation of the low perm fuel line will require the use of a small piece of 180-220 grit emery cloth to slightly rough up the fuel tank spud. One revolution performed in a horizontal motion is sufficient. Then use isopropyl alcohol on clean rag to clean the tank spud and wet it for line installation. While the tank spud is still wet from the alcohol push the line back on, but do not twist or kink the line. Re-install the clamp making sure the fuel line is approximately 3/32" (2mm) from tank bottom.

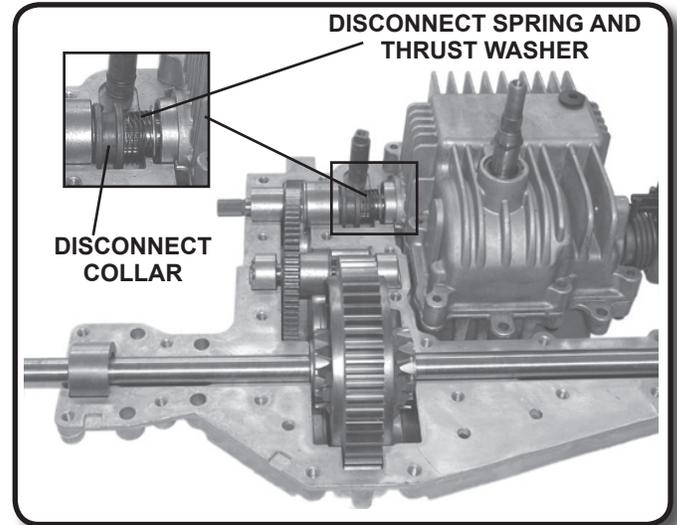
LTH Mechanical Disconnect Change

There has been a modification in the spring used on the mechanical disconnect mechanism of the LTH hydrostatic transaxle. The spring rate has been increased to prevent any units from forcing the connect collar off the drive shaft and disengaging the drive. These incidents occurred only occasionally under extreme conditions. Our warehouse stock has been purged and a running change was made in production. If you experience repeated incidents replace the spring. **Service Bulletin 309** outlines the procedure and tools required to make this repair.

We have identified a situation with the mechanical disconnect mechanism used on our LTH Hydrostatic transaxle. This situation affects a very small percentage of units causing a potential LOSS of drive during operation. This may be described as jumping in and out of gear by the customer.

4. Remove the brakshaft, disconnect collar and seal/bearing packs from the final drive.
5. Install the new brakshaft assembly, disconnect collar along with the original seal/bearing packs using the supplied seal protectors. All required new parts are supplied in service kit **799032**.

6. Apply a thin bead of Loctite 598 RTV sealant to the case including the bearing pockets. Install the cover and torque the screws to 90 inch lbs. (10 Nm) in a standard "X" pattern.
7. Install the new disconnect spring and thrust washer, lubricate shaft and spring as directed in the instructions included with the kit.
8. Connect the hydro module drive to the final drive. The alignment of these two modules is critical. The alignment tool **part number 670384** must be used during re-assembly. If you do not already have one, it can be purchased from your Tecumseh distributor.

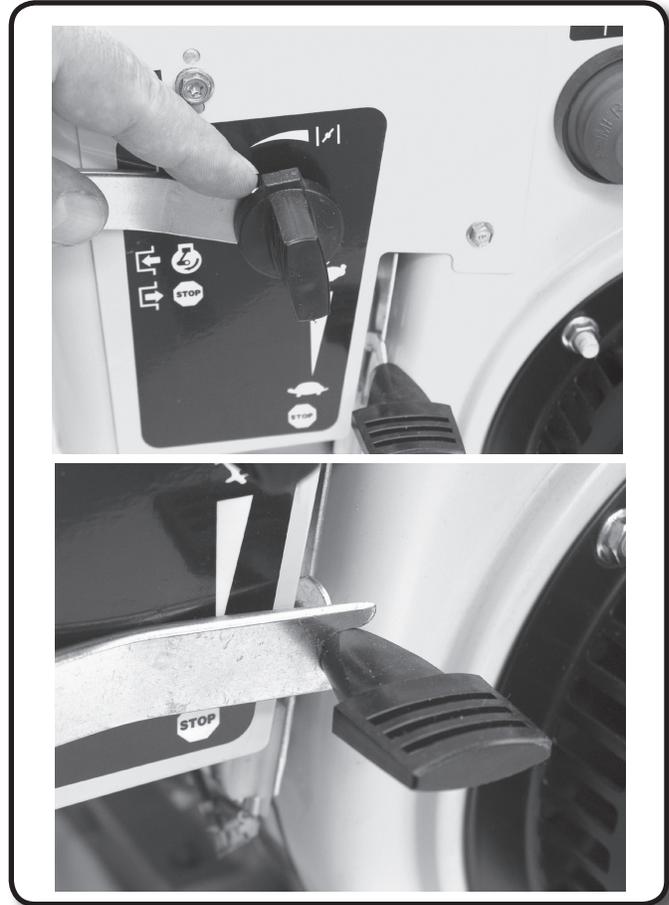
Fuel Line Tool Double Duty

The fuel line removal tool **670382** has been suggested as a handy tool for removing choke and control lever knobs. Often times when servicing engines these items are cumbersome and difficult to remove. Prying them off with a screwdriver or pliers can damage the component because of the press fit used to fasten them. This has been tried on all types of levers and removes them with ease every time.

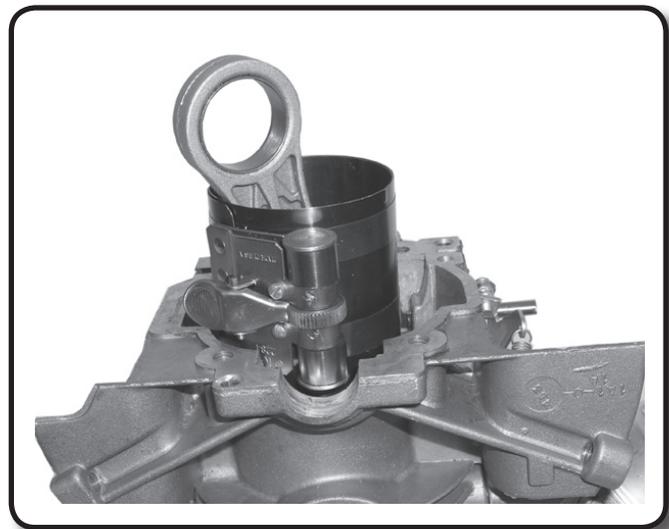
8 Cube Piston Tip

The popular 8 cubic inch vertical and horizontal shaft engine can at times present some challenges when installing the piston. The engine has no removable head and splits at the crankshaft to service the internal components. The cylinder is tapered so that the rings are compressed when the piston is pressed into the bore. This can be a painstaking procedure if you are short on patience. The following tip was shared at one our training schools this past year. Use the **670359** ring compressor tool to compress the rings as you would on any other two or four cycle engine, but do it in the inverted position. This will allow the release mechanism enough clearance in the crankcase to put the piston in position and tap it into the cylinder.

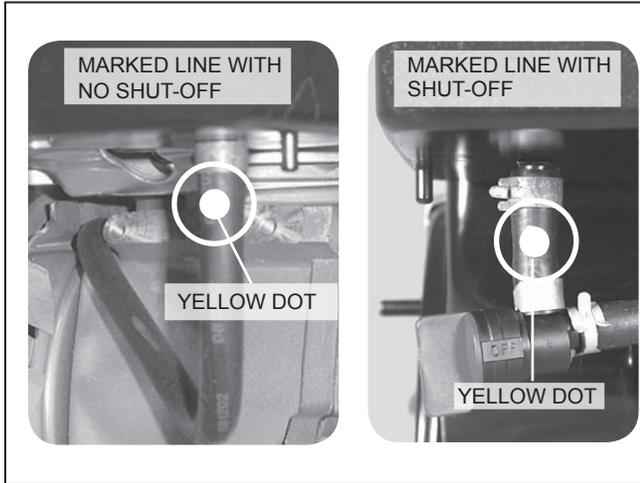
Figure 3

1. Crated/Boxed product that has been inspected or repaired will have a GREEN circle or self adhesive dot approximately 1" (25mm) diameter on the box. This will be located directly below the manufacturer's model/serial identification number (fig. 4). This mark identifies the product as **GOOD** and may be sold and used.
2. Engines in the affected D.O.M. range that have been repaired will have a **YELLOW** paint mark on the fuel line, adjacent to the fuel tank outlet (fig. 3).

7. Next use a permanent **YELLOW** paint marker to place a dot on the line as shown in (fig. 3) to mark the unit as repaired. These paint markers are available at many hardware or automotive stores.

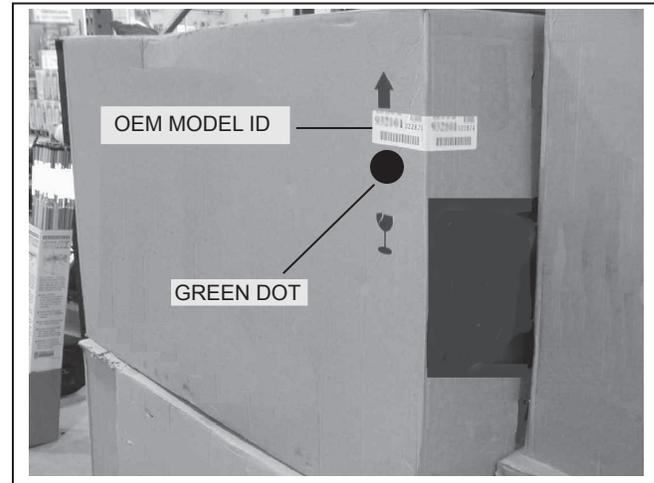
Figure 4

8. If the unit is boxed, reseal it to sellable condition using clear tape.
9. Place a 1" (25mm) diameter self adhesive GREEN dot (available at any office supply store) on the outside of the box below any OEM model/serial number location (this may be up to four per carton) as shown in fig. 4. If a self adhesive dot is not available use a GREEN paint pen and place a 1" (25mm) diameter circle in those locations (fig. 4).
