Service Update

50" Cutting Deck
Shown on a Husky 608 Lawn Tractor

MTD Products LLC - Product Training and Education Department

50" Cutting Deck Update

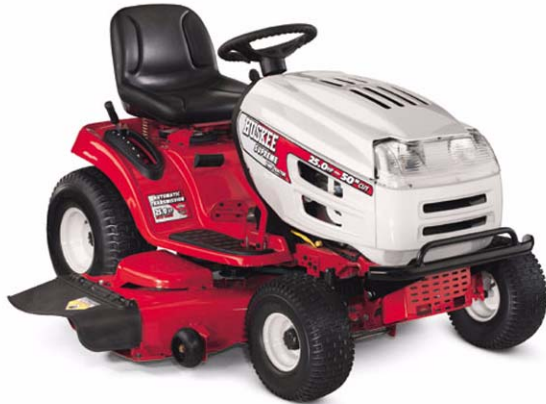
The Lawn Tractor used for service update procedures was a "Huskee" model 13AR608P731 / 1C184H20069.

This is the largest cutting deck that we have ever put on a 600 Series Lawn Tractor with the step-thru frame. The obvious thought is the high horse power and a big deck on a small frame tractor is an excellent combination for cutting grass.

The deck is made of heavy steel with all steel spindle covers that completely covers the blade spindle area. The design has the appearance of Diamond Plate on top of the belt cover. This deck is a floating deck.

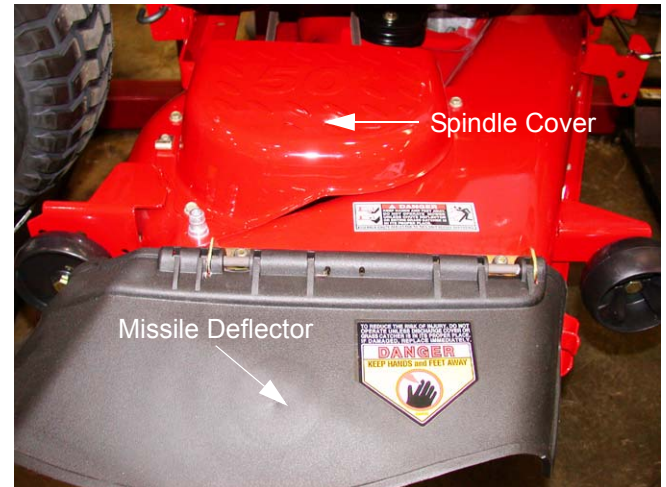
Figure 1

Right side view showing the discharge chute and the heavy steel spindle cover. See Figure 1.

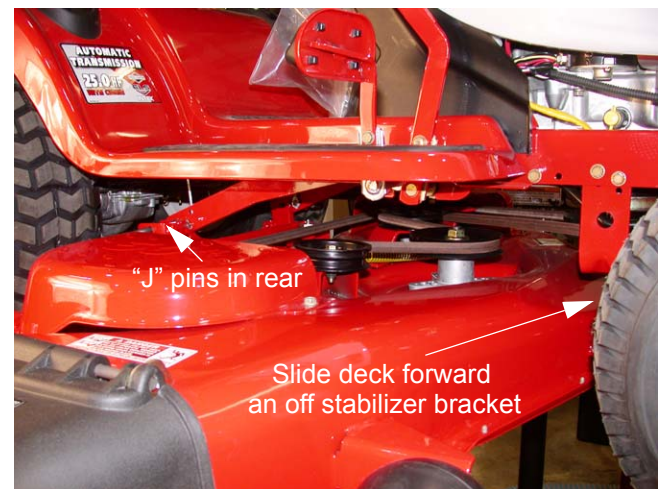
Figure 2

The deck removal is the same as any other size deck on the step-thru style frame. Just pull the "J" Pins and push the deck forward and off the front stabilizer support bracket. See Figure 2.

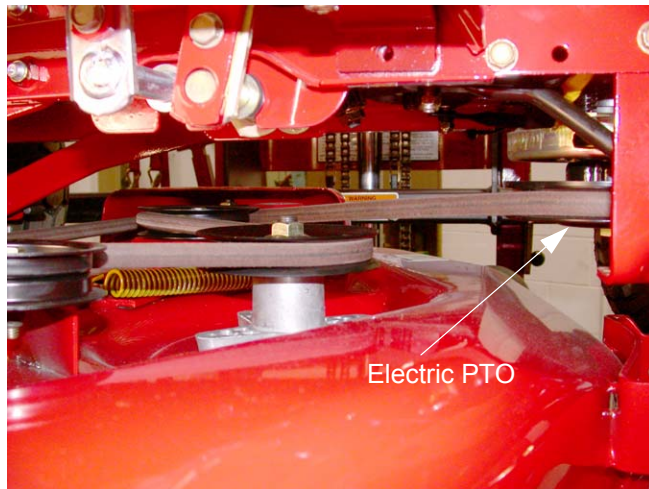
Figure 3

The deck blade belt is easily removed from the electric PTO on the engine. See Figure 3.

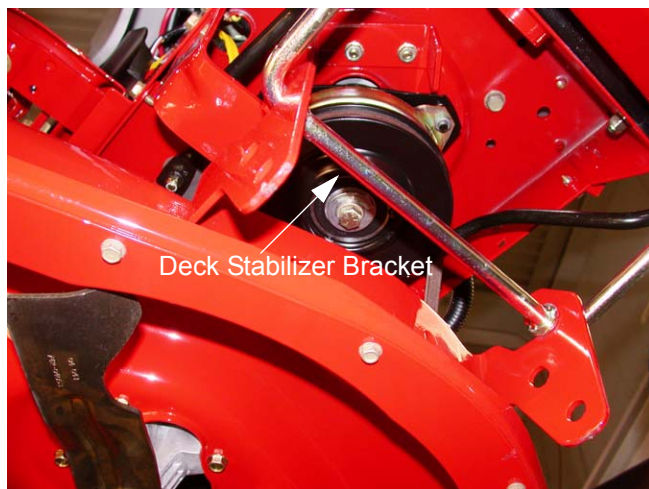
Figure 4

The front support is adjustable the same as units with a 46 inch deck and connects to the front bracket assembly on the deck. The new design appears that it is made to accommodate a front roller in the future. See Figure 4.

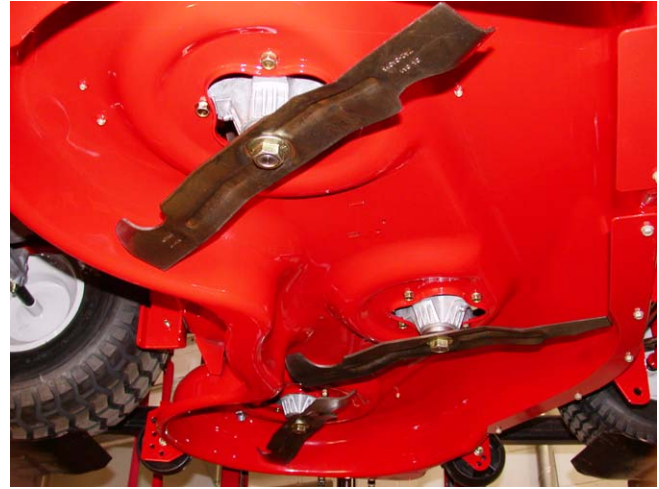
Figure 5

The underside of deck showing the three blades. See Figure 5.

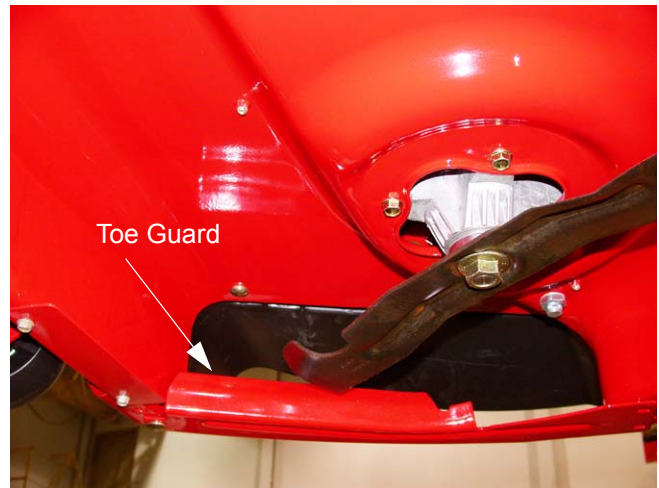
Figure 6

Looking from under the deck viewing the toe guard and discharge chute. See Figure 6..

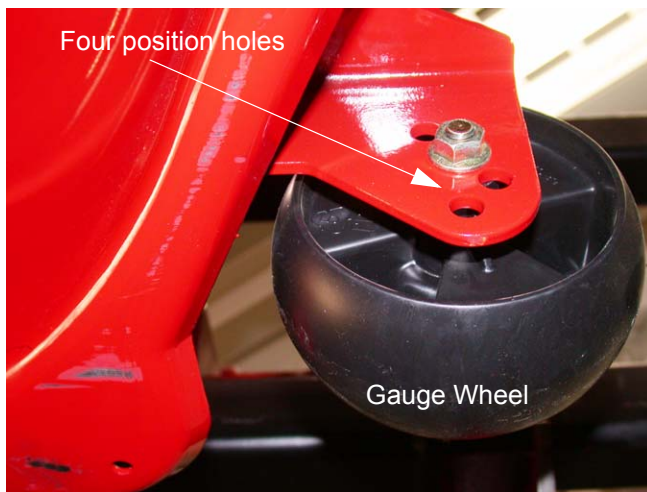
Figure 7

The front and rear gauge wheels have four positions for adjustment. See Figure 7.

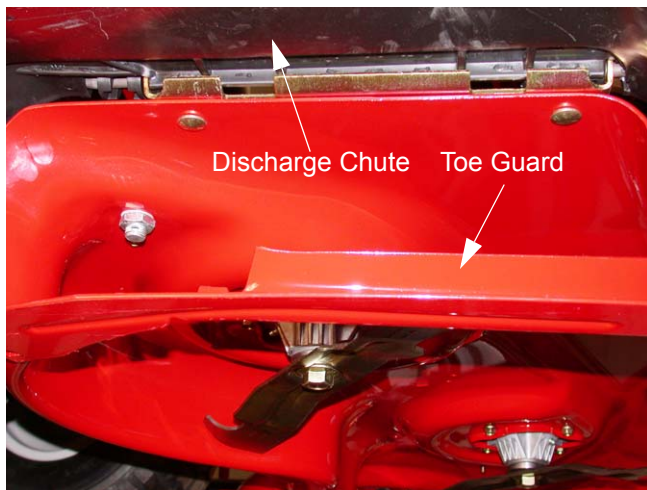
Figure 8

Showing the discharge chute and toe guard area. See Figure 8.

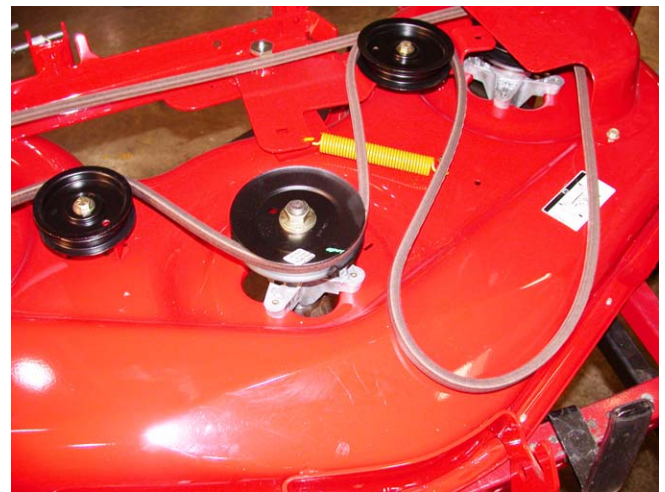
Figure 9

View with the deck removed. Loop shown goes around the electric PTO. See Figure 9.

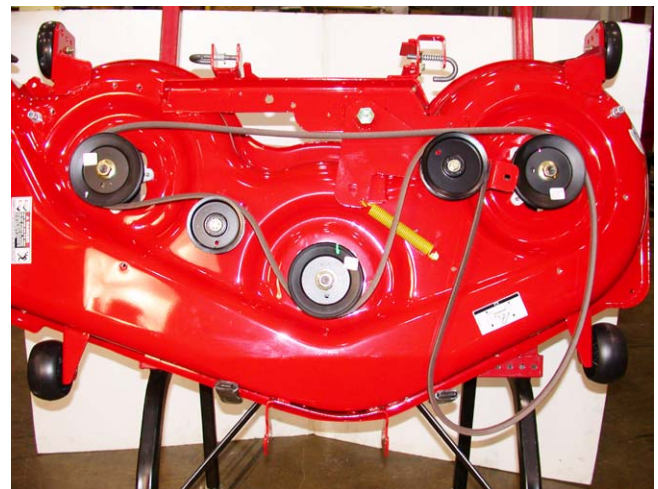
Figure 10

The complete deck removed from the Lawn Tractor and on a deck cart for servicing. Note the belt routing which is also displayed on a label on the deck. Also note the spindle assembly numbers on the spindle pulleys. See Figure 10.

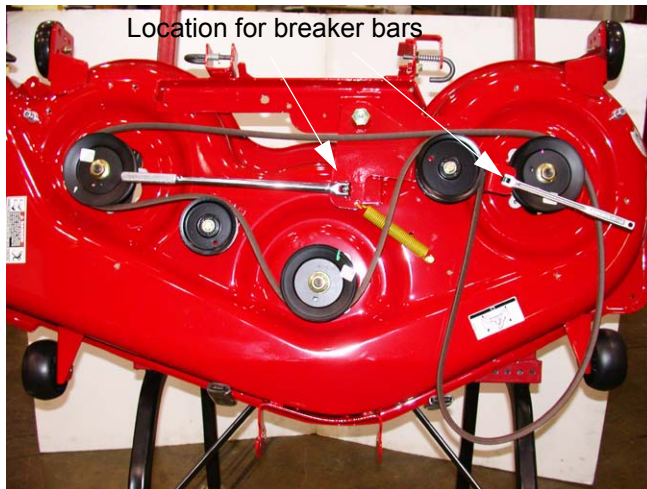
Figure 11

When reassembling the deck on the tractor it is necessary to turn the belt tension idler bracket to allow slack in the belt when placing it around the PTO pulley. Two holes are provided for placement of a breaker bar. See Figure 11.

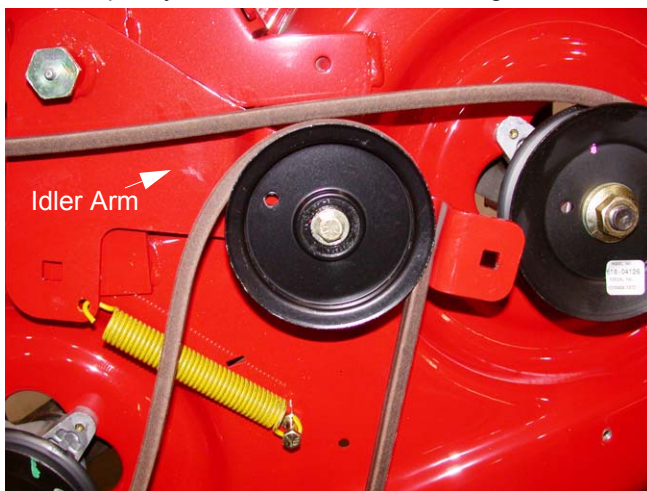
Figure 12

The belt tension idler bracket showing the holes for the breaker bars and the grease fitting on the pivot shoulder bolt holding the bracket. It is necessary to loosen the idler pulley to remove the belt. See Figure 12.

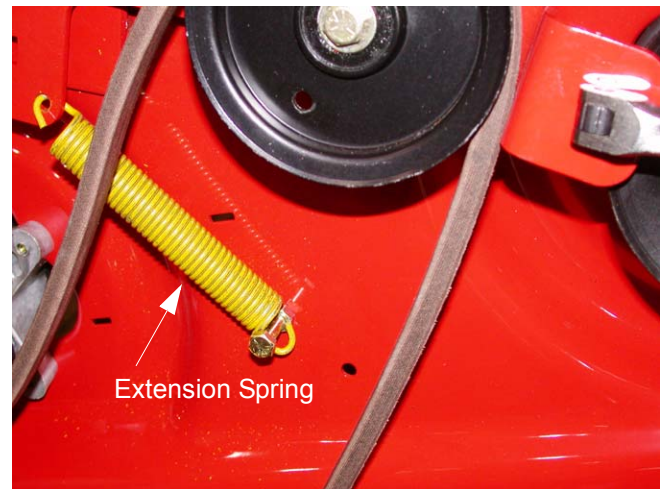
Figure 13

The extension spring is easily removed by placing a 3/8 " breaker bar in the bracket and pushing upward. This removes any tension on the spring. See Figure 13.

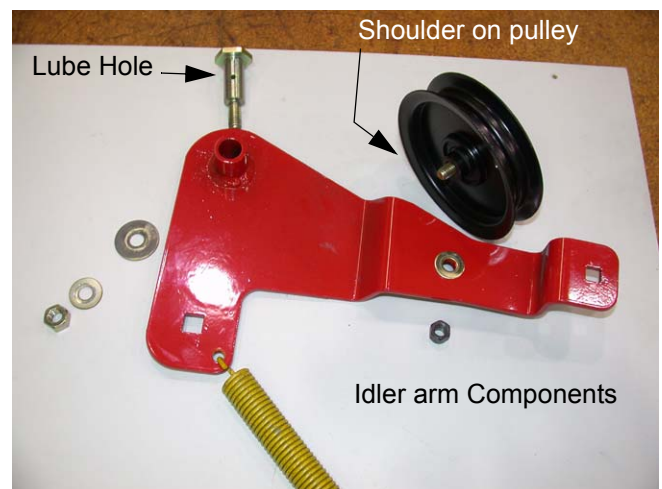
Figure 14

The Idler bracket removed showing the hole in the pivot bolt for lubrication of the sleeve. Also note the shoulder on the idler goes down. See Figure 14.

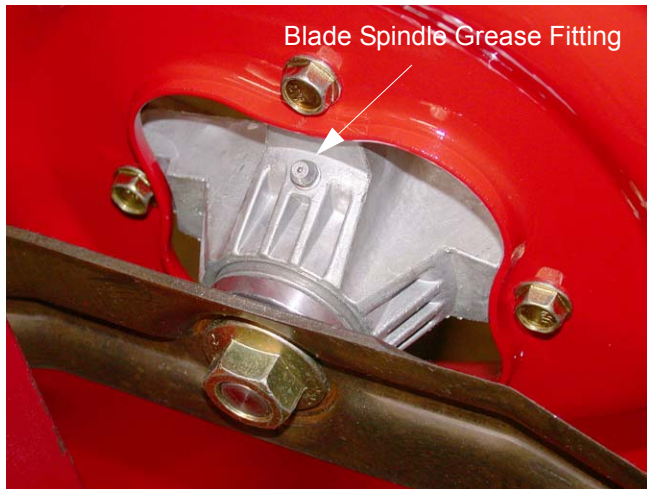
Figure 15

View of the blade spindle showing the position of the grease fitting for lubrication. See Figure 15.

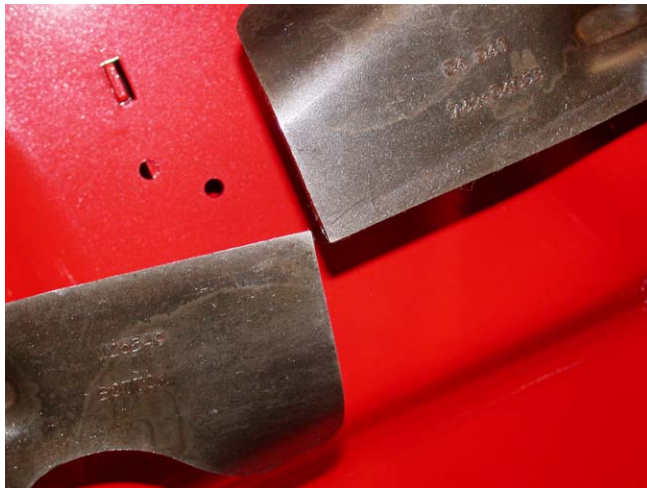
Figure 16

View showing the blade alignment and tolerance between blades of 3/16. See Figure 16.

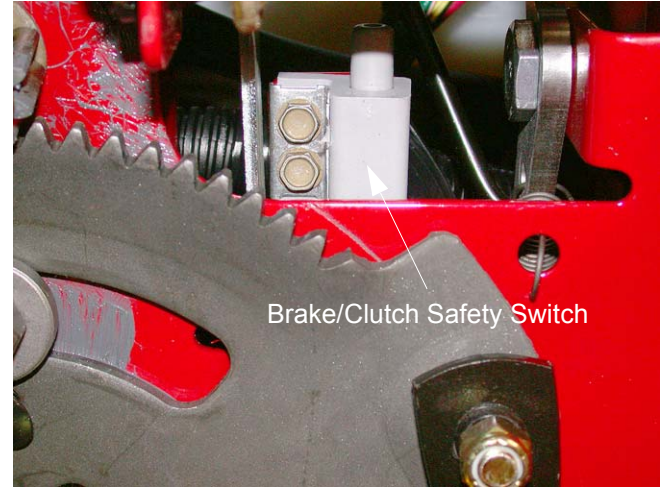
Figure 17

The brake /clutch safety switch location just in front of the steering gear segment. See Figure 17.

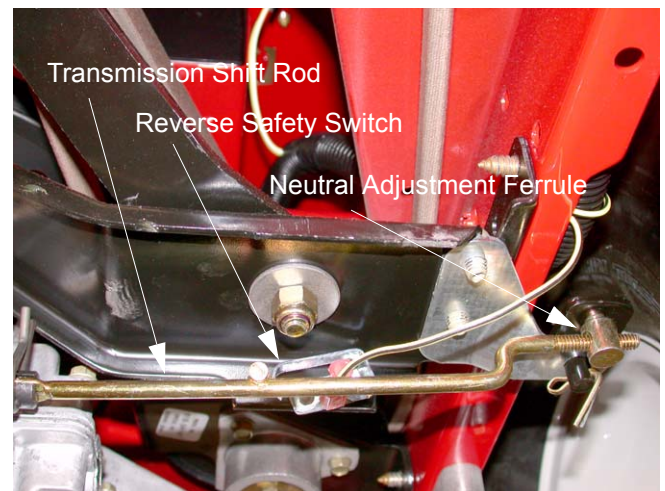
Figure 18

An updated view of the transmission shift rod, the neutral adjustment ferrule, and the reverse safety switch. See Figure 18.
