# 2012 ATV and ROV Updates

# 2012 ATV and Prowler Update

# HDX Transmission Improvements

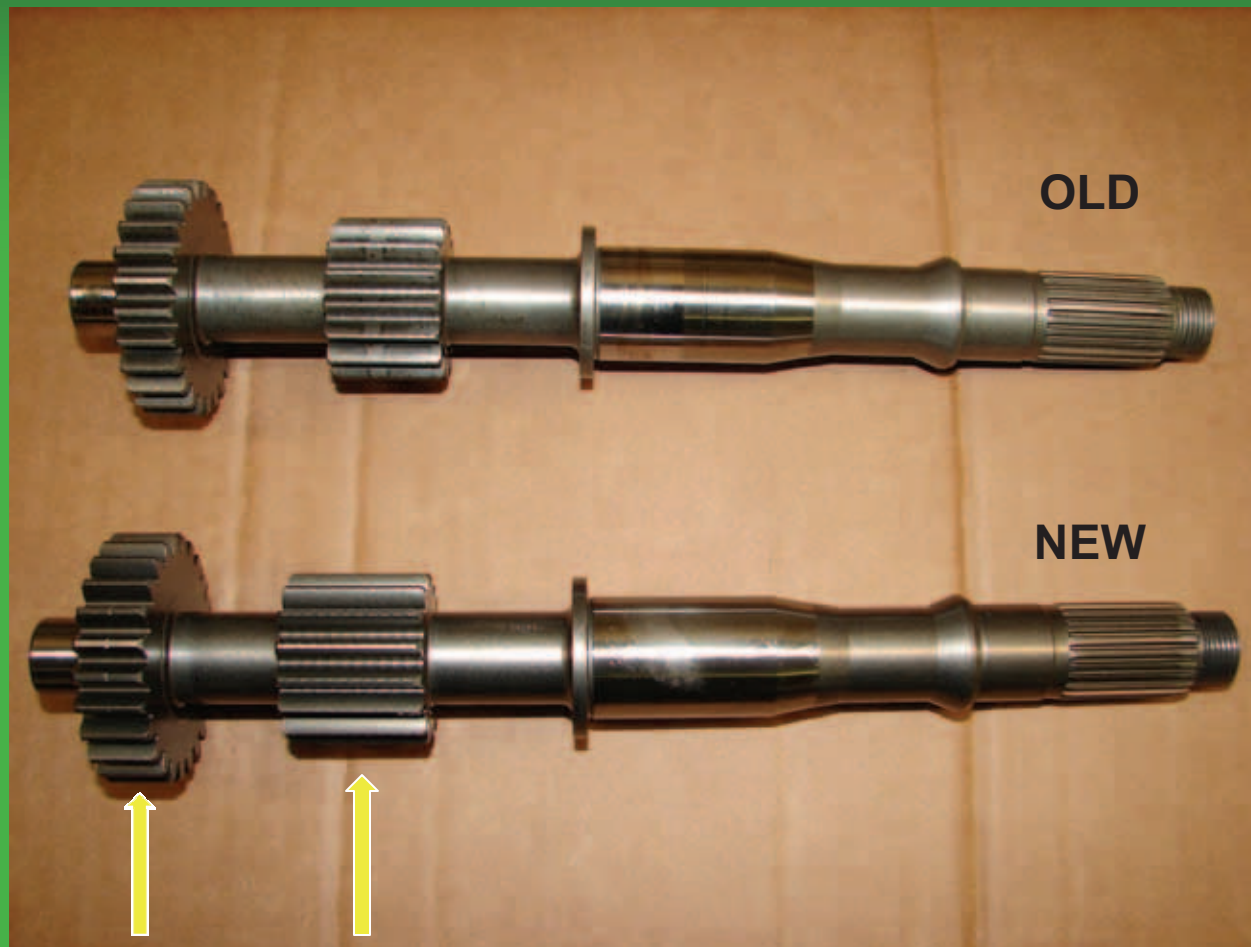
# Drive Shaft

**Wider gears on drive shaft**

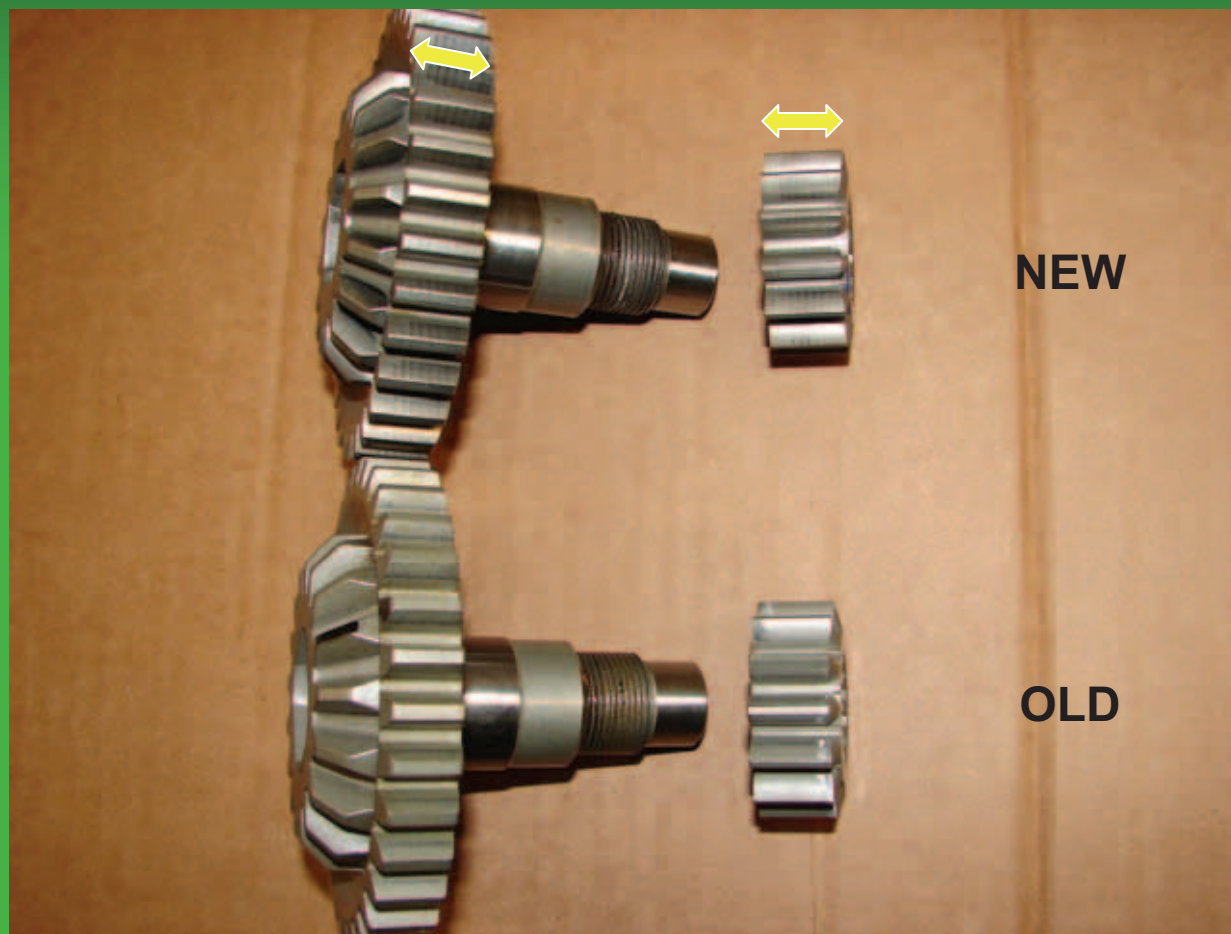
# Secondary Drive Gear

**Wider gears on the secondary drive.**

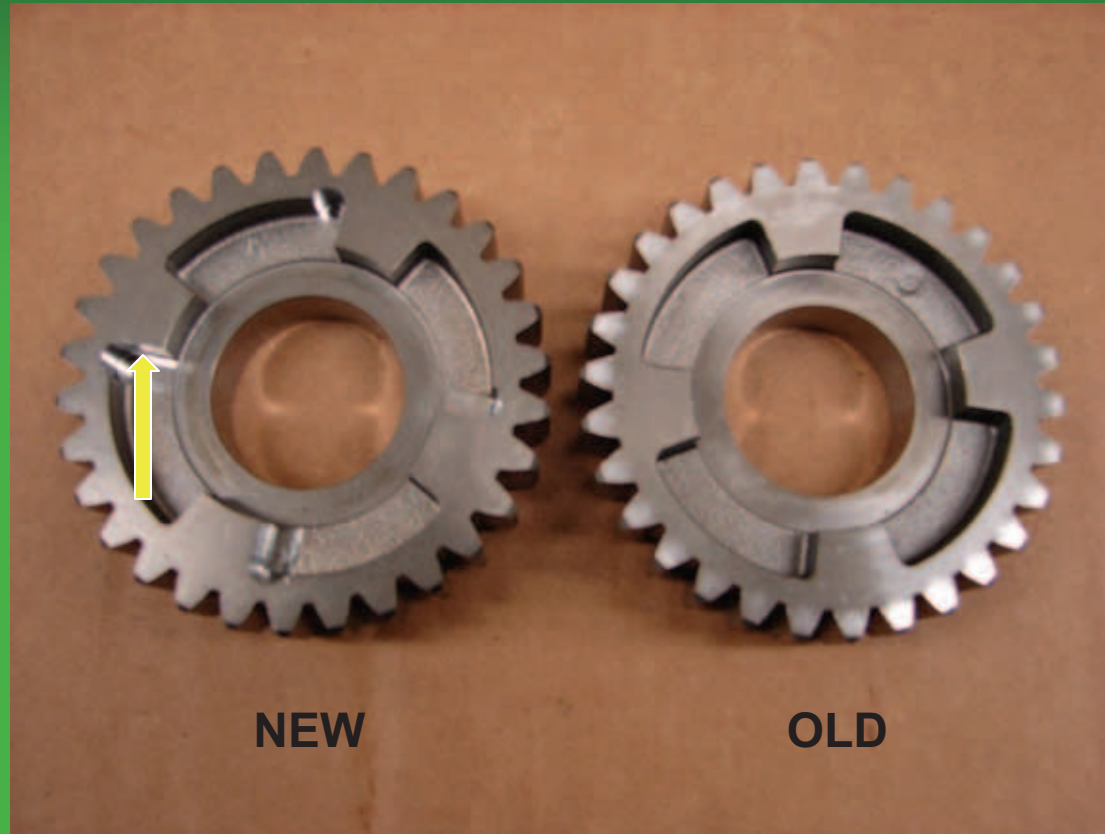
# Driven High Range Gear

**Engagement surface on the driven high range gear has 0.5° undercut to keep the gear and slider engaged**

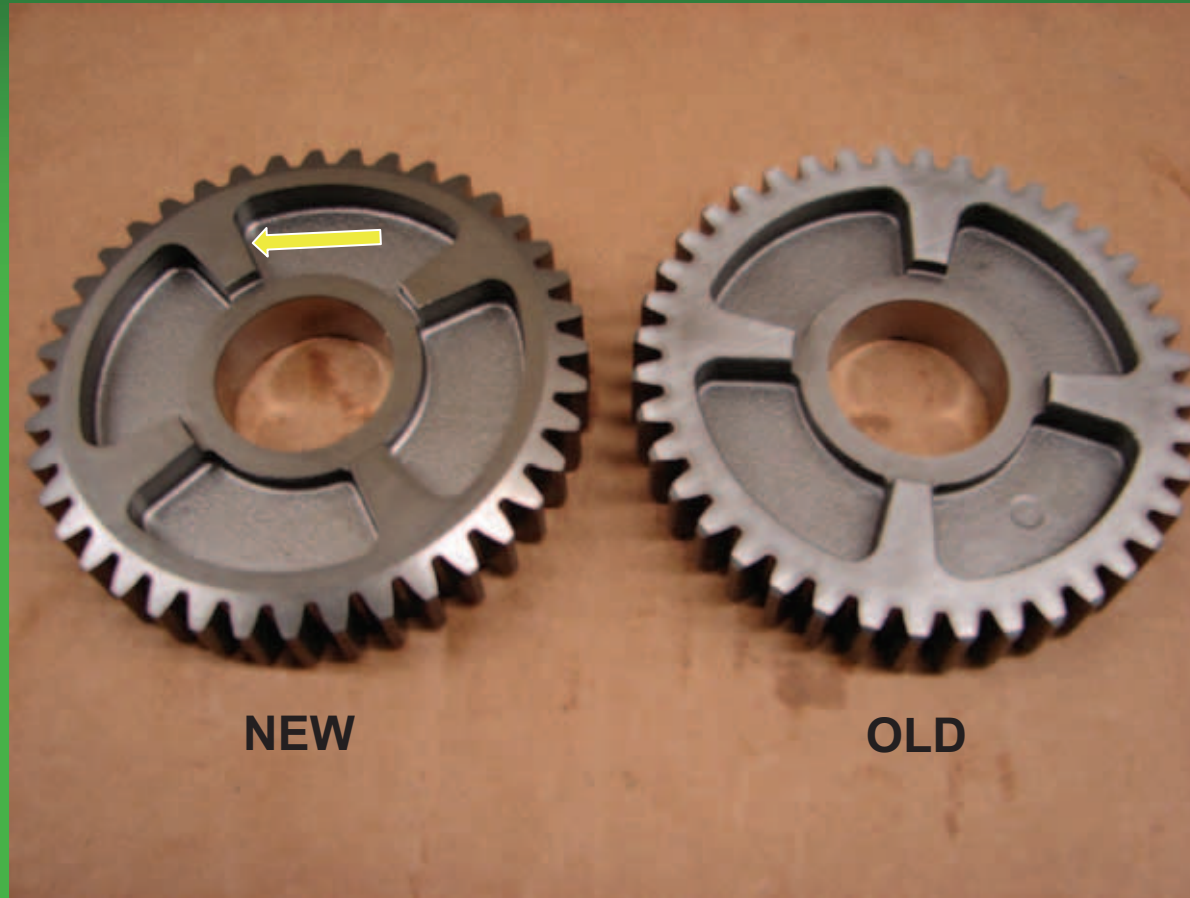
# Driven Low Range Gear

**Low range gear now has a forged chamfer,  
this will help against breaking.**

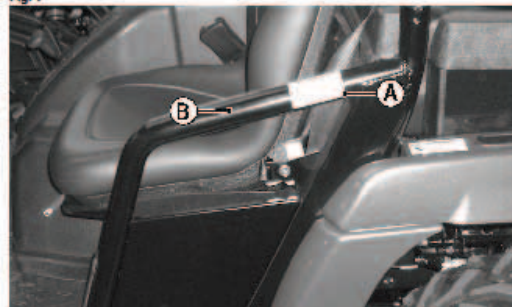
Fig. 1

**Condition:** The affected models have been manufactured without the ROPS (Roll Over Protective Structure) Warning Decal and needs to be adhered to the operator side hip restraint bar.

**Instructions:** Clean the intended decal area; then remove the backing from ROPS Warning Decal (A) and adhere to the outside of the operator side hip restraint bar (B). See Fig. 1.

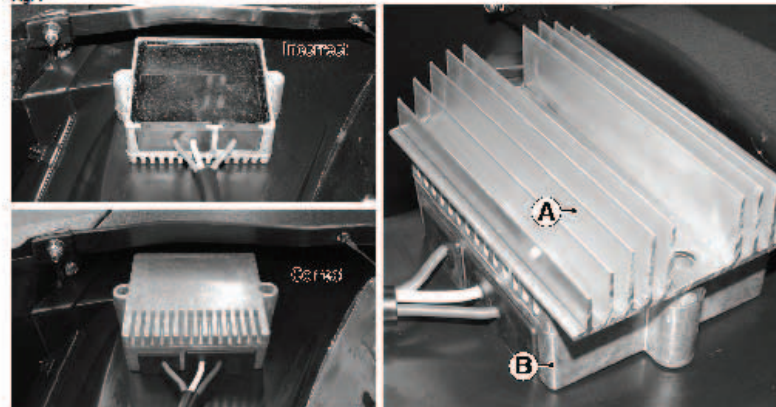
Fig. 1

**Condition:** On the affected models, the voltage regulator may have been installed upside down and should be corrected.

1. Open the hood; then remove the two machine screws and nuts securing the voltage regulator and the heat regulator to the right-side belly pan.
2. Make sure the aluminum side of the voltage regulator is facing up; then secure the heat regulator (A) and voltage regulator (B) to the right-side belly pan using existing machine screws and nuts. Tighten securely. See Fig. 1.
