RIDER 850 - THE 1988 MODEL

7: X 88.008-26 1.15 5-88

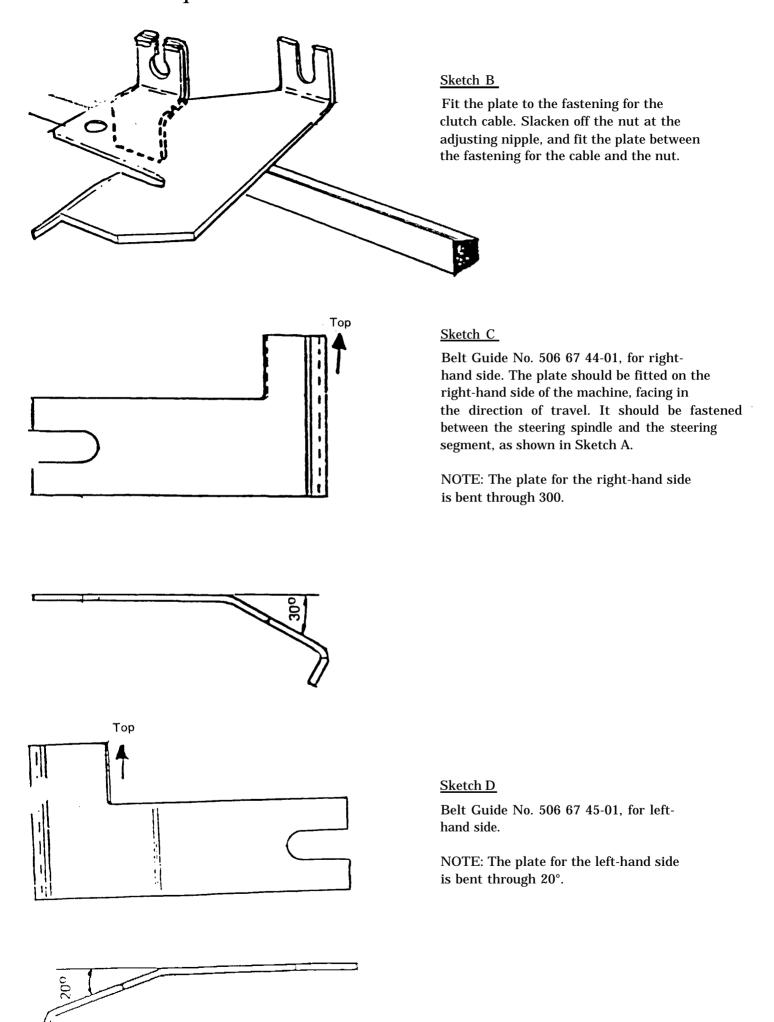
The 1988 model of the Rider 850 features a new gearbox. Since the gearbox has now been reinforced, and has four carrier keys where the old gearbox had only two, the friction in the gear shift mechanism is greater. This can sometimes make it difficult to disengage a gear, especially on a slope. The drive belt tries to become circular when the gears are disengaged, and is thus touching the drive wheels of both the engine and the gearbox. This results in the gear shift mechanism becoming "prestresses" and makes it difficult to engage the next gear.

Sketches C and D show the plates that should be fitted to the fastenings in the steering spindle.

How to remedy the problem: Fit belt guides as shown in Sketch A. The plates (1) and (2) should be fitted to the fastenings in the steering spindle for the steering cables, A further plate (3) should be fixed to the fastening for the clutch cable as shown in Sketch B. The bolt (4) should be fitted in the groove in the disengagement arm, and then adjusted so that the distance between the head of the bolt and the belt is 5 mm when a gear is engaged. The bolt should be at the same height as the belt.

Fitting these belt guides produces complete disengagement of the gearbox drive wheel, and makes the gears easy to change.
