RIDER 850 - THE 1988 MODEL

7: X 88.008-26 1.15 5-88

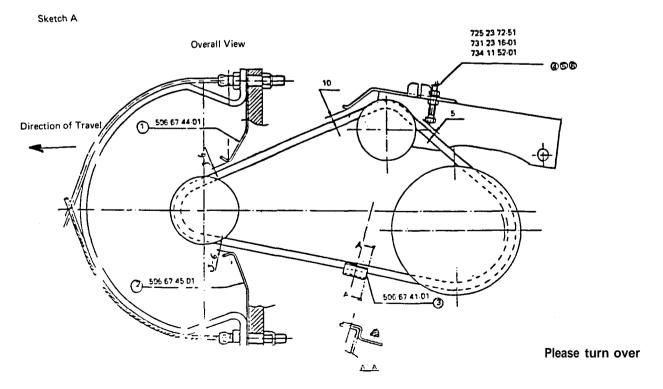
The "1988 model of the Rider 850 features a new gearbox. Since the gearbox has now been reinforced, and has four carrier keys where the old gearbox had only two, the friction in the gear shift mechanism is greater. This can sometimes make it difficult to disengage a gear, especially on a slope. The drive belt tries to become circular when the gears are disengaged, and is thus touching the drive wheels of both the engine and the gearbox. This results in the gear shift mechanism becoming "prestresses" and makes it difficult to engage the next gear.

Sketches C and D show the plates that should be fitted to the fastenings in the steering spindle.

How to remedy the problem: Fit belt guides as shown in Sketch A. The plates (1) and (2) should be fitted to the fastenings in the steering spindle for the steering cables. A further plate (3) should be fixed to the fastening for the clutch cable as shown in Sketch B. The bolt (4) should be fitted in the groove in the disengagement arm, and then adjusted so that the distance between the head of the bolt and the belt is 5 mm when a gear is engaged. The bolt should be at the same height as the belt.

Fitting these belt guides produces complete disengagement of the gearbox drive wheel, and makes the gears easy to change.
