Service Advisory

W-140

Models Affected: LT 942G (13AX605G790)

Subject: **ANCHOR POINT FAILURE ON DECK**

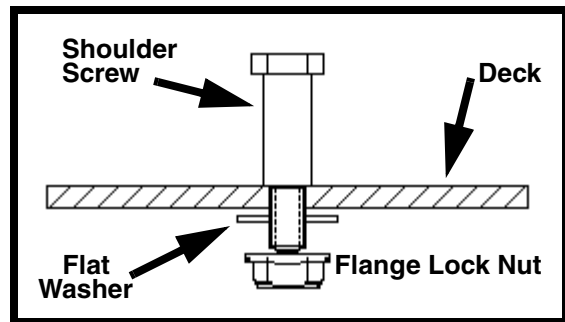
PURPOSE: To provide a stronger anchoring point for the deck belt idler spring.

9. Attach the tension spring onto the new shoulder screw anchor point.
10. Reinstall deck and test run unit for proper operation.
